**Drainage Strategy Report (DSR) For:**  
New Build Classrooms,  
Ty Dysgu Primary School,  
Market Street, CF48 2AJ

Merthyr Tydfil CBC

REF: 16691 – DSR R02 Iss2

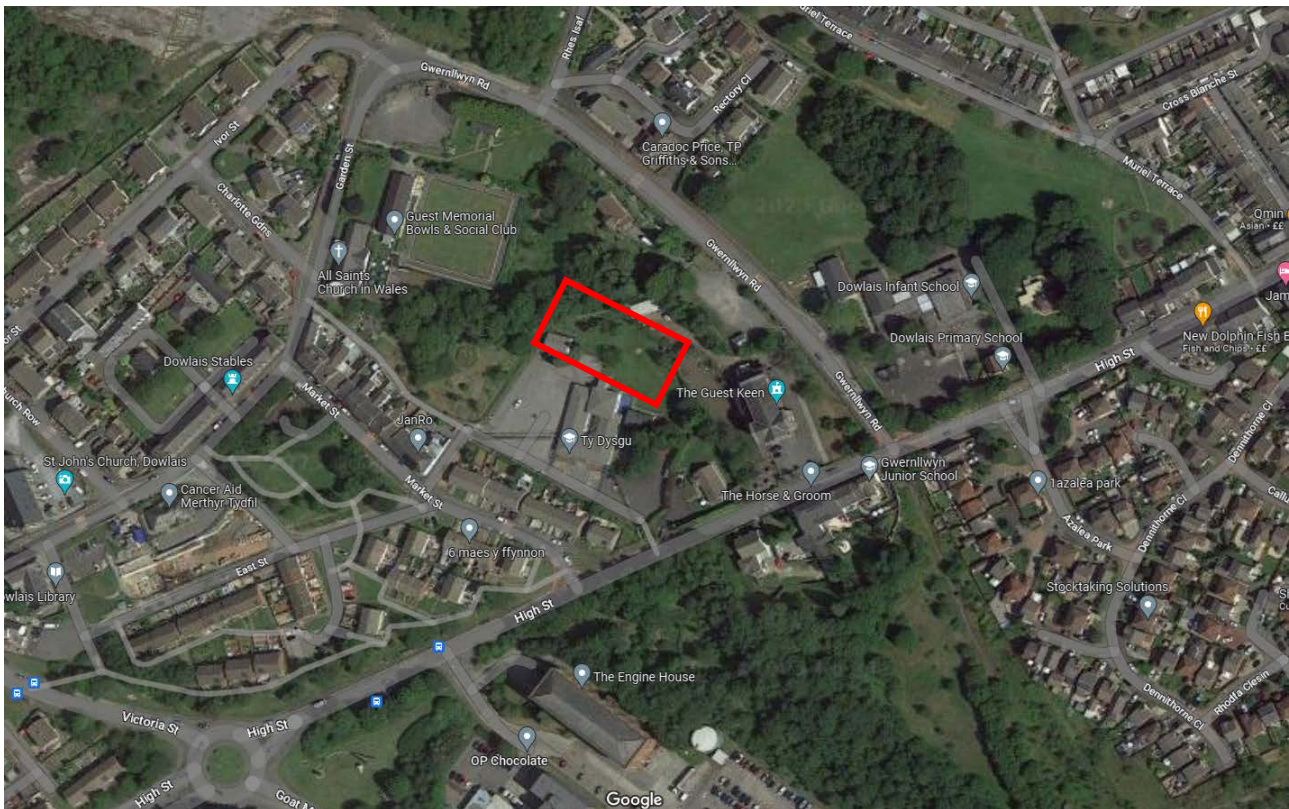
Figure 1 - Site Location Plan

The development site has a total site area of **2203 m<sup>2</sup> (0.22ha)** of unused land.

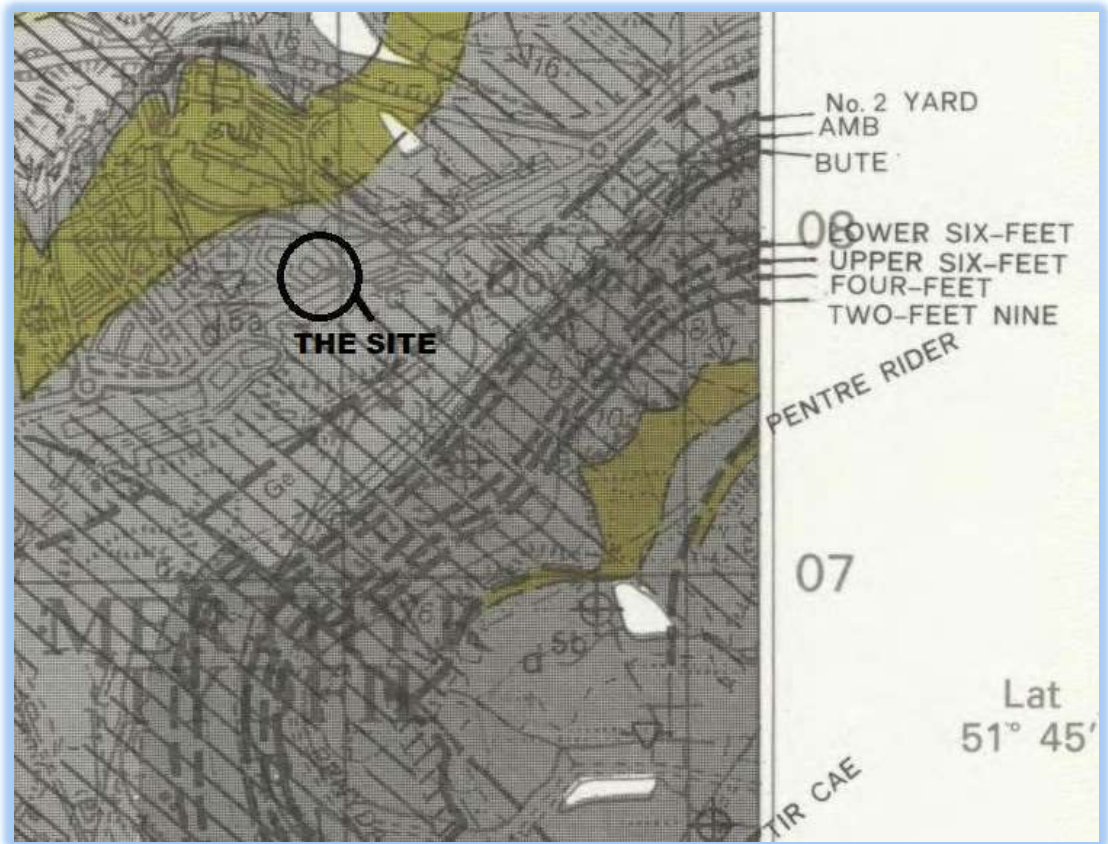
**Figure SGS/22156/02: BGS Solid Map**

- **Superficial deposits**  
*Till, Devensian - Diamicton. Sedimentary superficial deposit formed between 116 and 11.8 thousand years ago during the Quaternary period.*
- **Bedrock geology**  
*South Wales Lower Coal Measures Formation - Mudstone, siltstone and sandstone. Sedimentary bedrock formed between 319 and 318 million years ago during the Carboniferous period.*

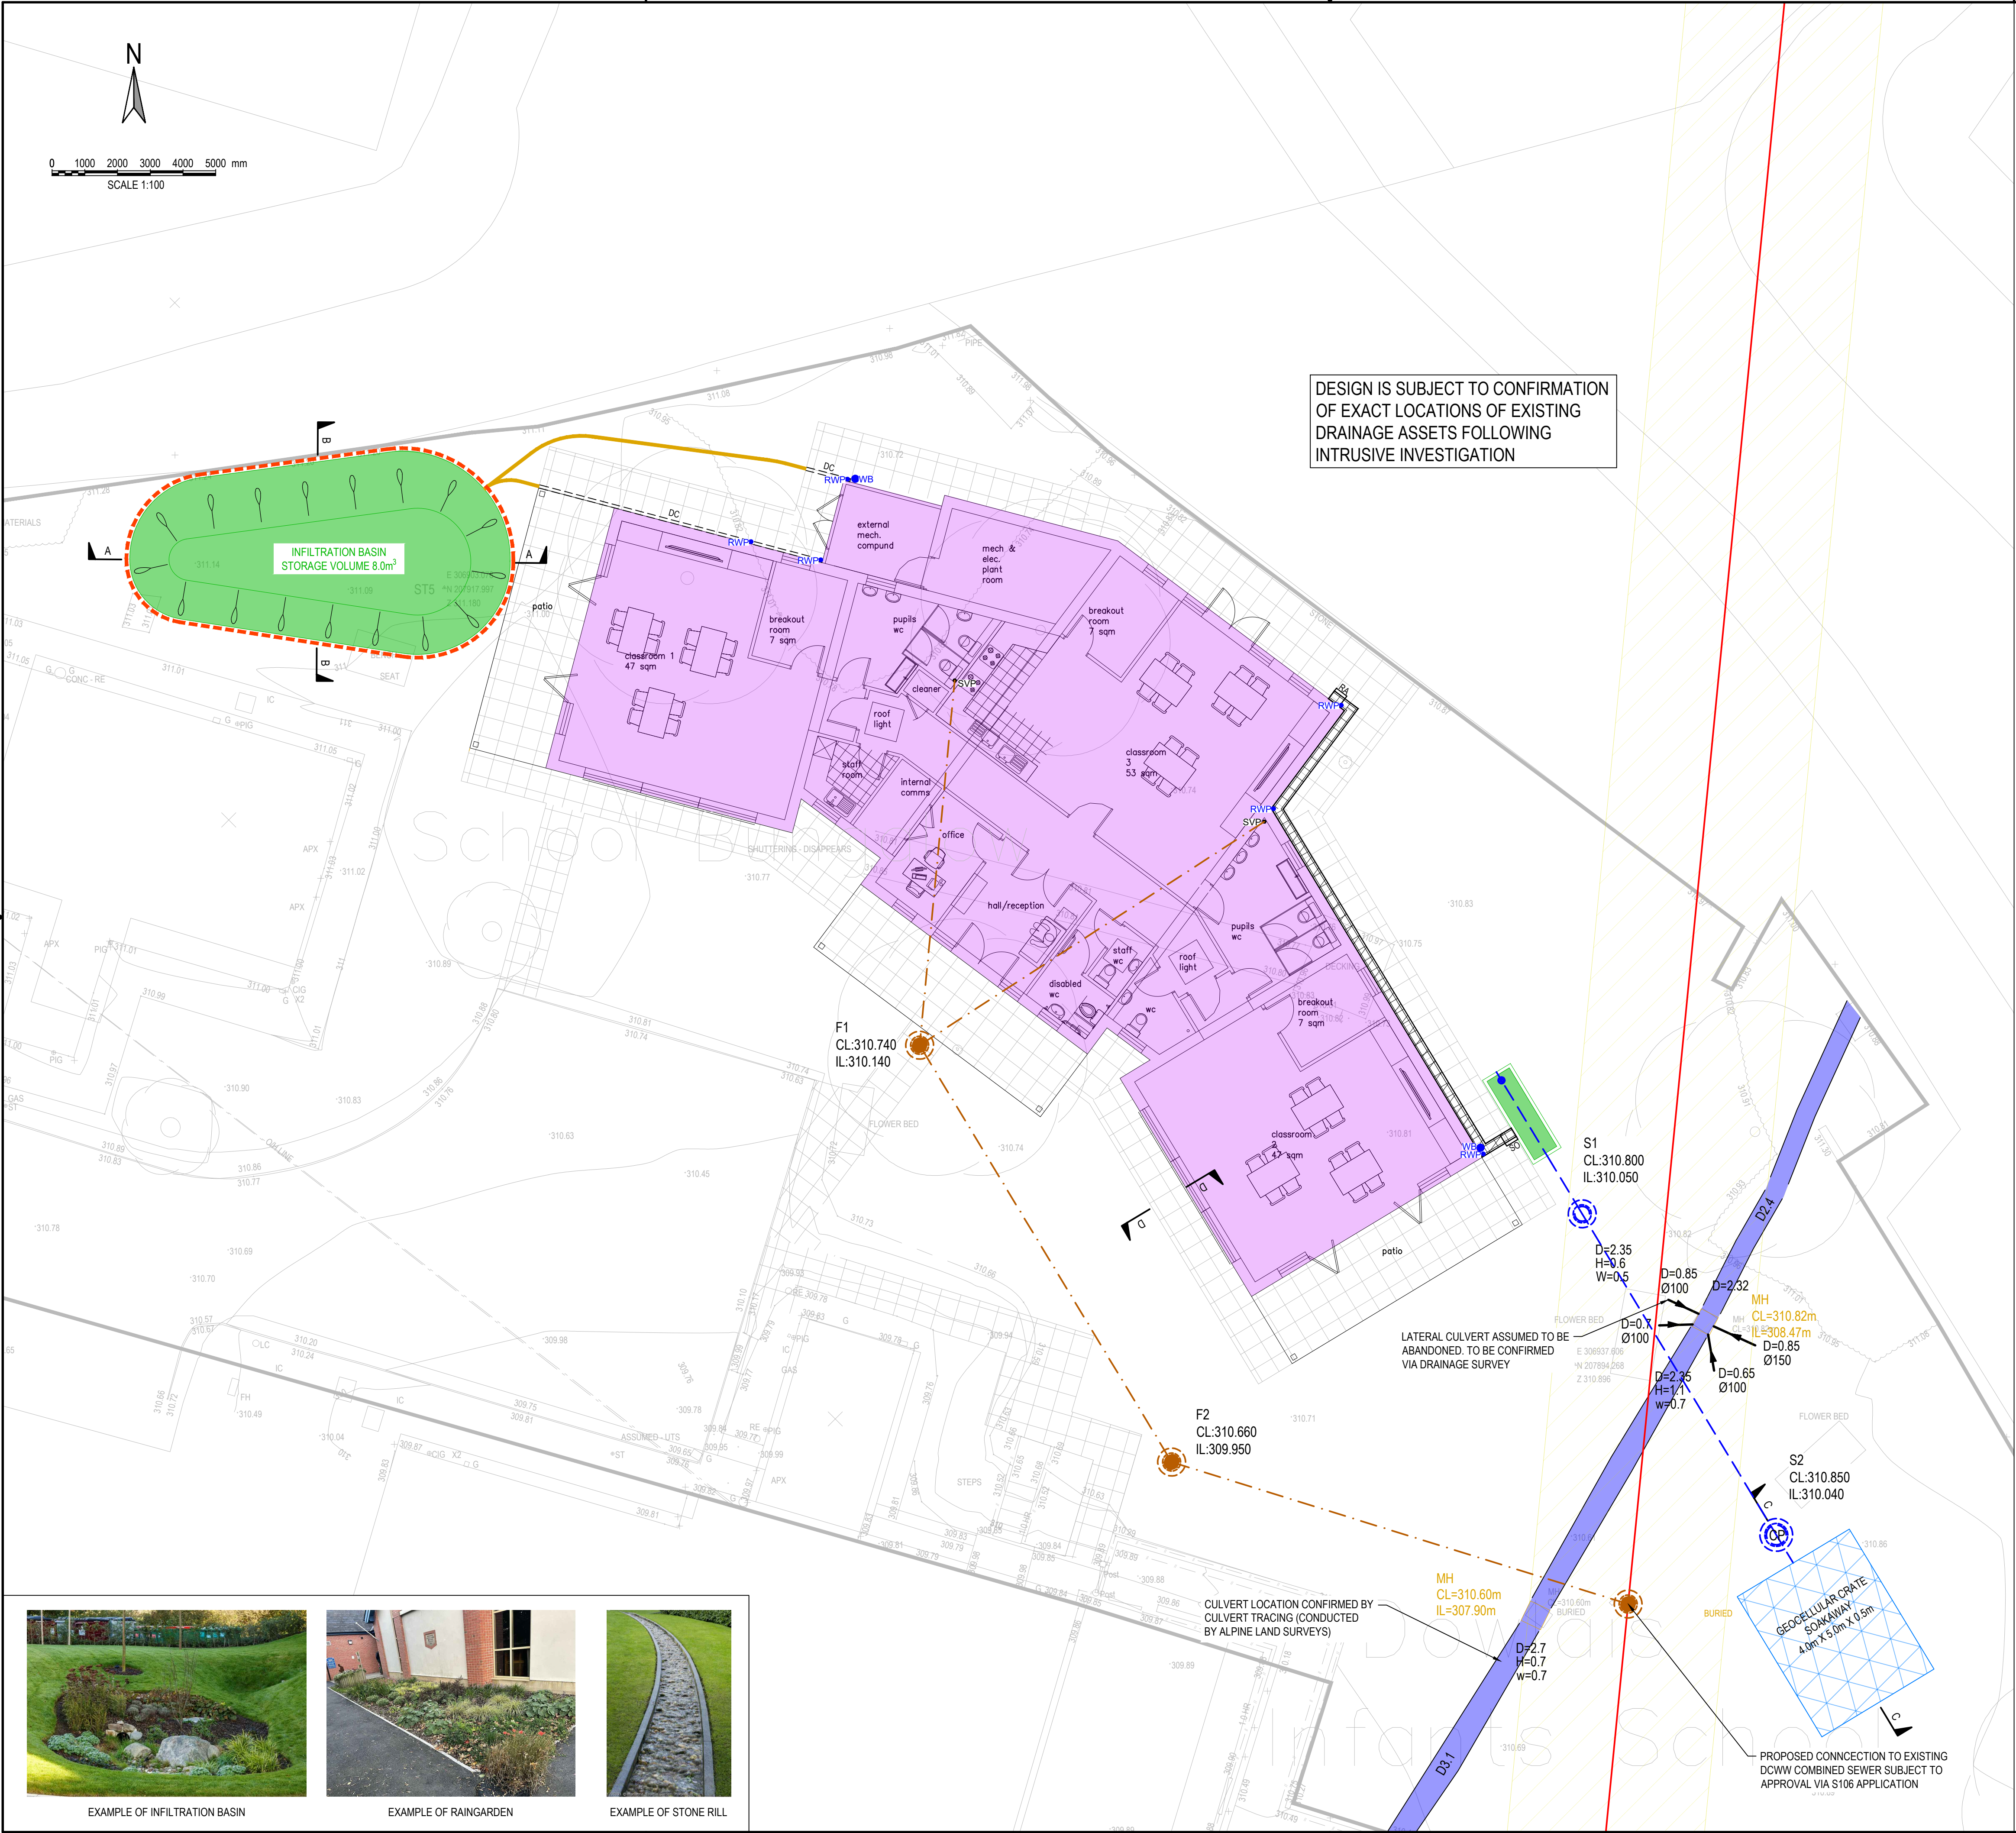
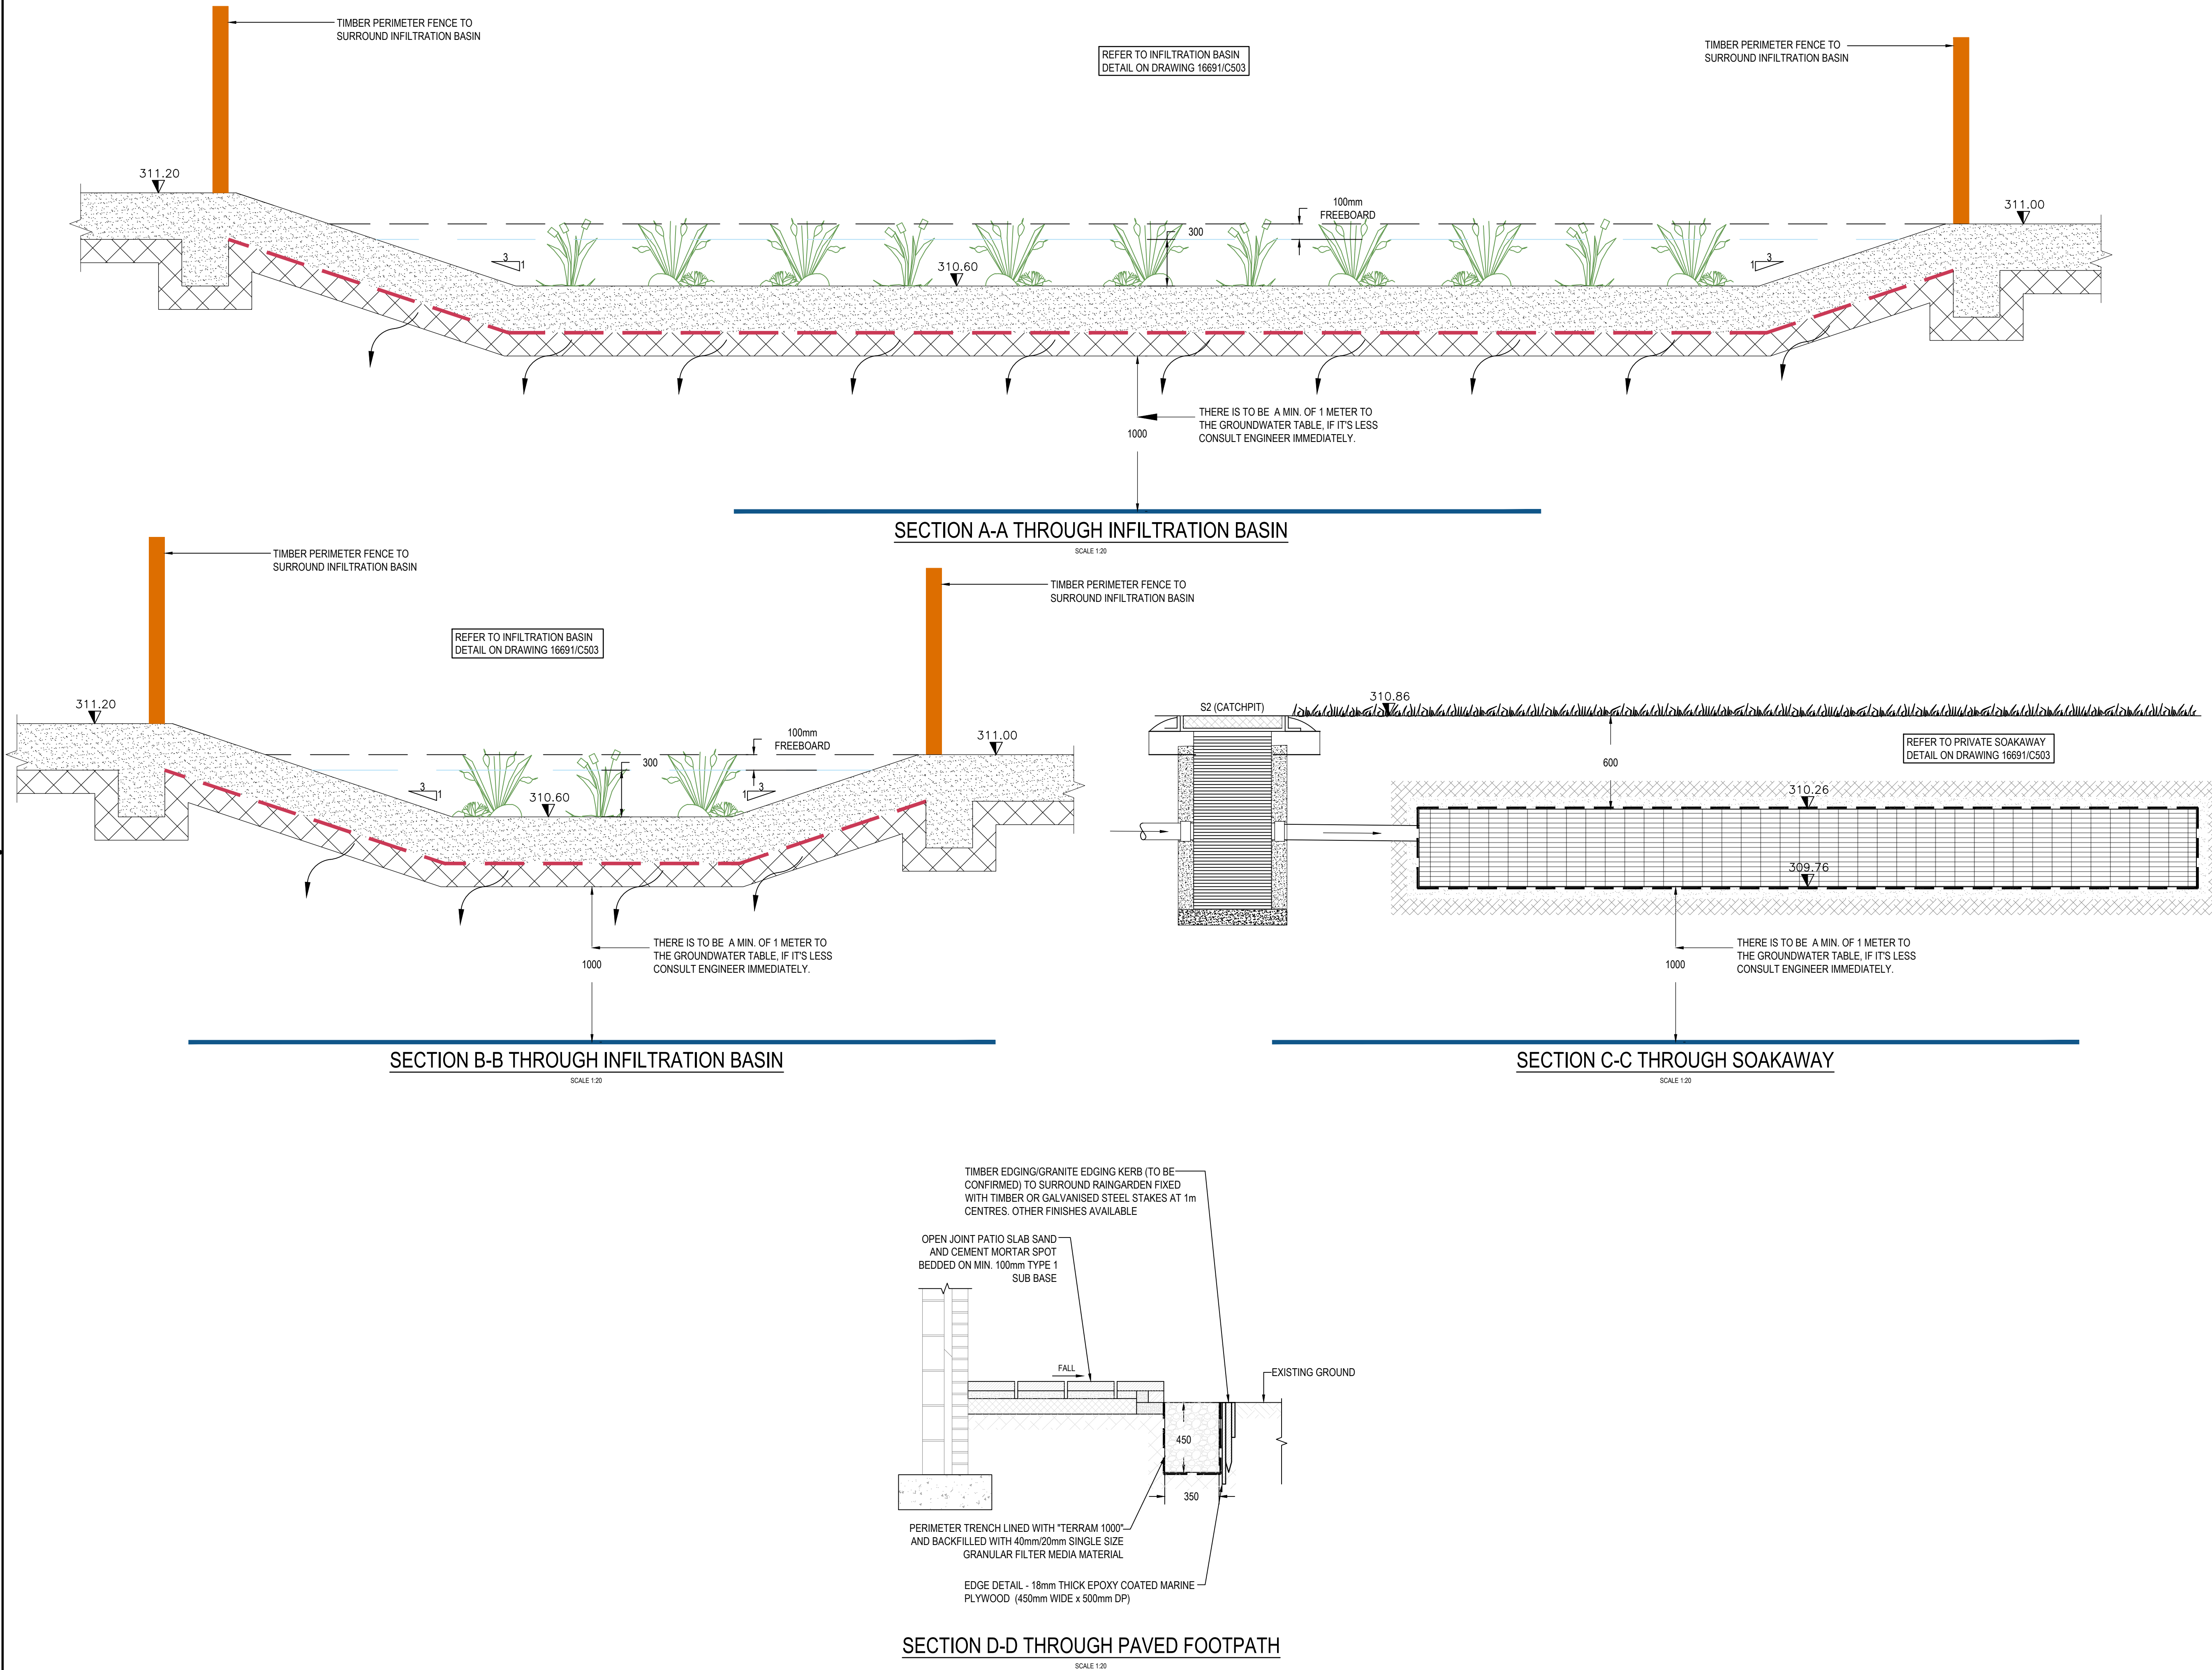
## APPENDIX H: C500 Proposed Drainage Layout and Details

The principles of the surface water management system are to discharge to a geocellular crate soakaway located to the South-East of the proposed building and also to an infiltration basin to the North-West of the proposed building. Surface water runoff will be collected from the rainwater pipes via raingardens, dished channels and an ACO linedrain .

Attenuation storage for catchment 1 will be provided by the infiltration basin and will be configured as shown in the proposed drainage layout (drawing 16691\_C500). Attenuation for catchment 2 will be provided as a below ground tanked geo-cellular crate soakaway system, the crate will be configured and located as shown in the drainage layout (drawing 16691\_C500). Although the site is considered as brownfield from a development perspective, as the site does not currently have any surface water management, it has been considered as greenfield for the purpose of the hydraulic calculations to replicate the natural water cycle and runoff rates.

The micro drainage source control model identifies that a total attenuation of 15.5m<sup>3</sup> is required. A total 16.0m<sup>3</sup> has been provided by both the geocellular crate soakaway (8.0m<sup>3</sup>) and infiltration basin (8.0m<sup>3</sup>). The geocellular crate soakaway and infiltration basin have been designed to provide a minimum 1m distance from the surface of the groundwater to their base.

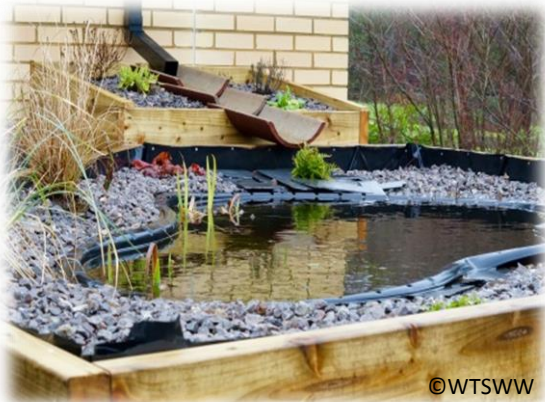
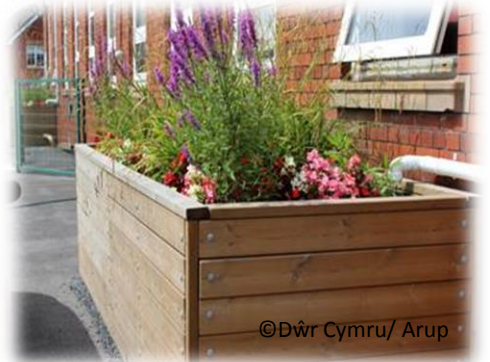
Rain gardens are usually depressions in the ground or raised planters into which a downpipe from the guttering is directed, thereby capturing water during storms that would otherwise have gone straight down the drain, helping to prevent flooding and pollution.

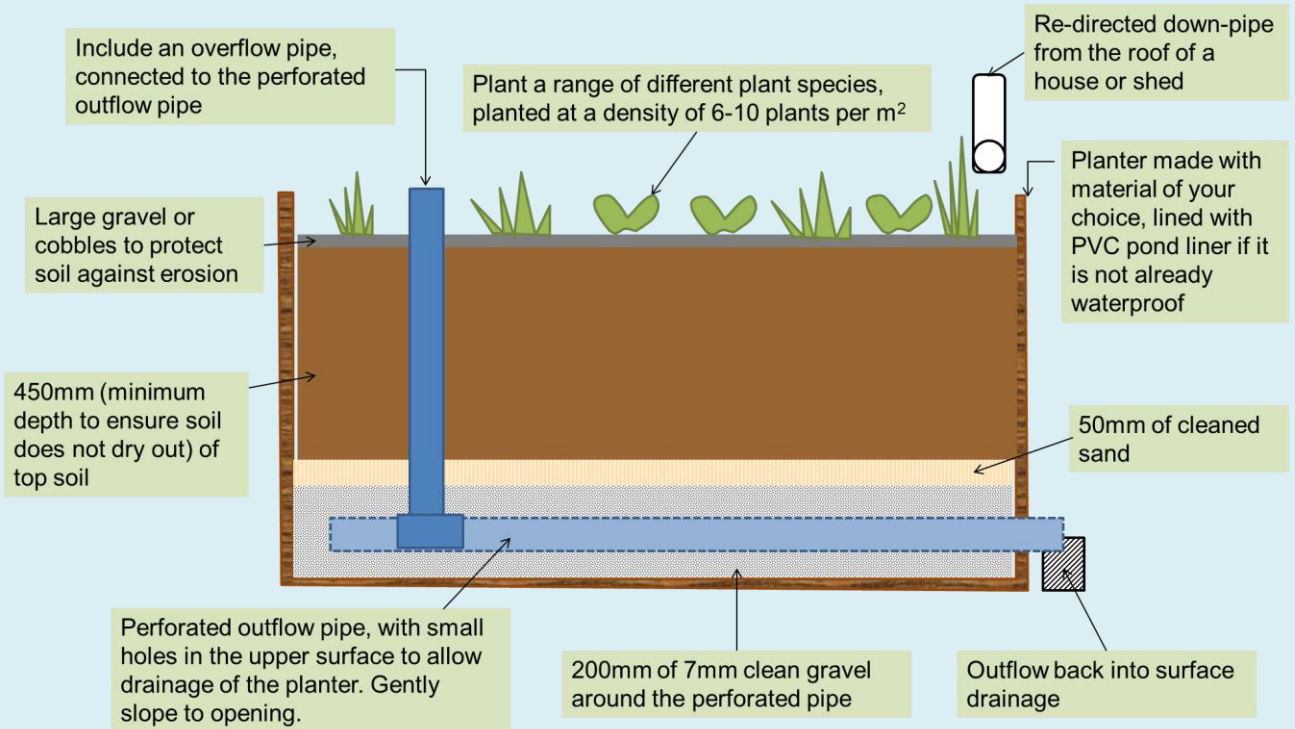
1. The first step is to identify the drain that your planter will empty in to.
2. You will then need to work out how much water your Rain Garden Planter may need to hold in litres. Do this by multiplying the average rainfall of your area (mm) (find via an internet search) by the area of the roof it will be fed by in m<sup>2</sup>. [1].
3. Decide how big you want the planter to be based on amount of water it will receive in high rainfall, and your own personal preference. It is recommended that the minimum planter depth is 45cm to provide adequate water storage. [2]
4. Build a planter with the following structure:

5. Re-direct the chosen downpipe into the planter. If you have any worries about the drainage, consult with your local plumber.
6. Sit back and enjoy your Rain Garden. Watch how it collects water when it rains.
