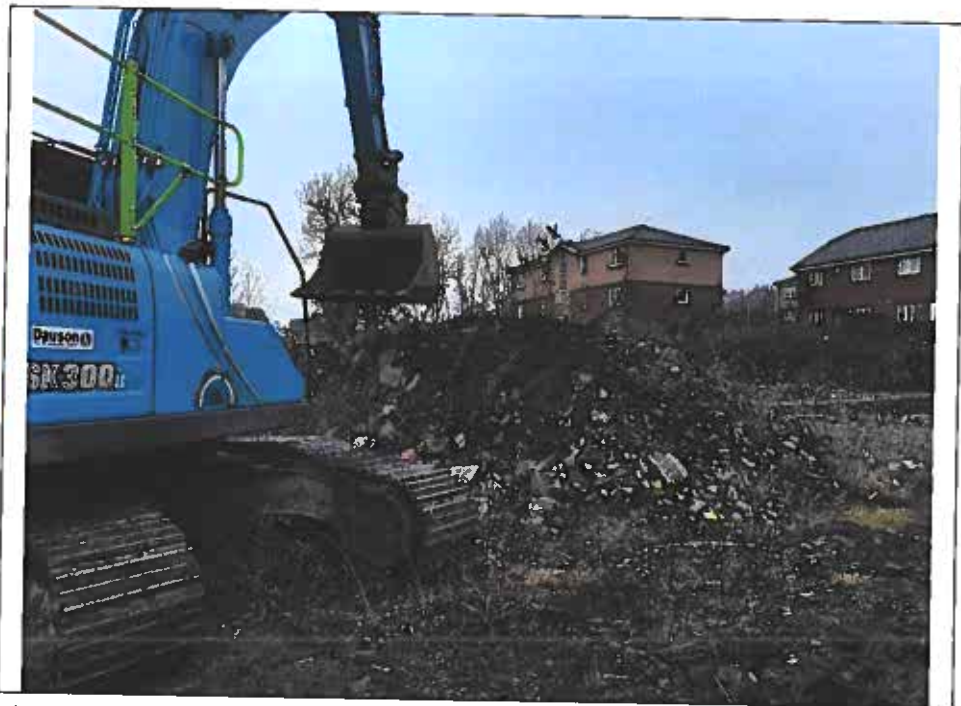
Plate 1: Overview of Stockpile 1 in the north of site.

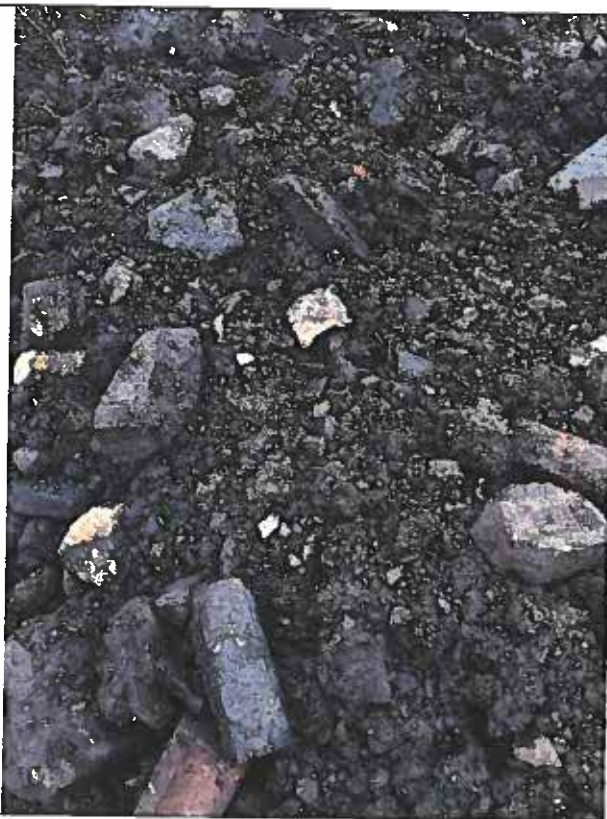
Plate 2: Stockpile 1A of black-grey made ground containing fine gravel to boulder-sized fragments of concrete, brick, wood, pipes, and linoleum.

7.4.3.3 For stockpiled materials to be safely re-used on site poorly sorted rubble would likely need to be processed to a grade where it would be geotechnically suitable and if hydrocarbon impacted pockets are removed (Stockpile sample 6C). The presence of asbestos materials and potential for their deterioration from crushing and screening activities could result in significant hazard to health and hamper re-use efforts where segregation is difficult, time consuming or expensive. It is recommended a remediation contractor is consulted to advise on practicality of segregating ACMs to allow processing. The very low levels of asbestos fibres indicate that airborne levels could be minimised during processing and placement. However, use of fibre impacted brick and concrete crush is recommended only under sufficient depth of clean cover and with robust safeguards. Placement as running surfaces/haul routes is not recommended due to potential for drying out and dust generation.
