# Synagogue, Merthyr Tydfil

## RECORD OF BUILDING AND CONDITION ASSESSMENT REPORT

.....  
(449)2503-GWP-A-HIS-P00

Date: 17.03.25

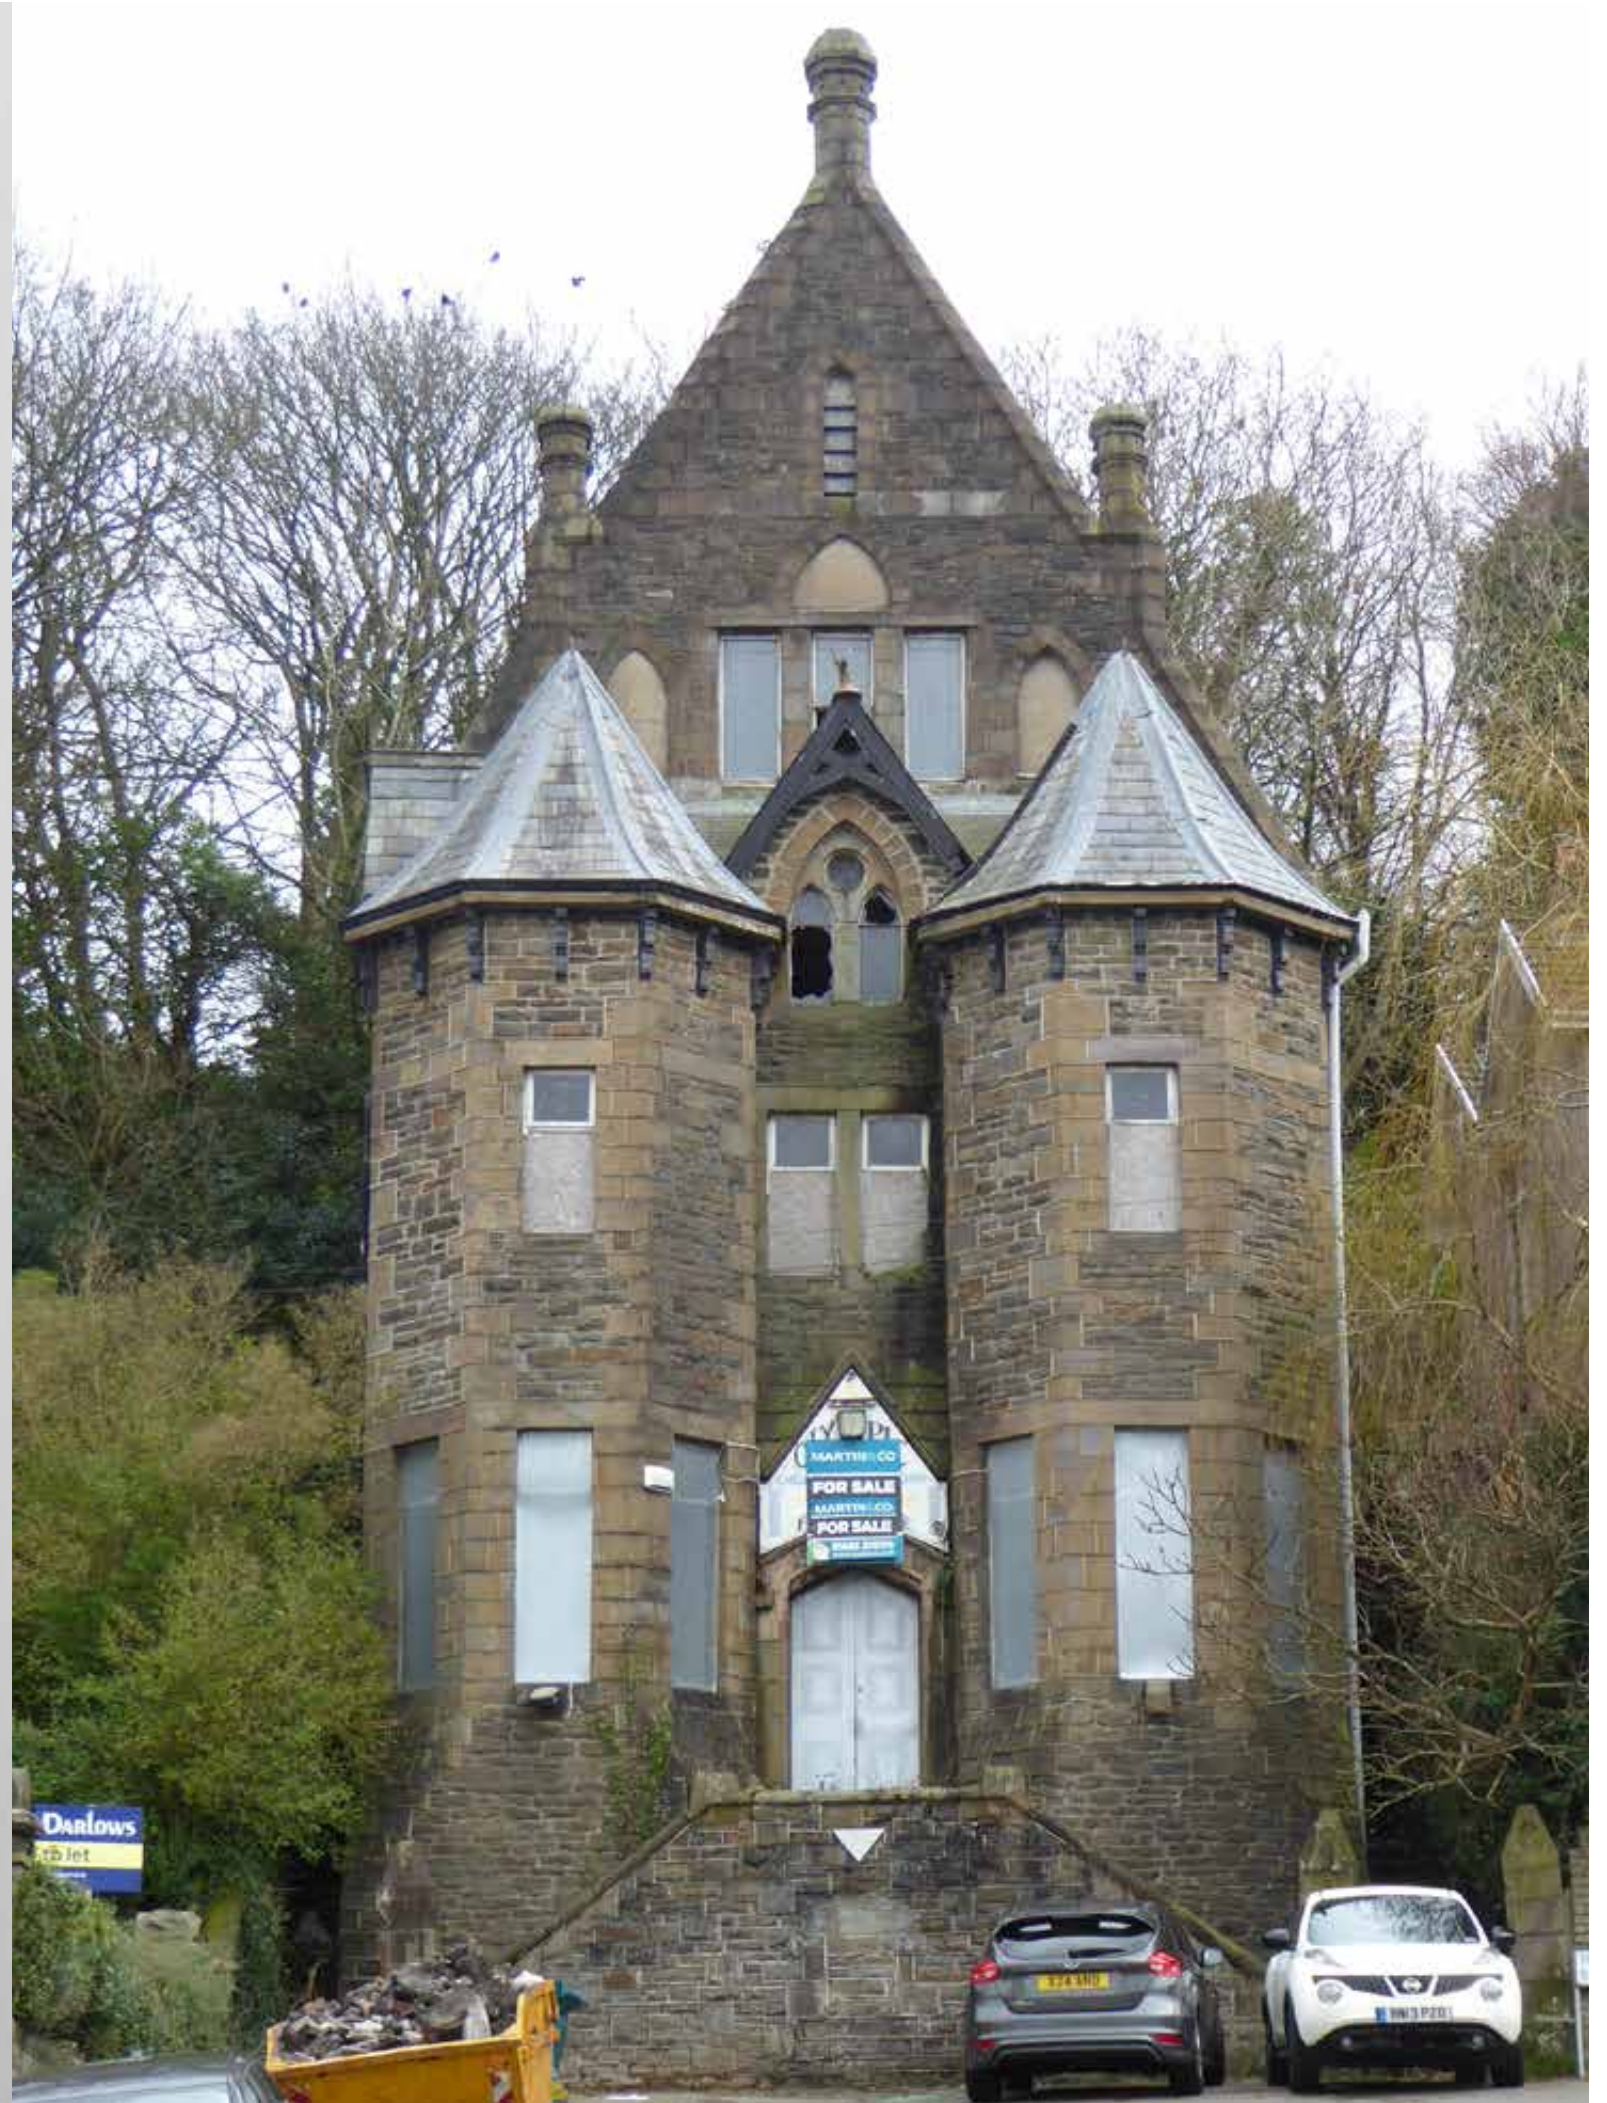
## 5.1 FRONT (WEST) ELEVATION

### Drawing Identifying Areas Of Poor Condition

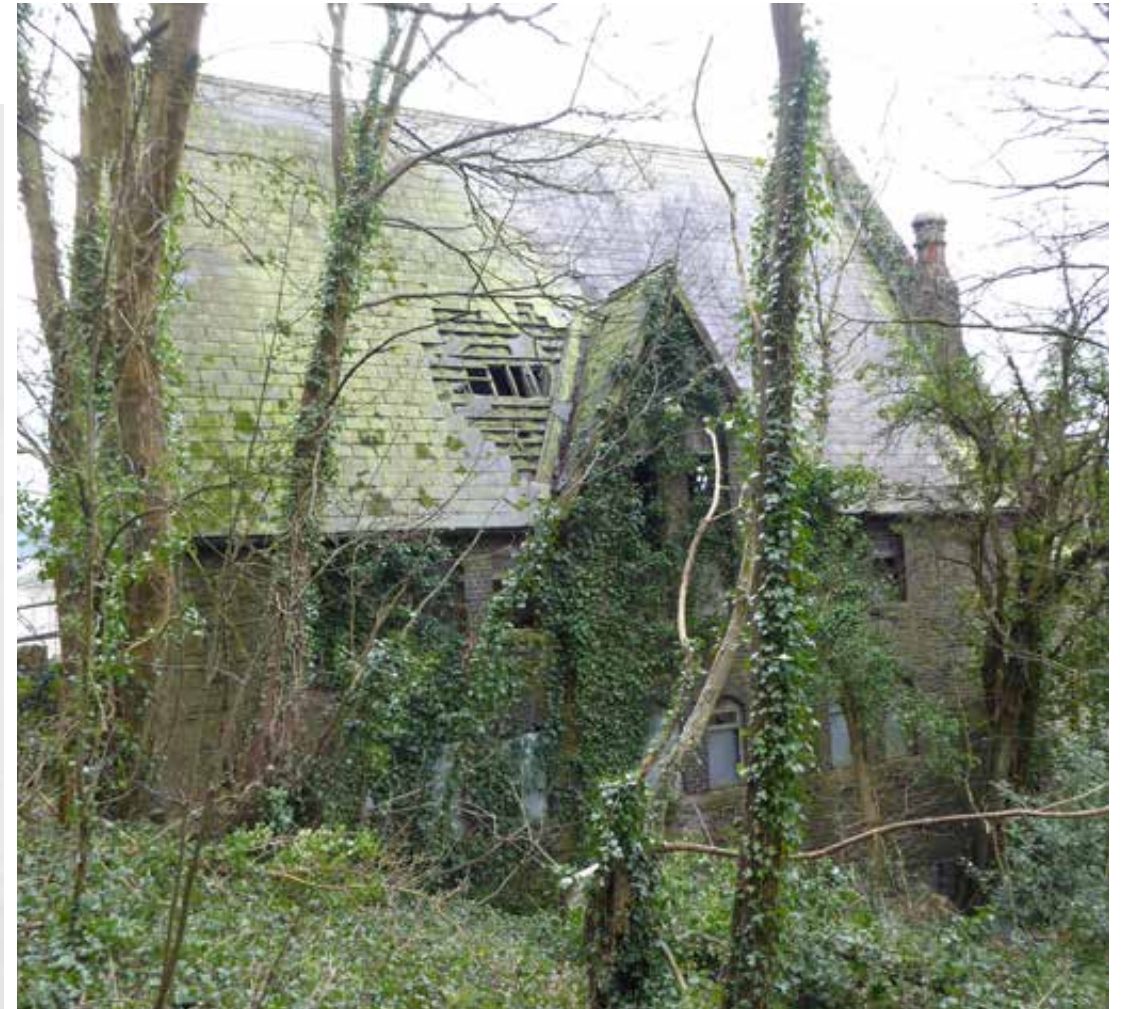
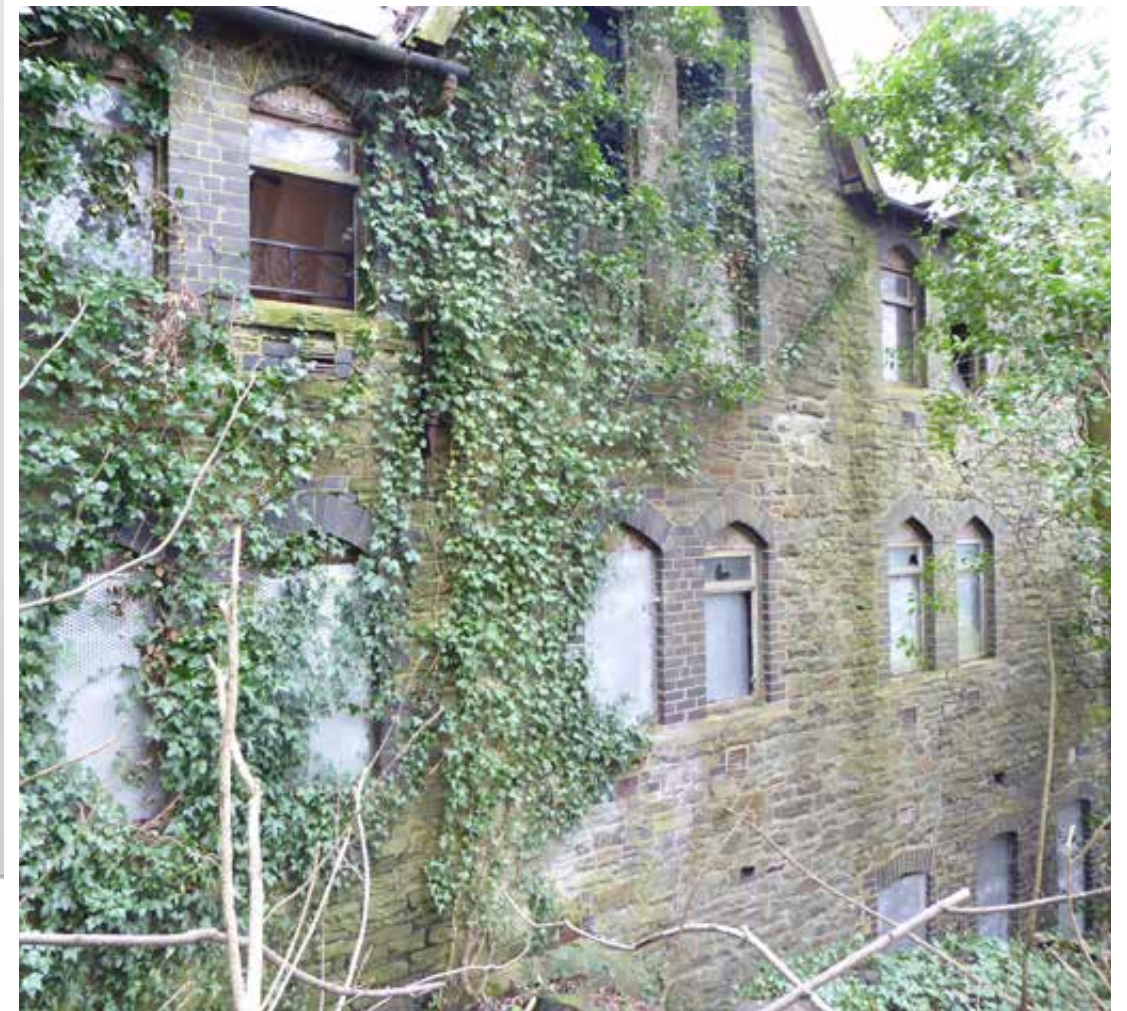
## 5.2 SIDE (NORTH) ELEVATION

### Drawing Identifying Areas Of Poor Condition

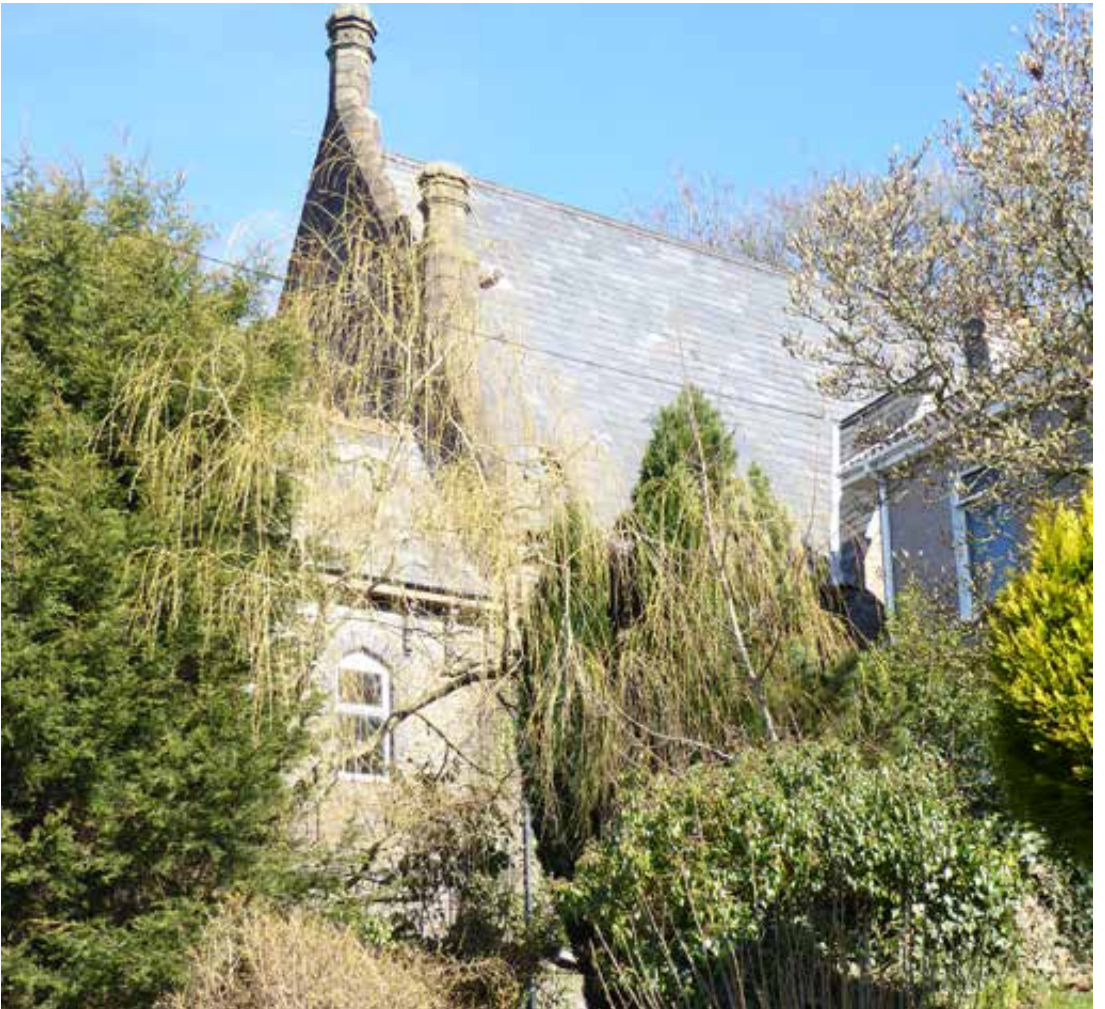
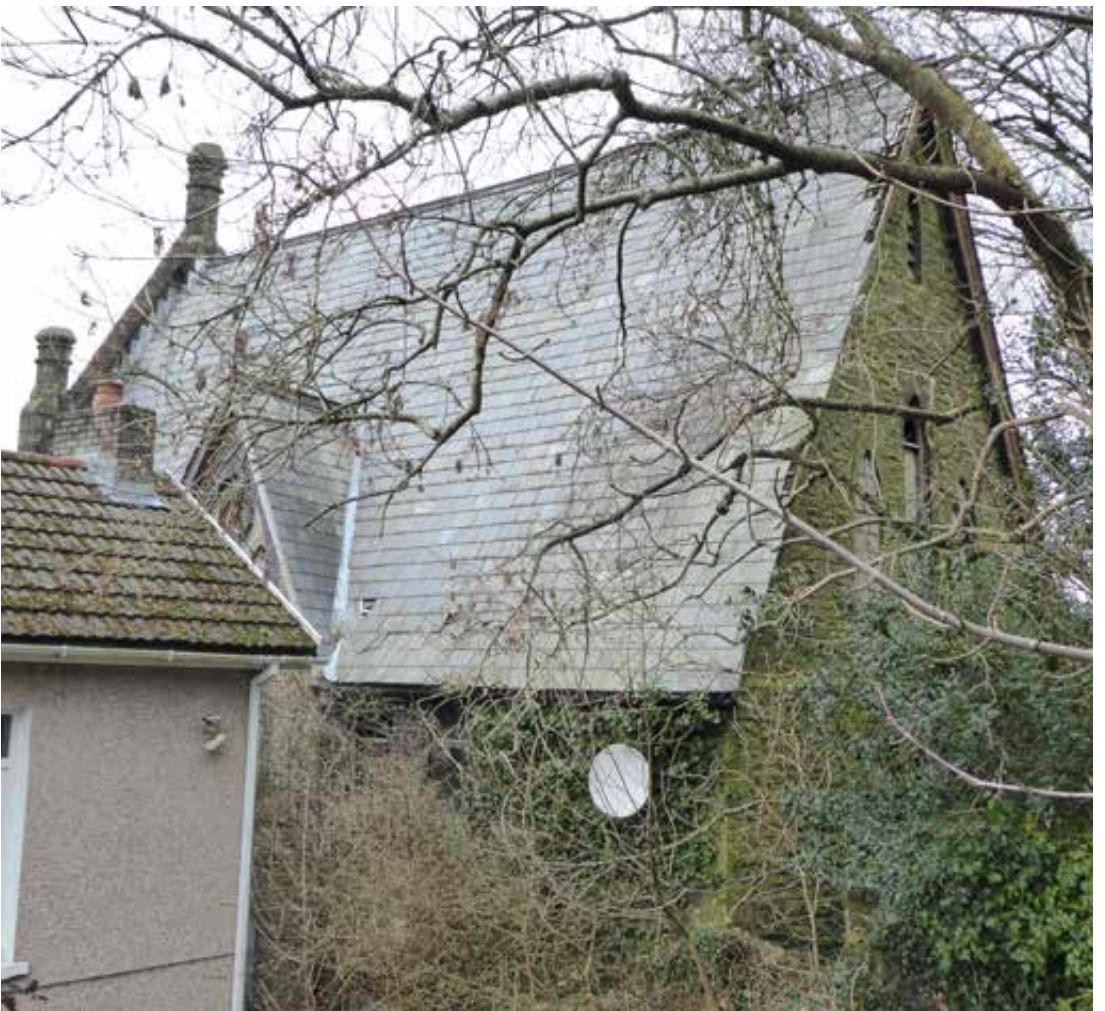
### 5.3 SIDE (SOUTH) ELEVATION

#### Drawing Identifying Areas Of Poor Condition

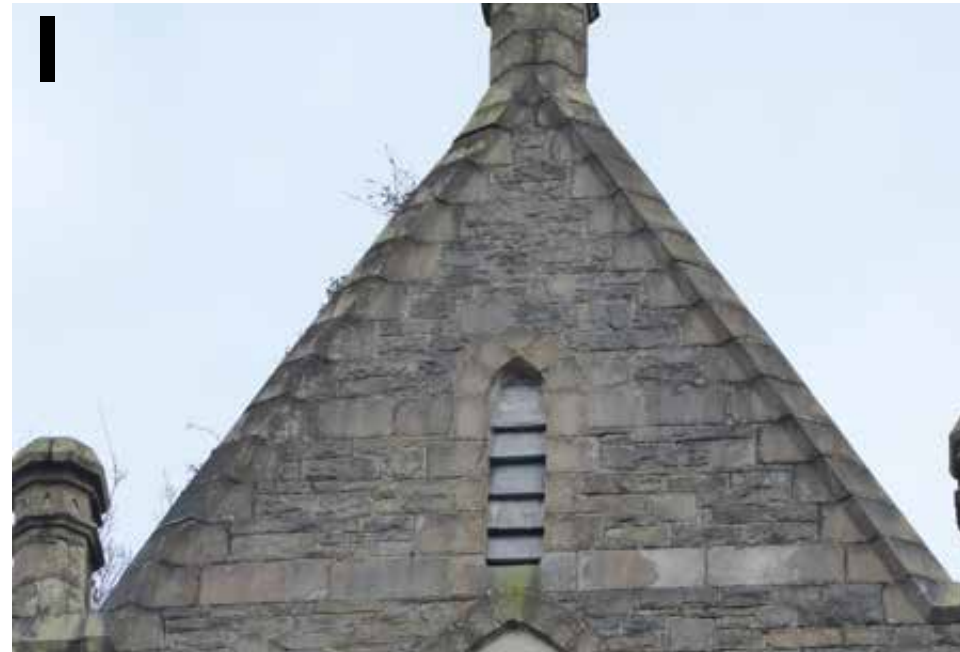
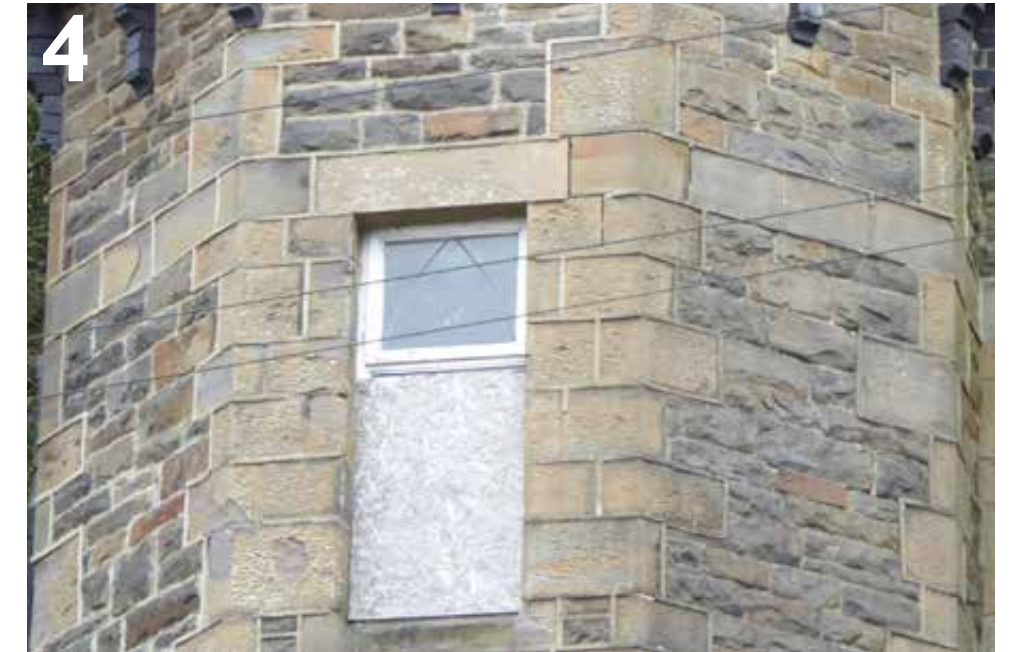
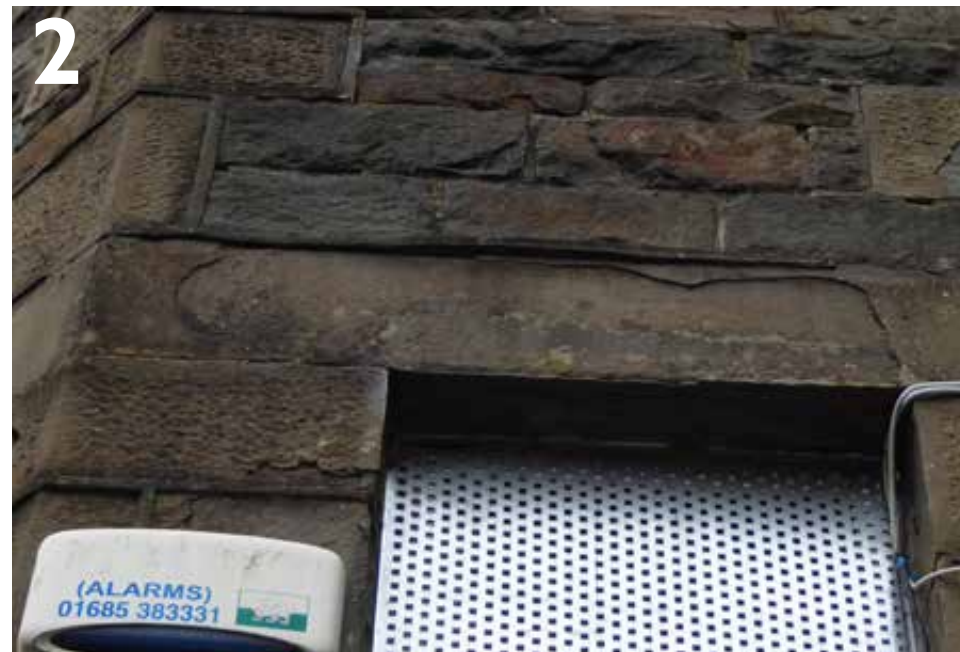
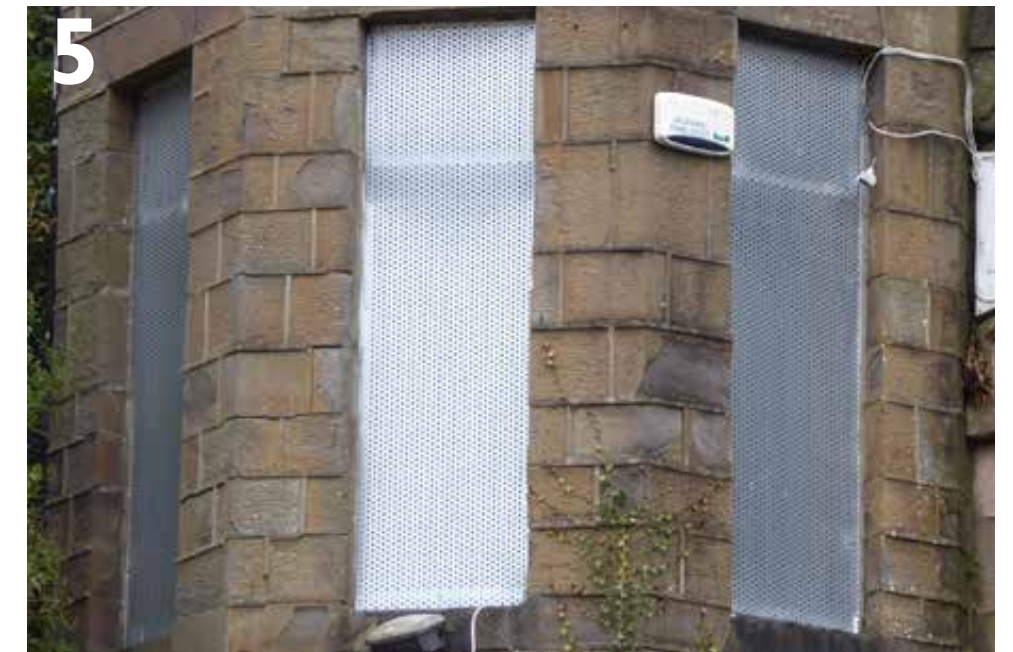
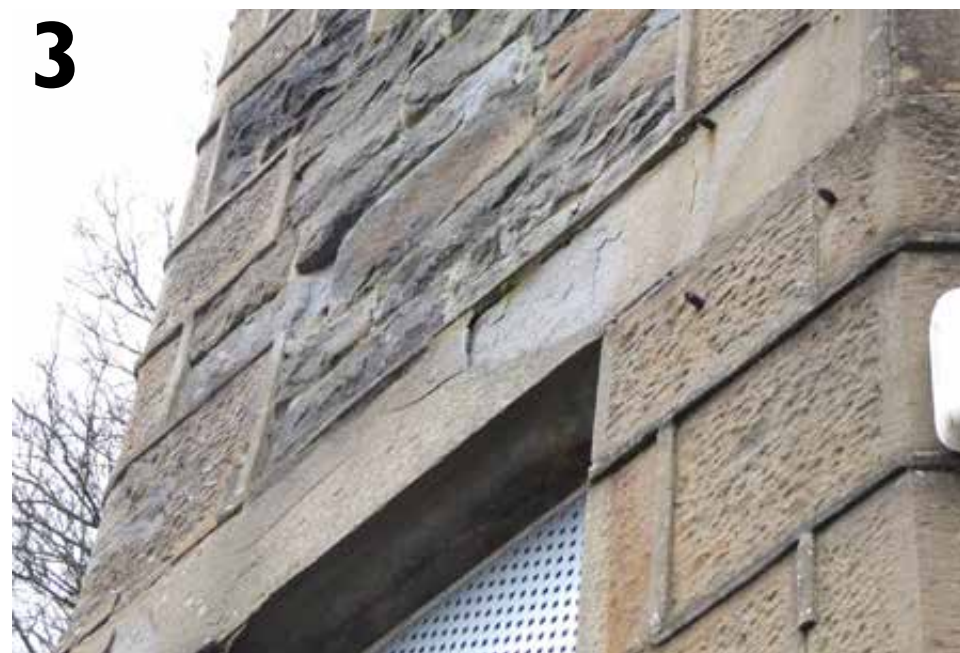
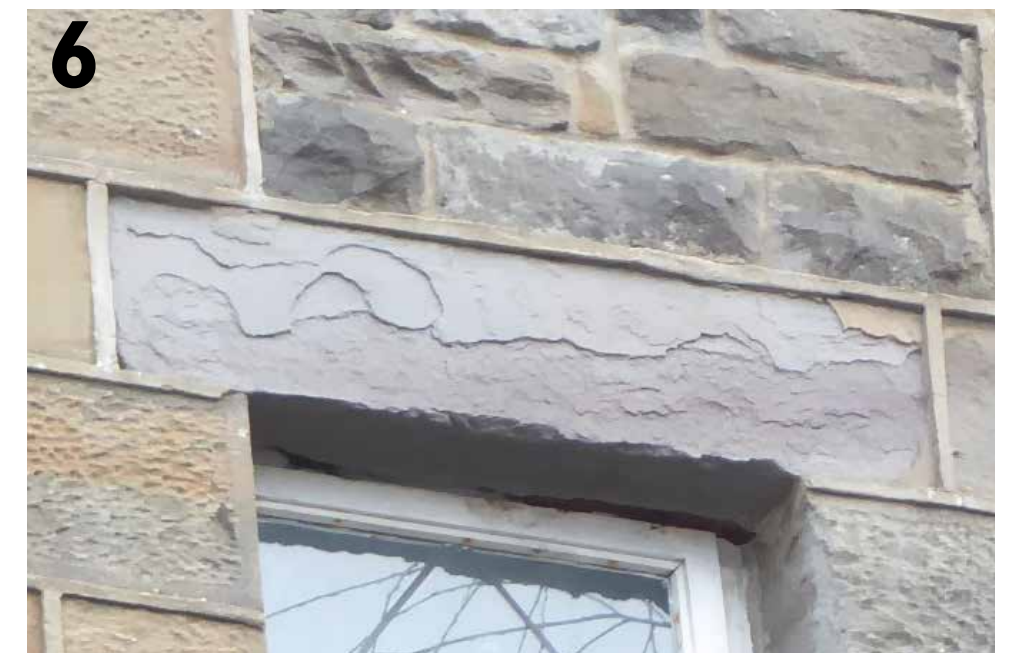
### Examples of Condition Issues

**with the Stonework**

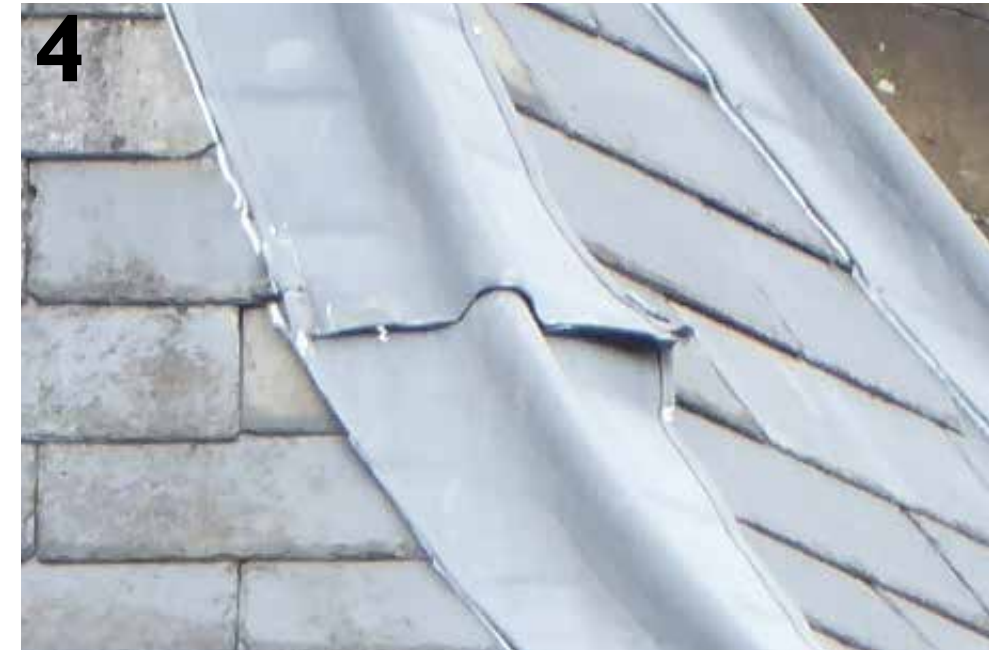
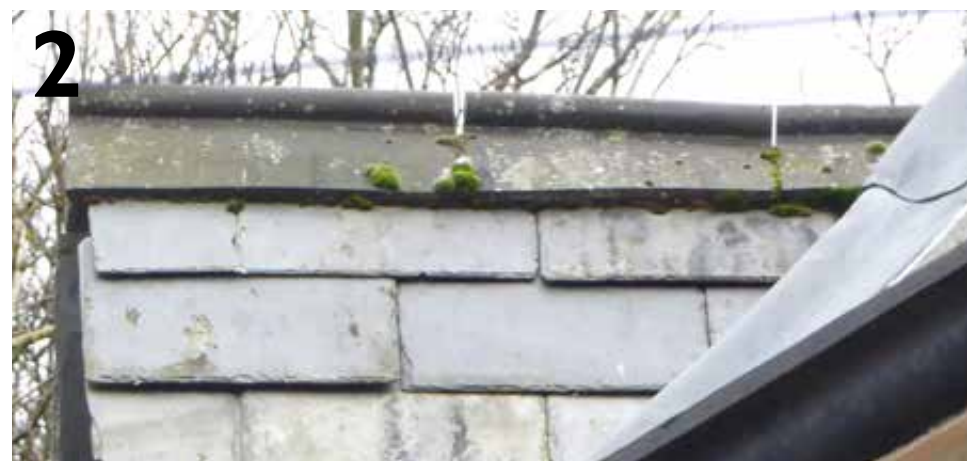
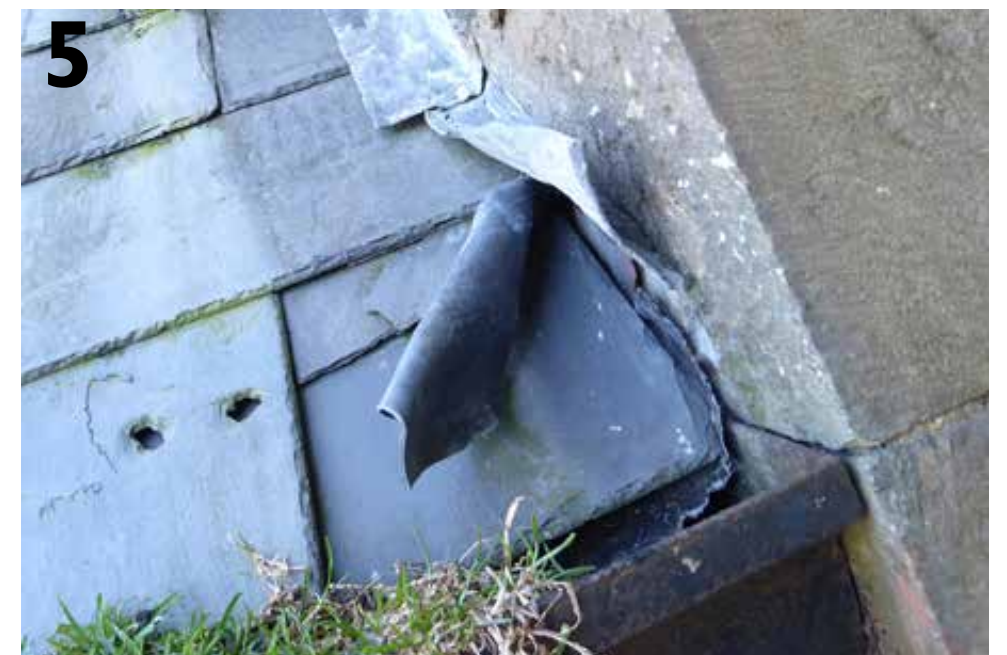
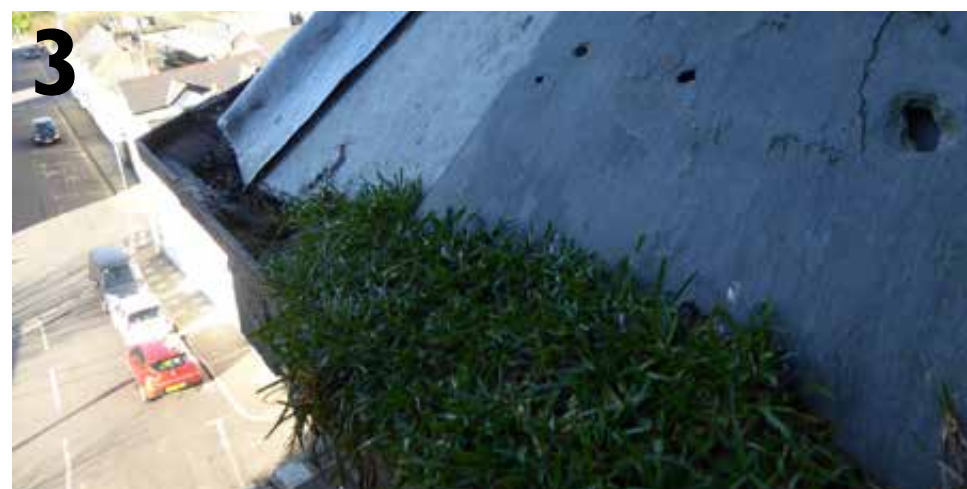
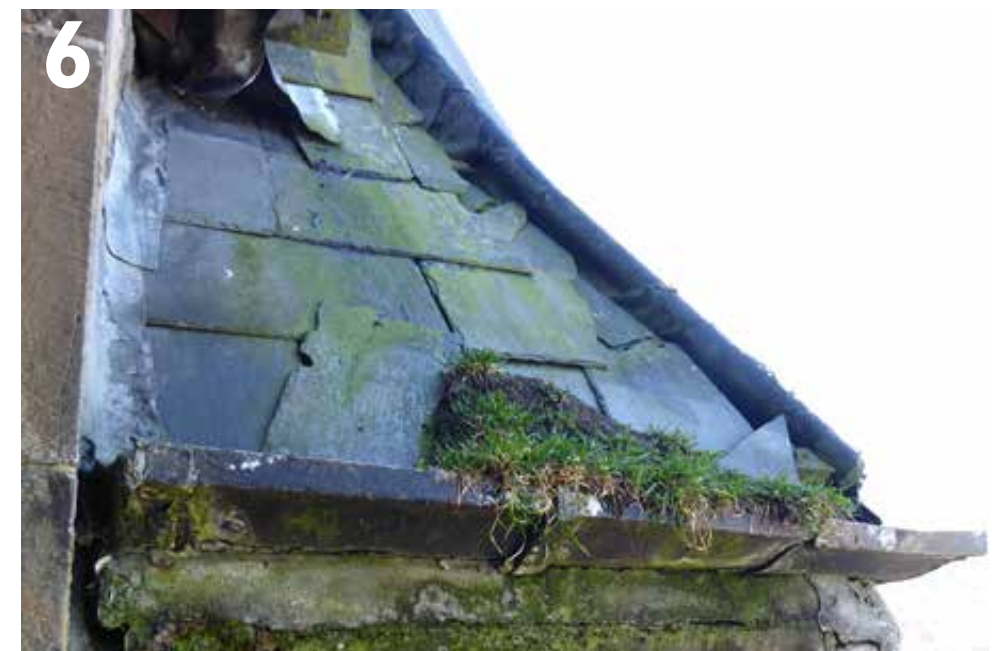
### Examples of Condition Issues with the Roof (with numbers referring to photographs)

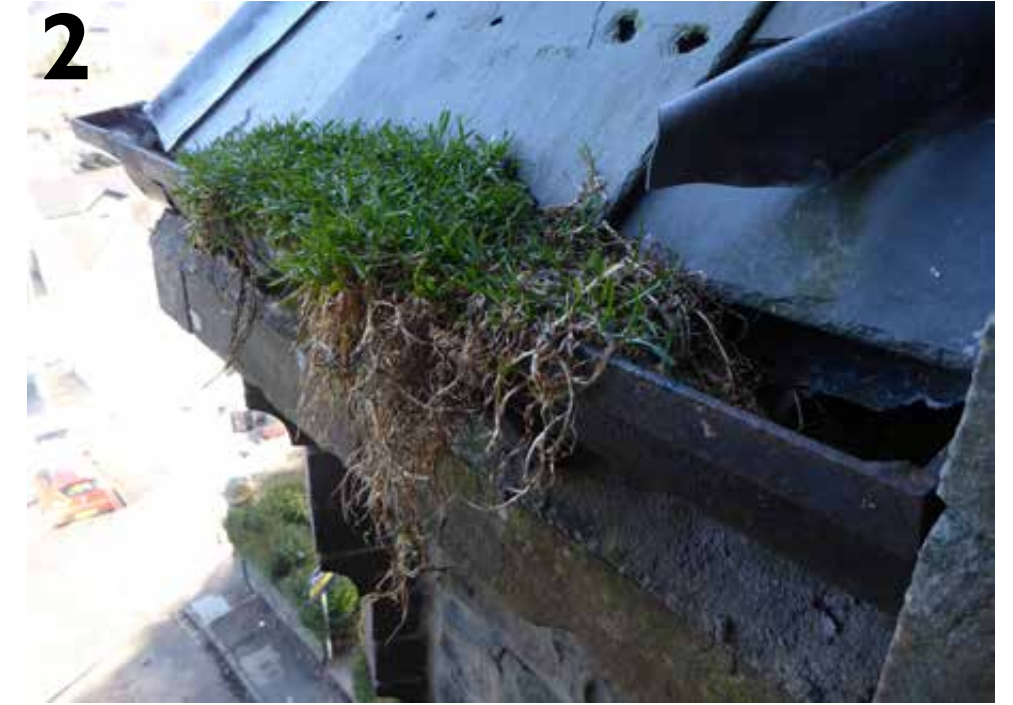
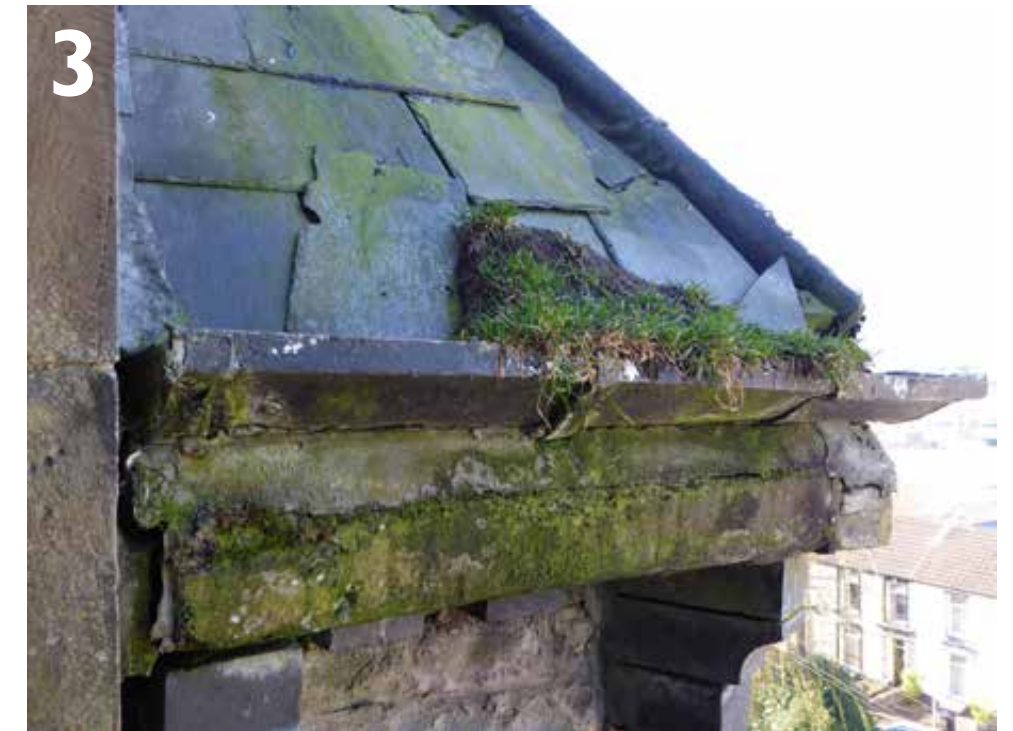
### 6.1 FRONT (WEST) ELEVATION

### Examples of Condition Issues with the Rainwater Goods

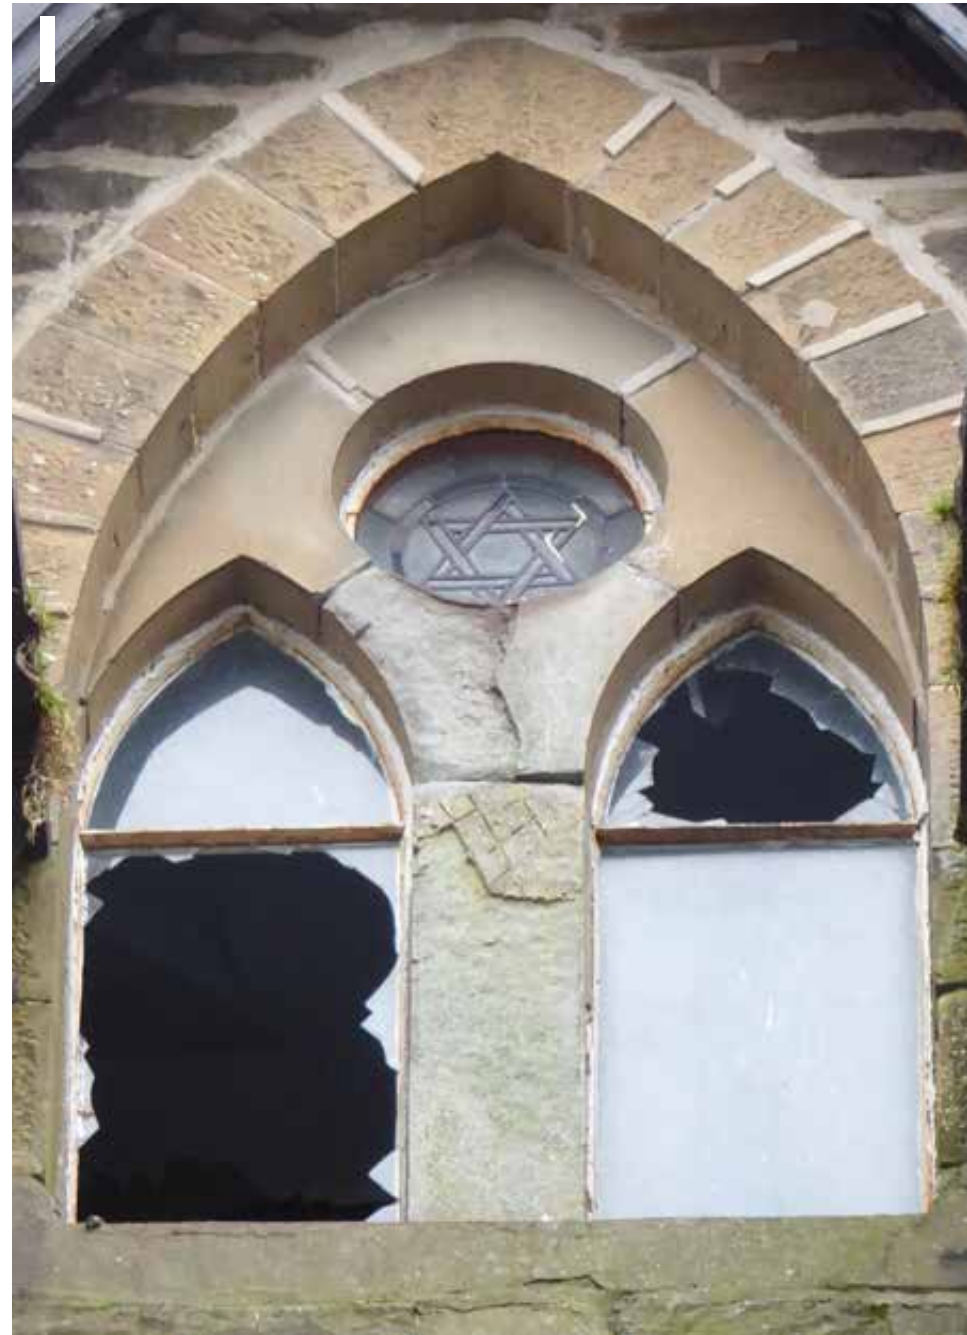
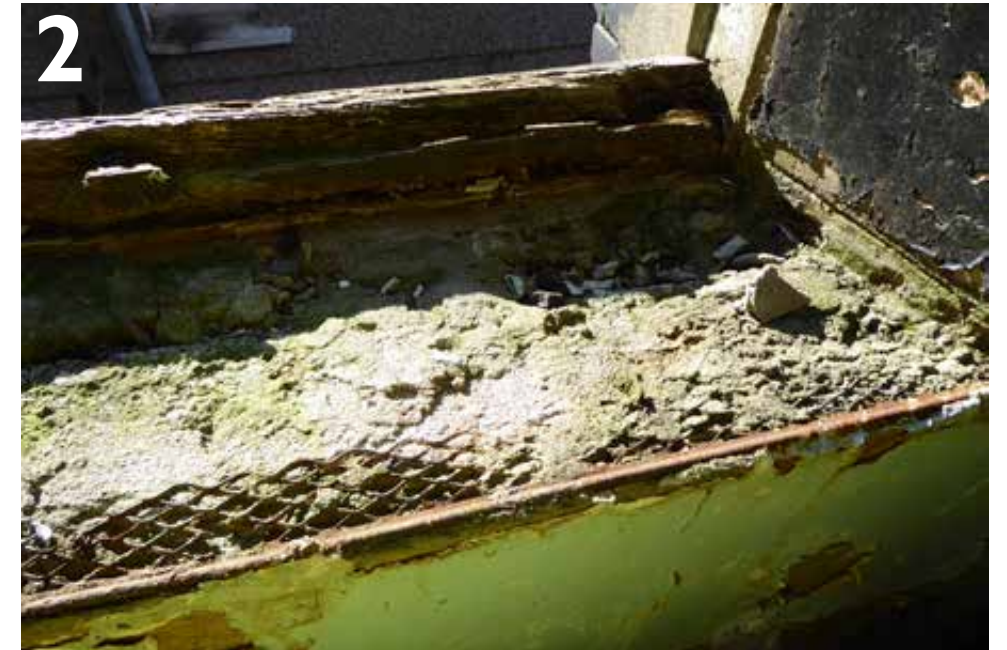
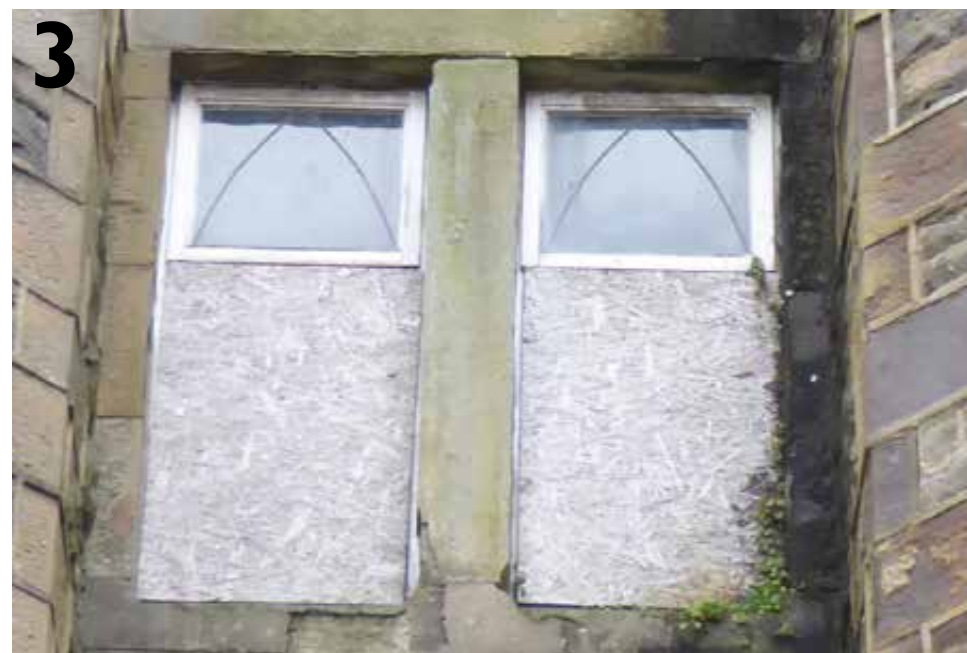
### Examples of Condition Issues with the Windows & Door (with numbers referring to photographs)

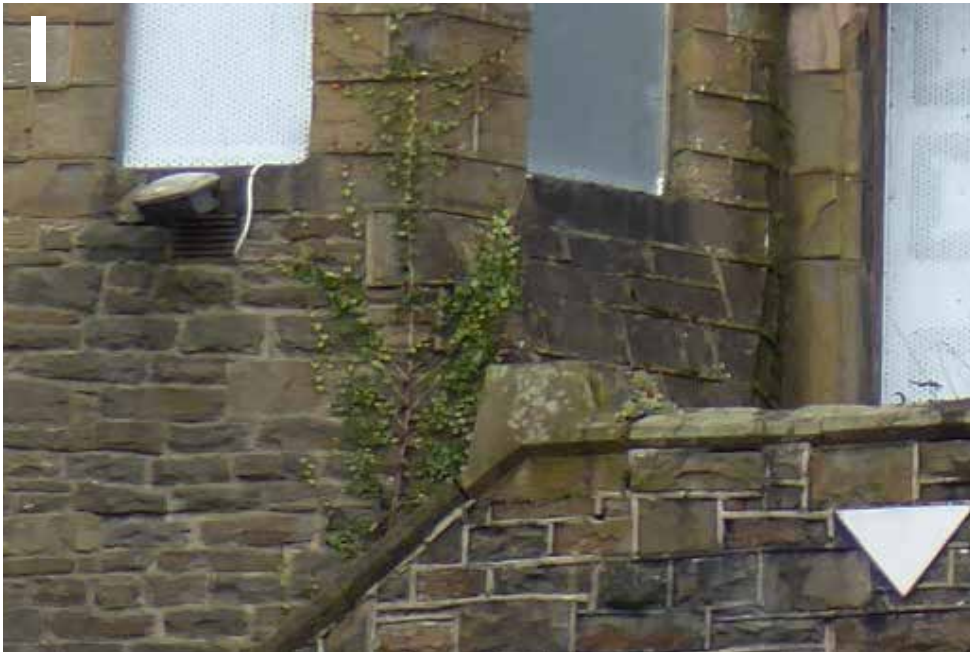
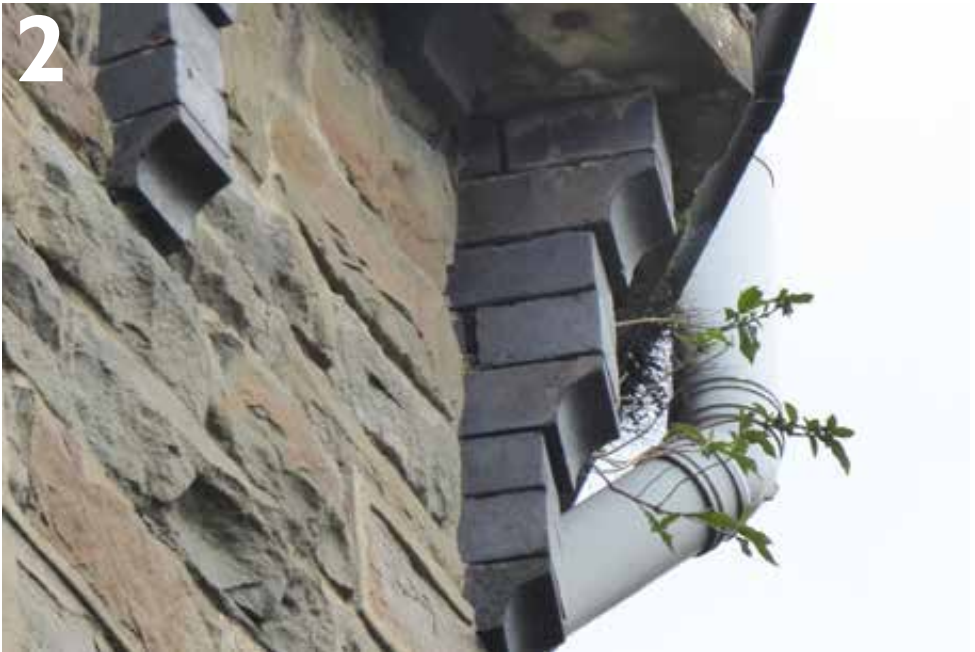
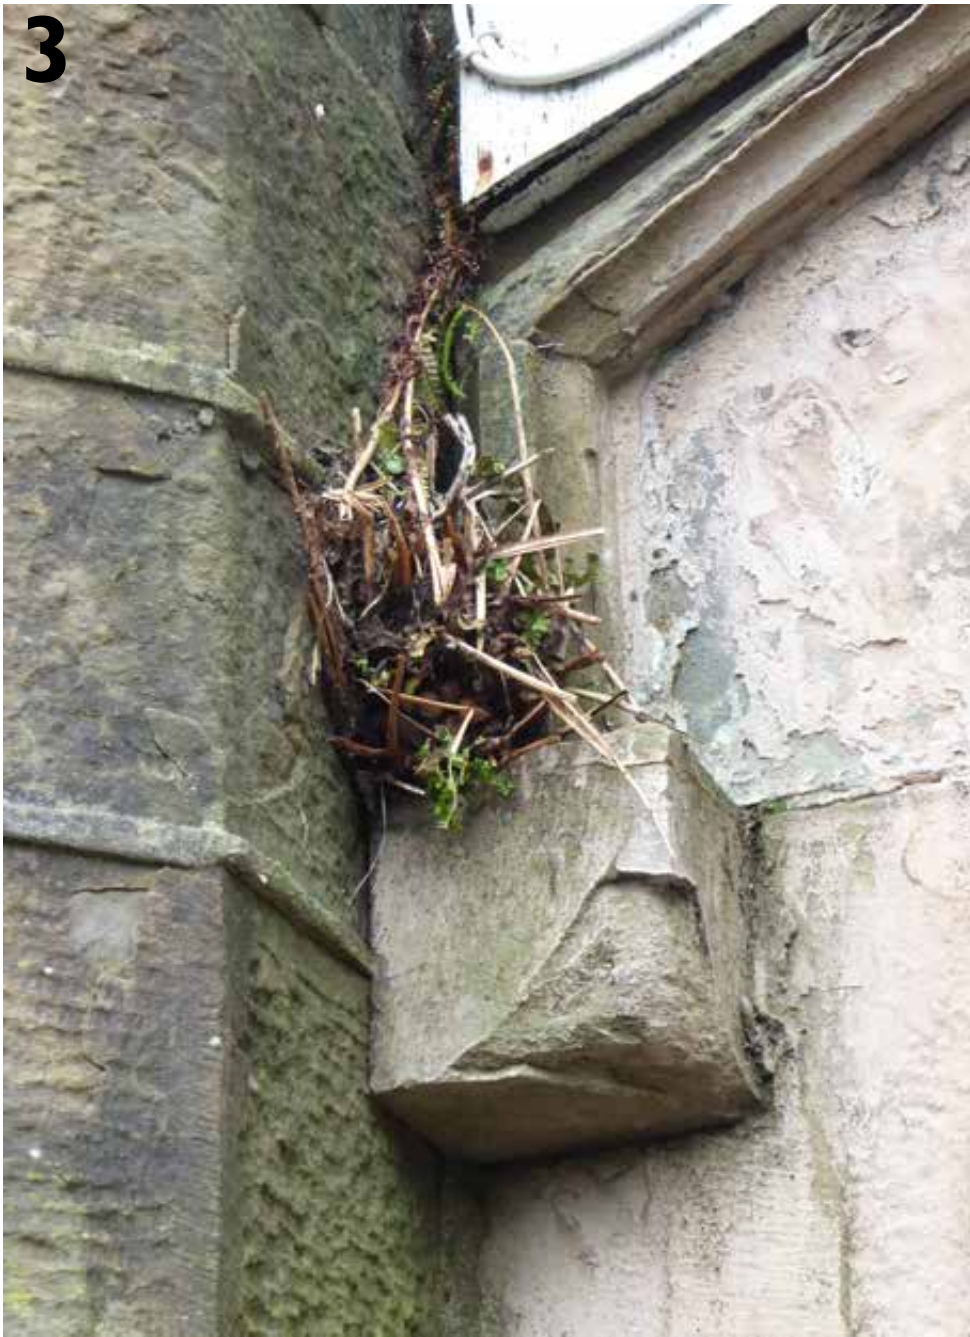
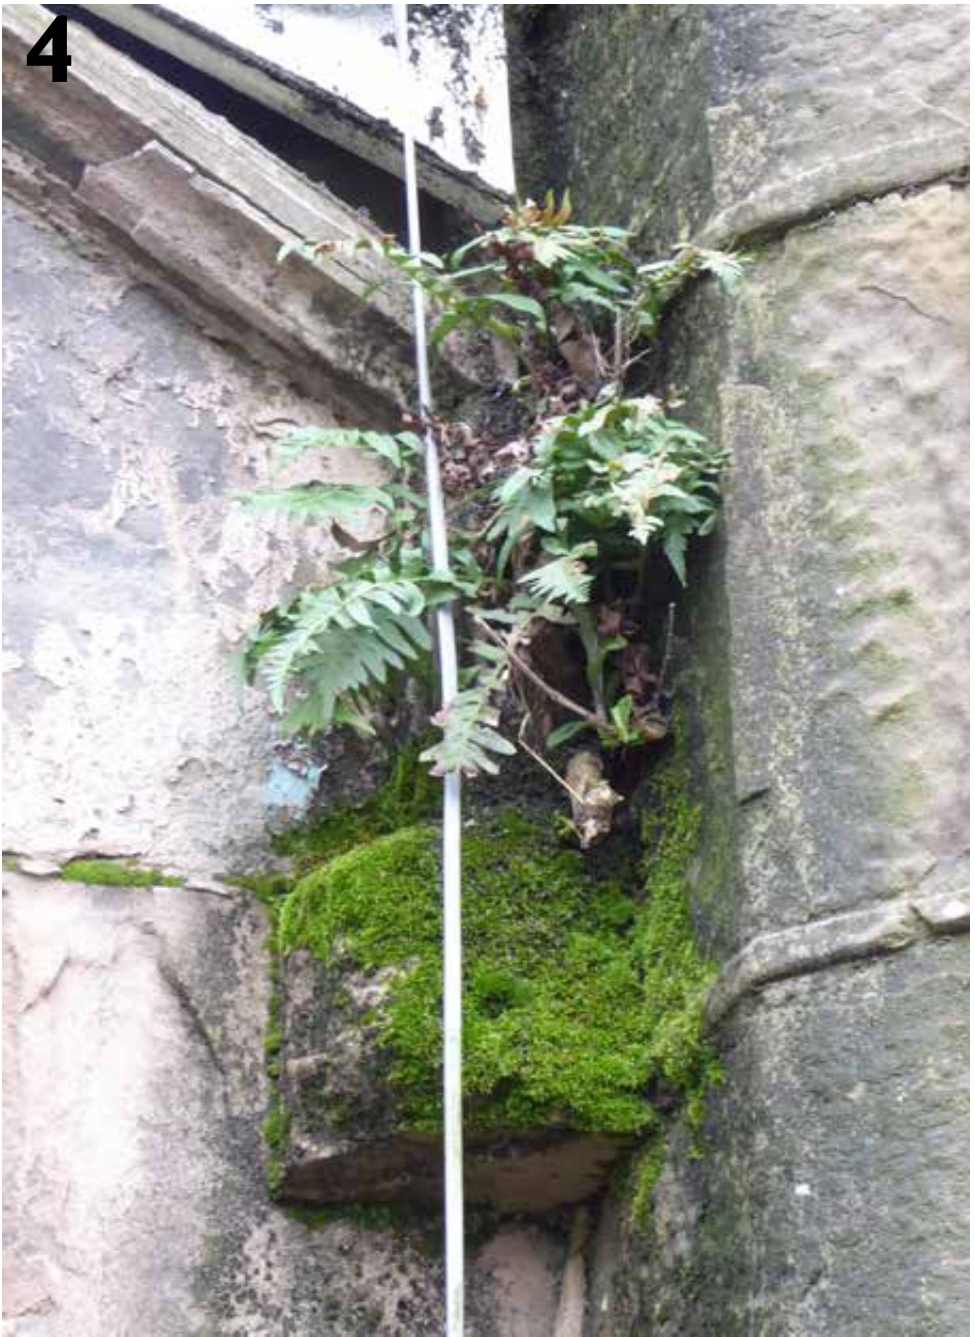
6.1 FRONT (WEST) ELEVATION  
Examples of Condition Issues with Vegetation  
(with numbers referring to photographs)
