# Synagogue, Merthyr Tydfil

## RECORD OF BUILDING AND CONDITION ASSESSMENT REPORT

.....  
(449)2503-GWP-A-HIS-P00

Date: 17.03.25

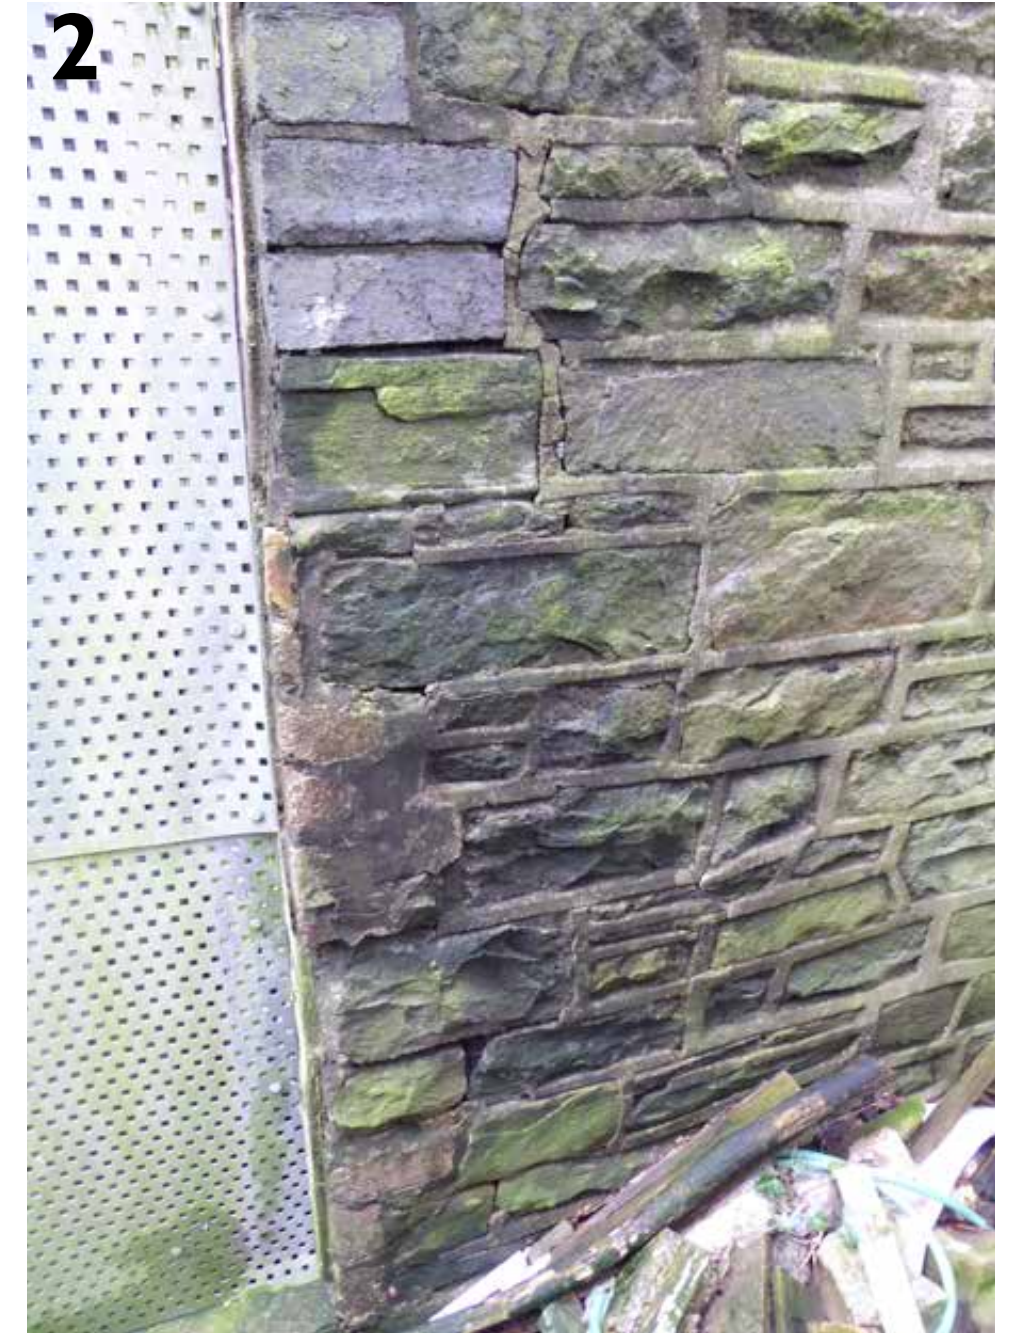
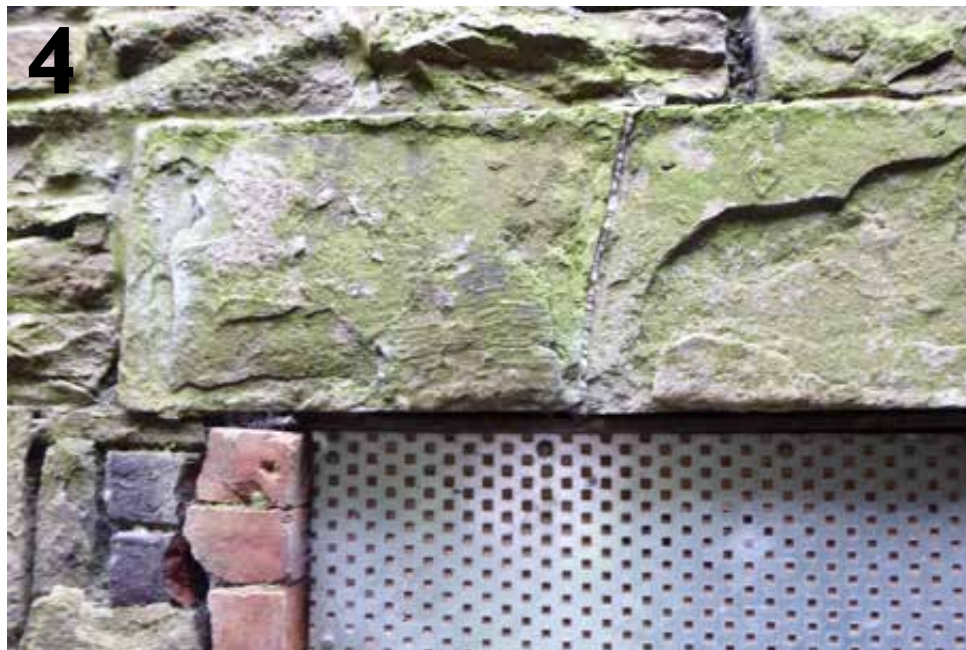
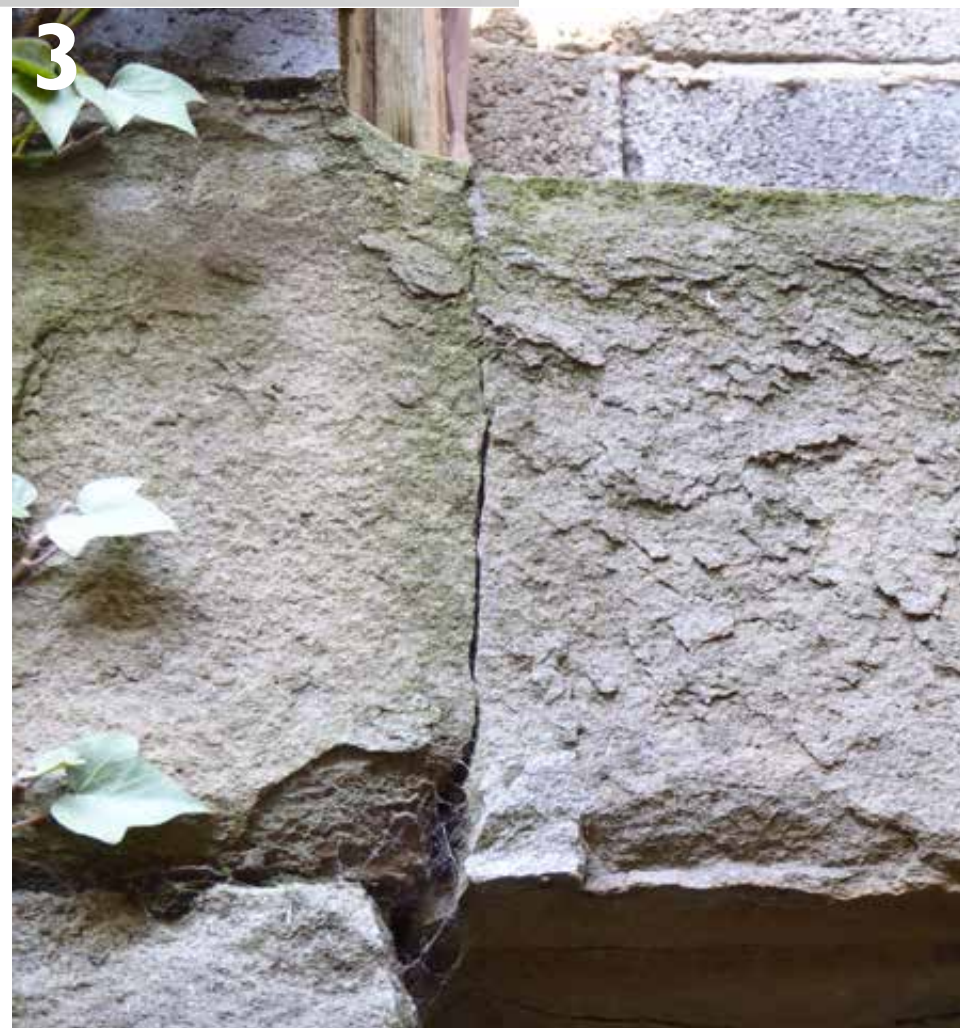
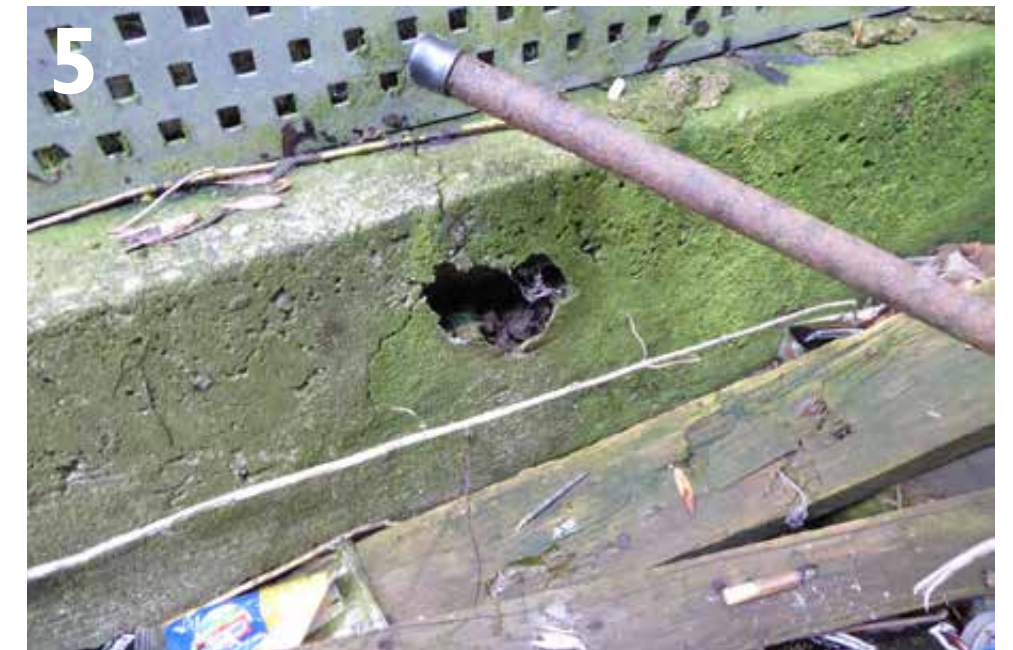
## Examples of Condition Issues with the Stonework (with numbers referring to photographs)

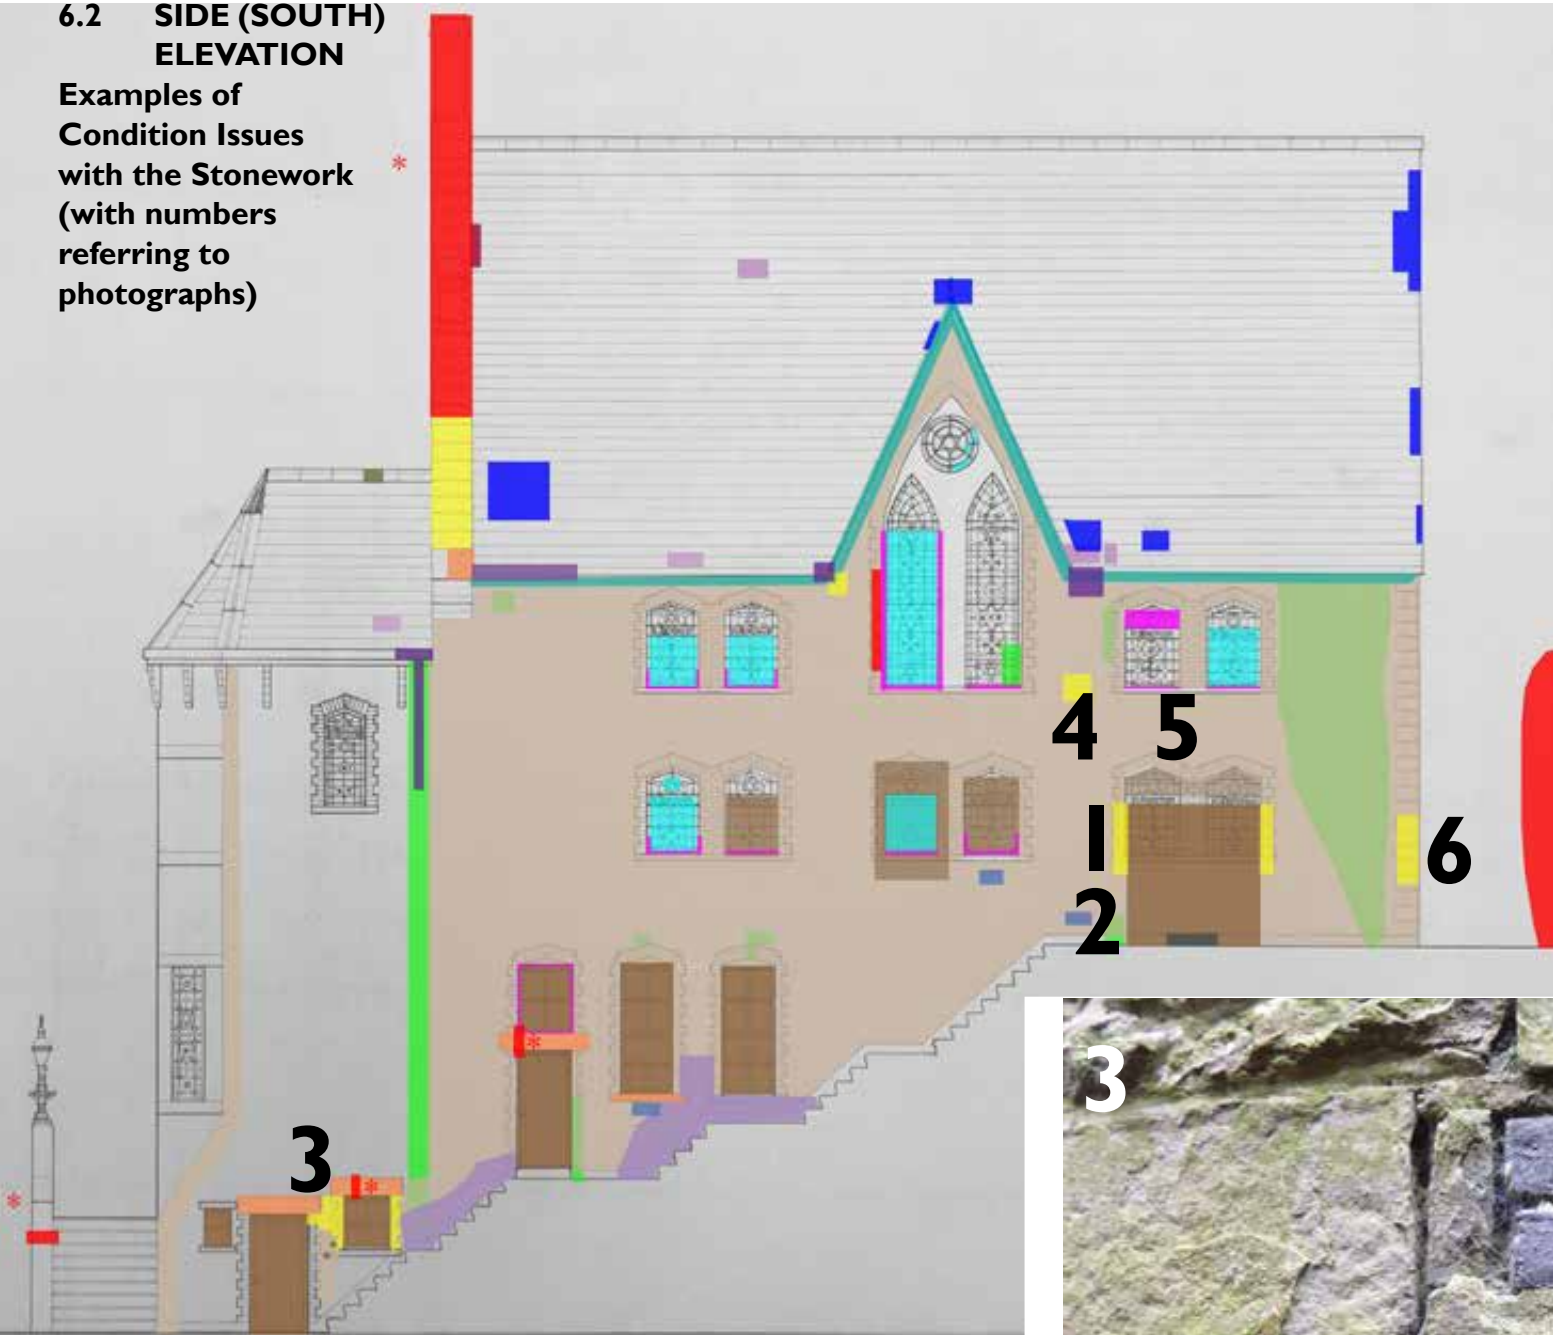
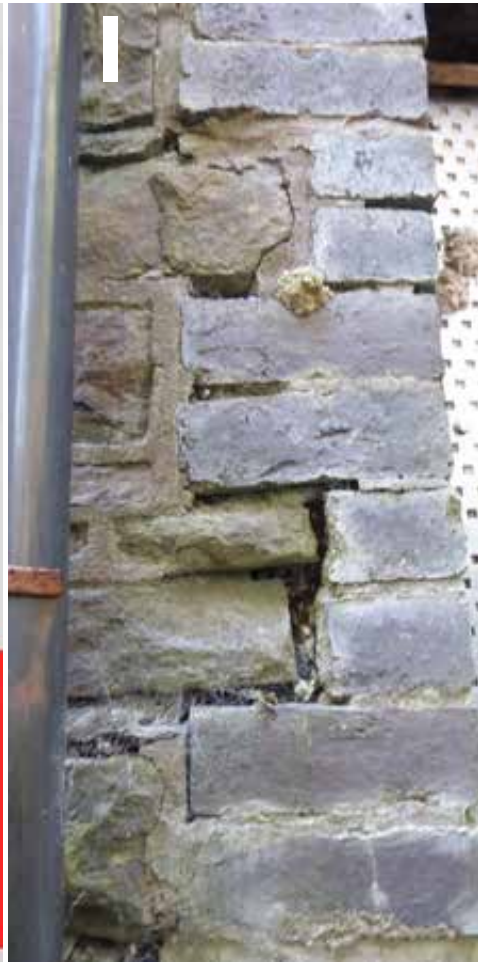
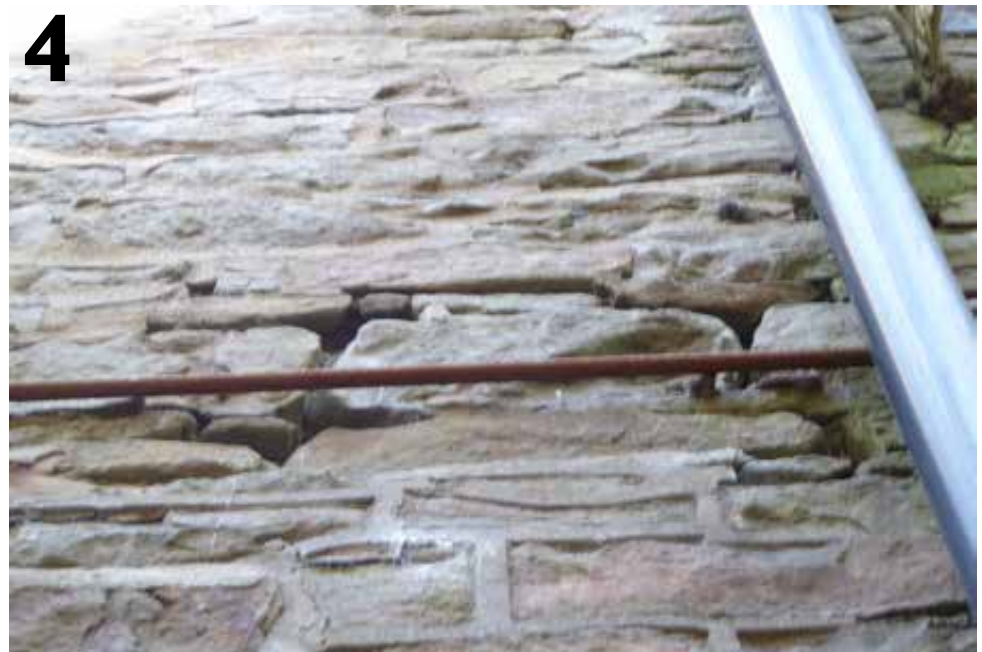
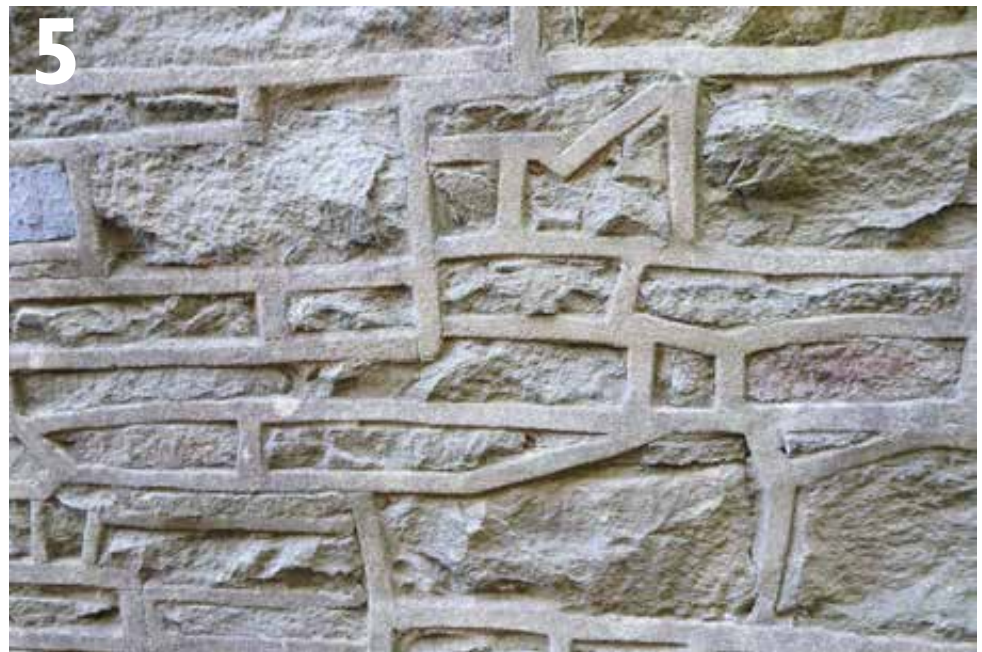
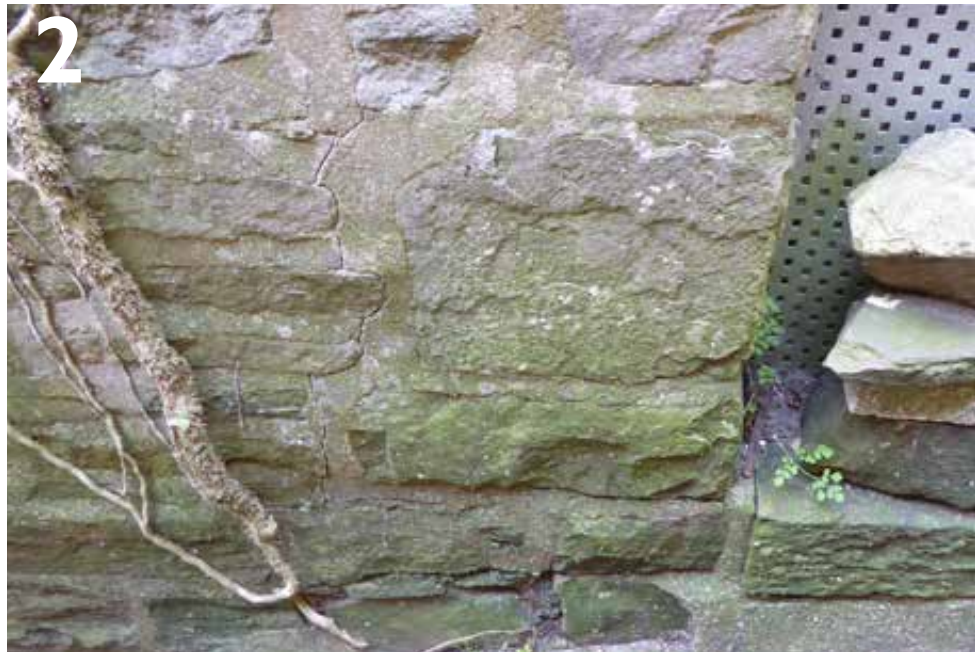
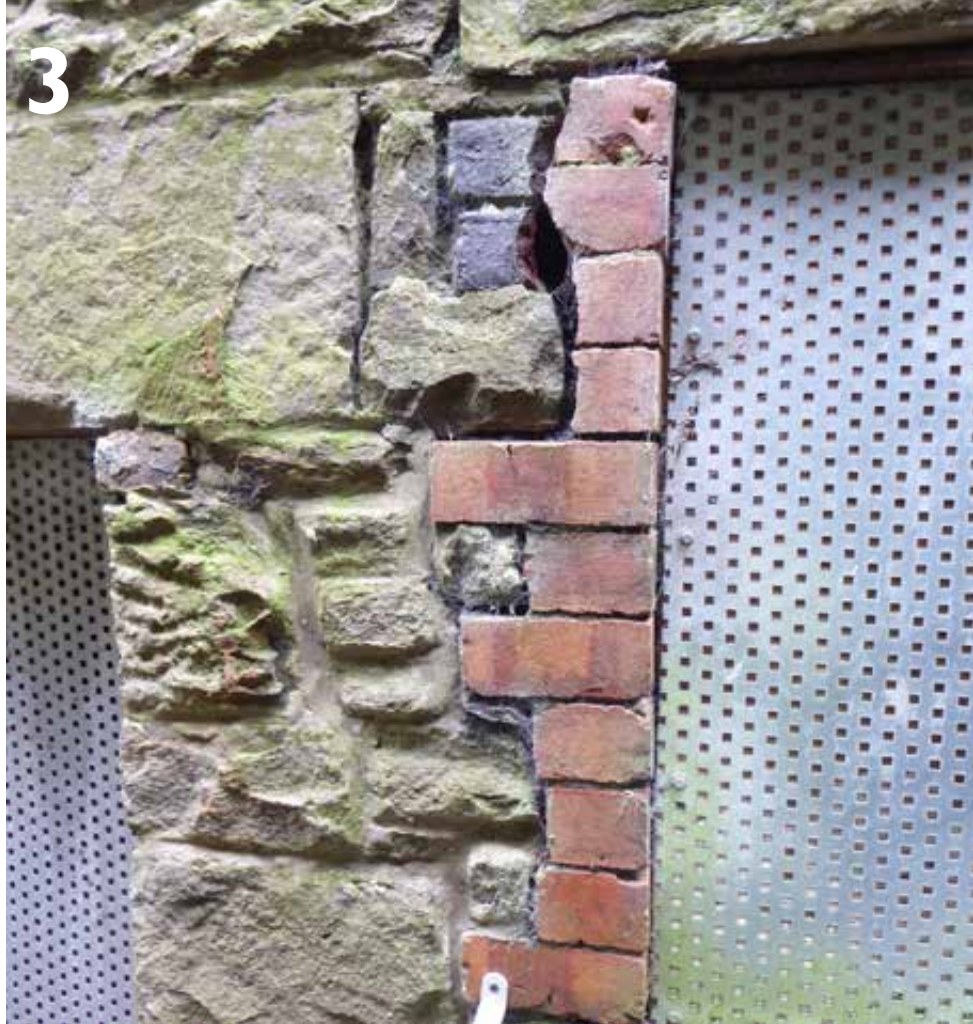
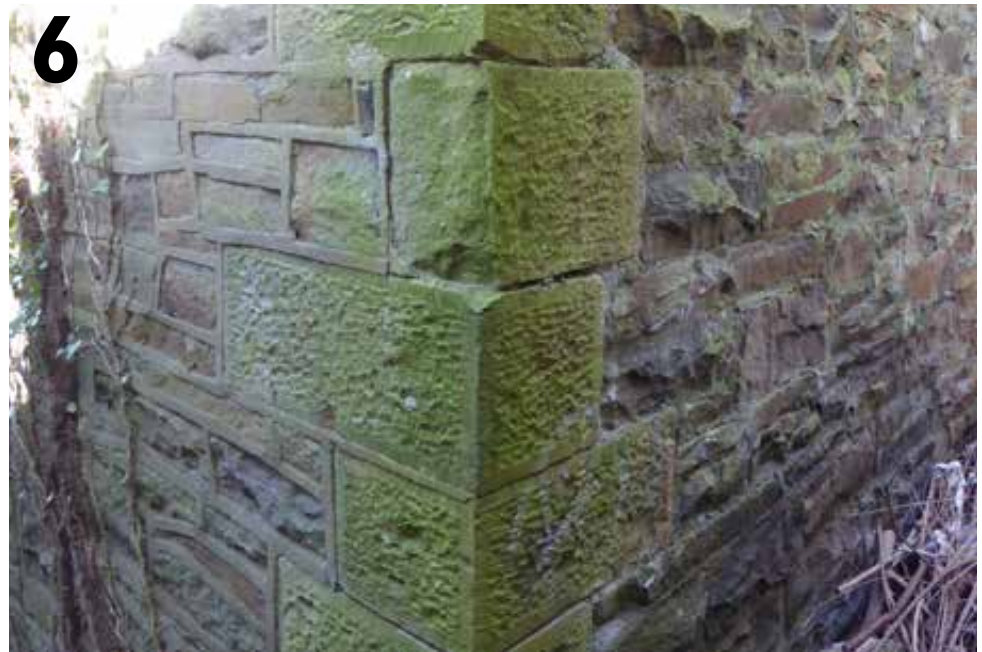
6.2 SIDE (SOUTH)  
ELEVATION  
Examples of  
Condition Issues  
with the Stonework  
(with numbers  
referring to  
photographs)

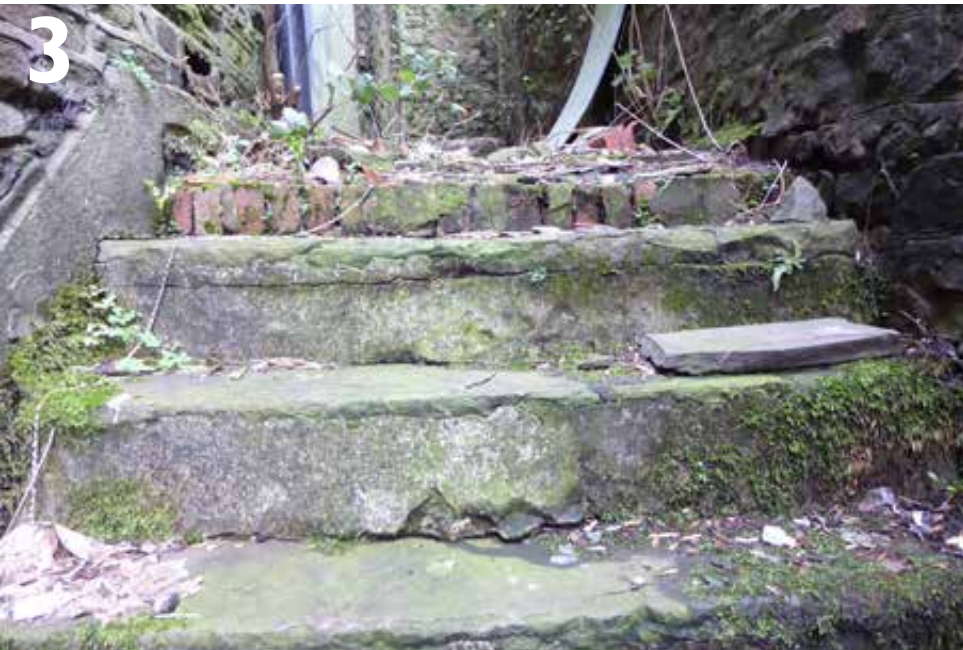
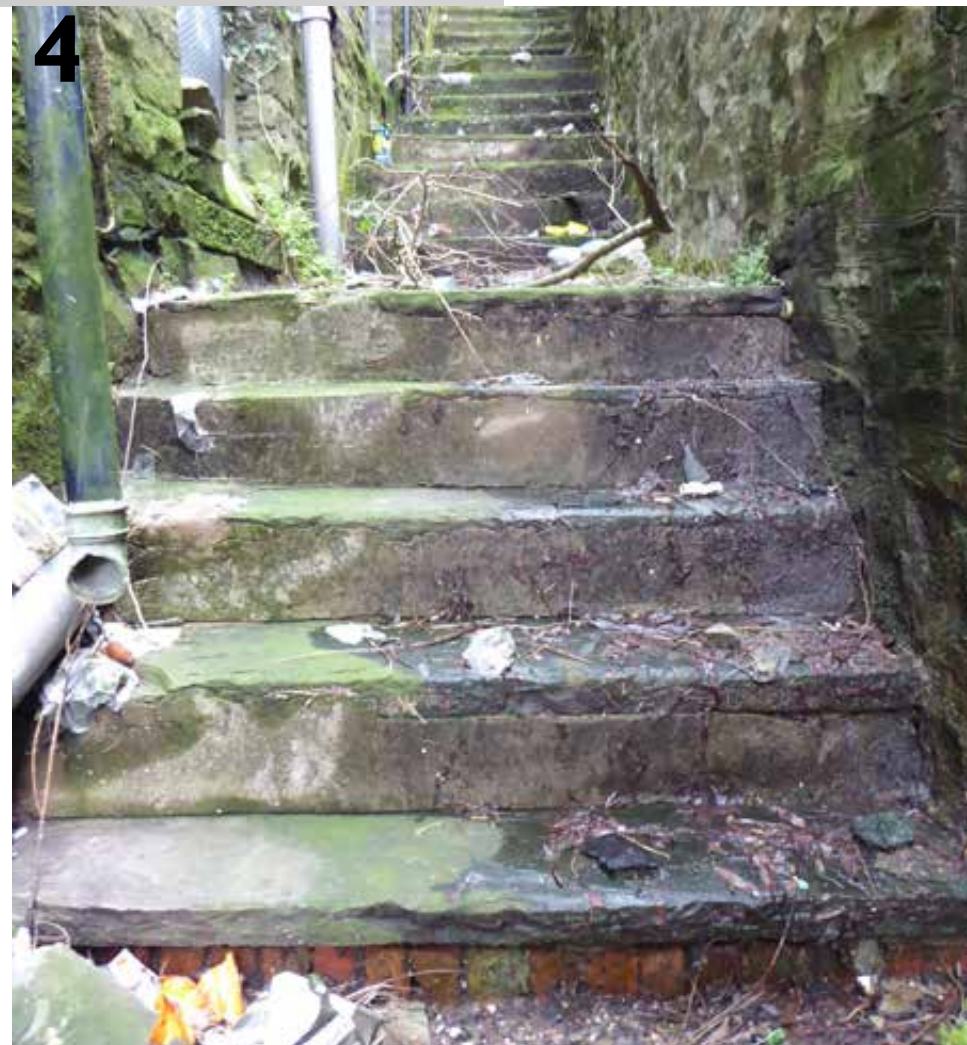
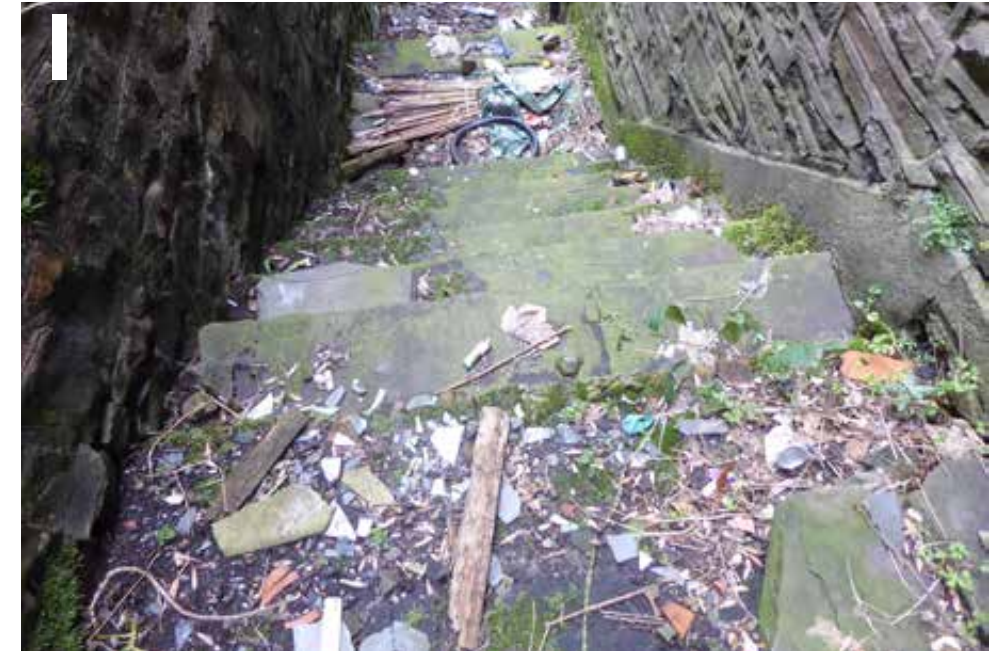
## Examples of Condition Issues with the Stonework (with numbers referring to photographs)

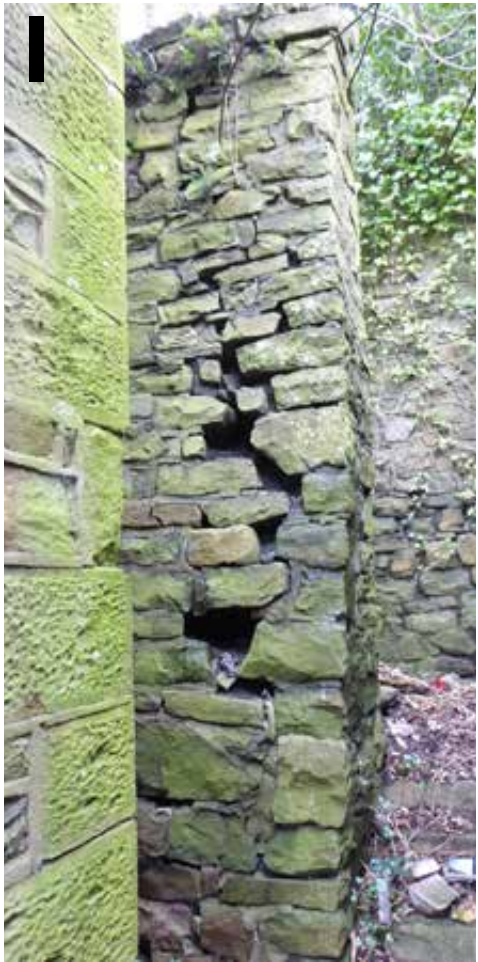
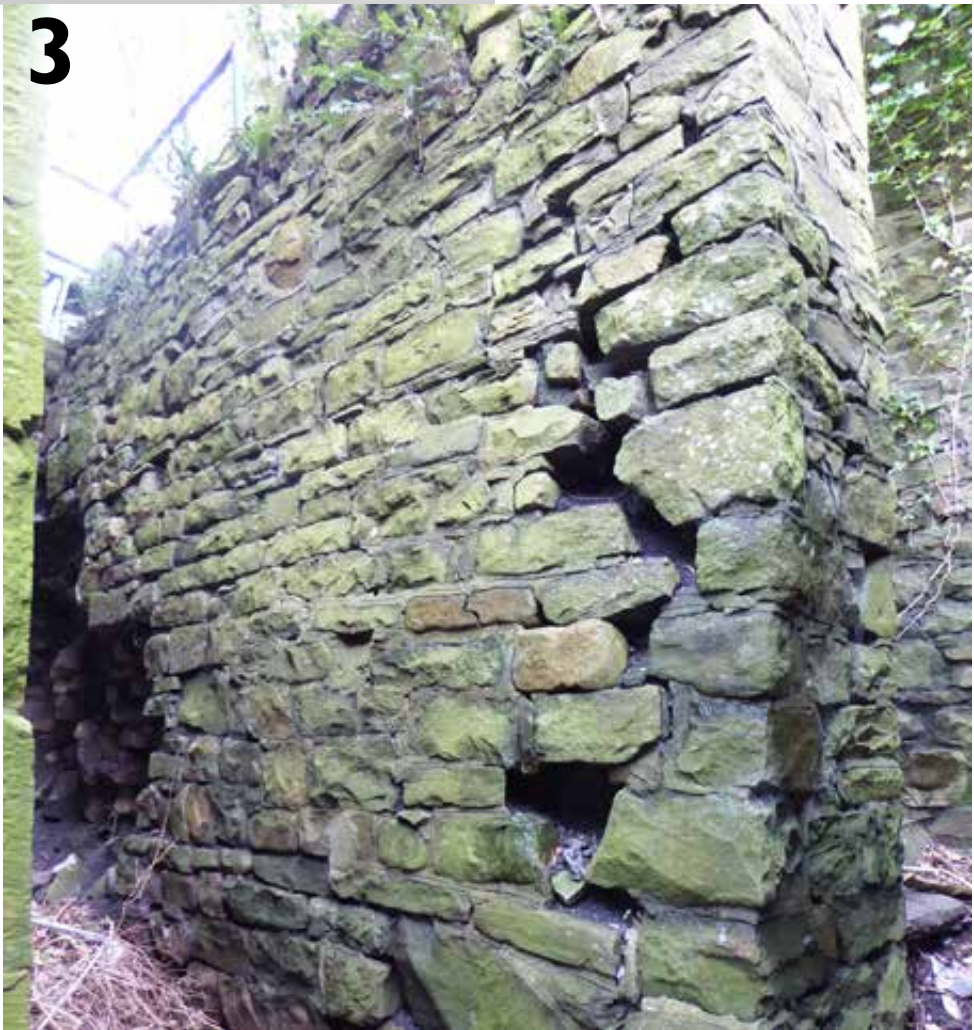
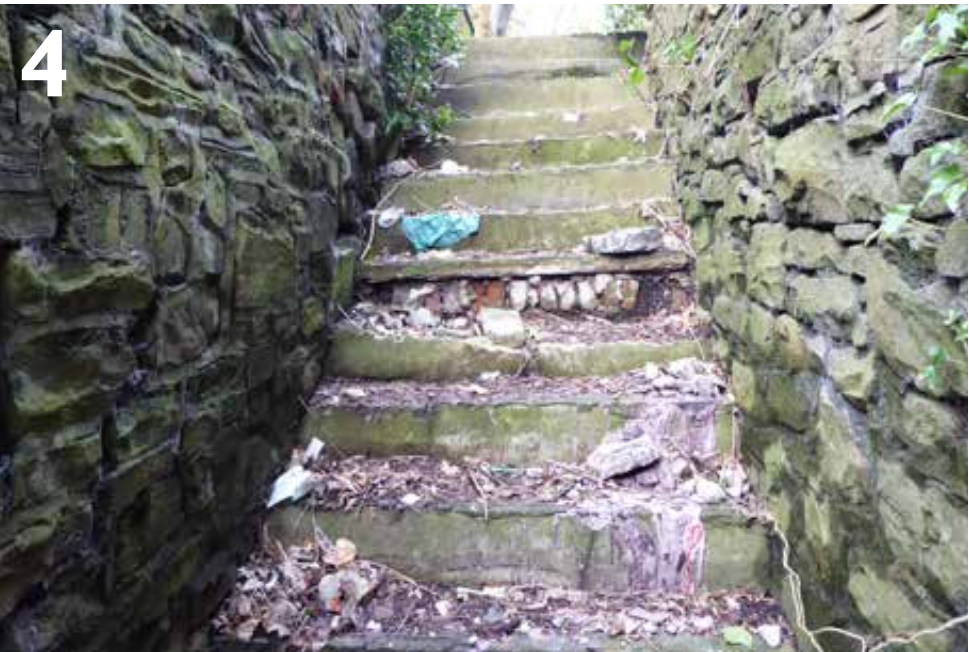
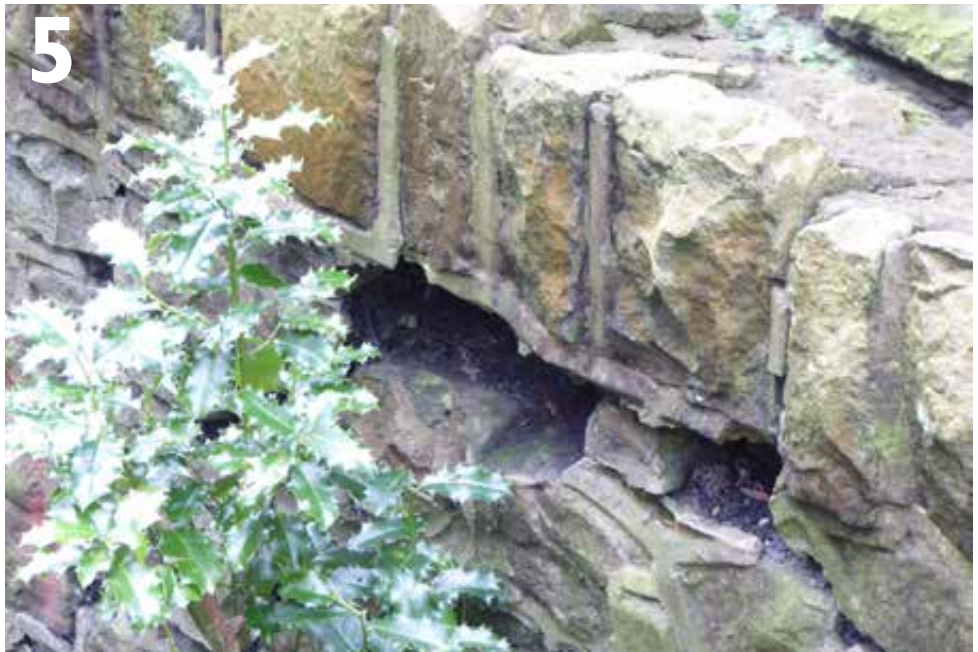
6.2 REAR /SIDE  
(EAST / SOUTH)  
ELEVATION

Examples of Condition  
Issues  
with the Stonework  
(with numbers referring  
to photographs)

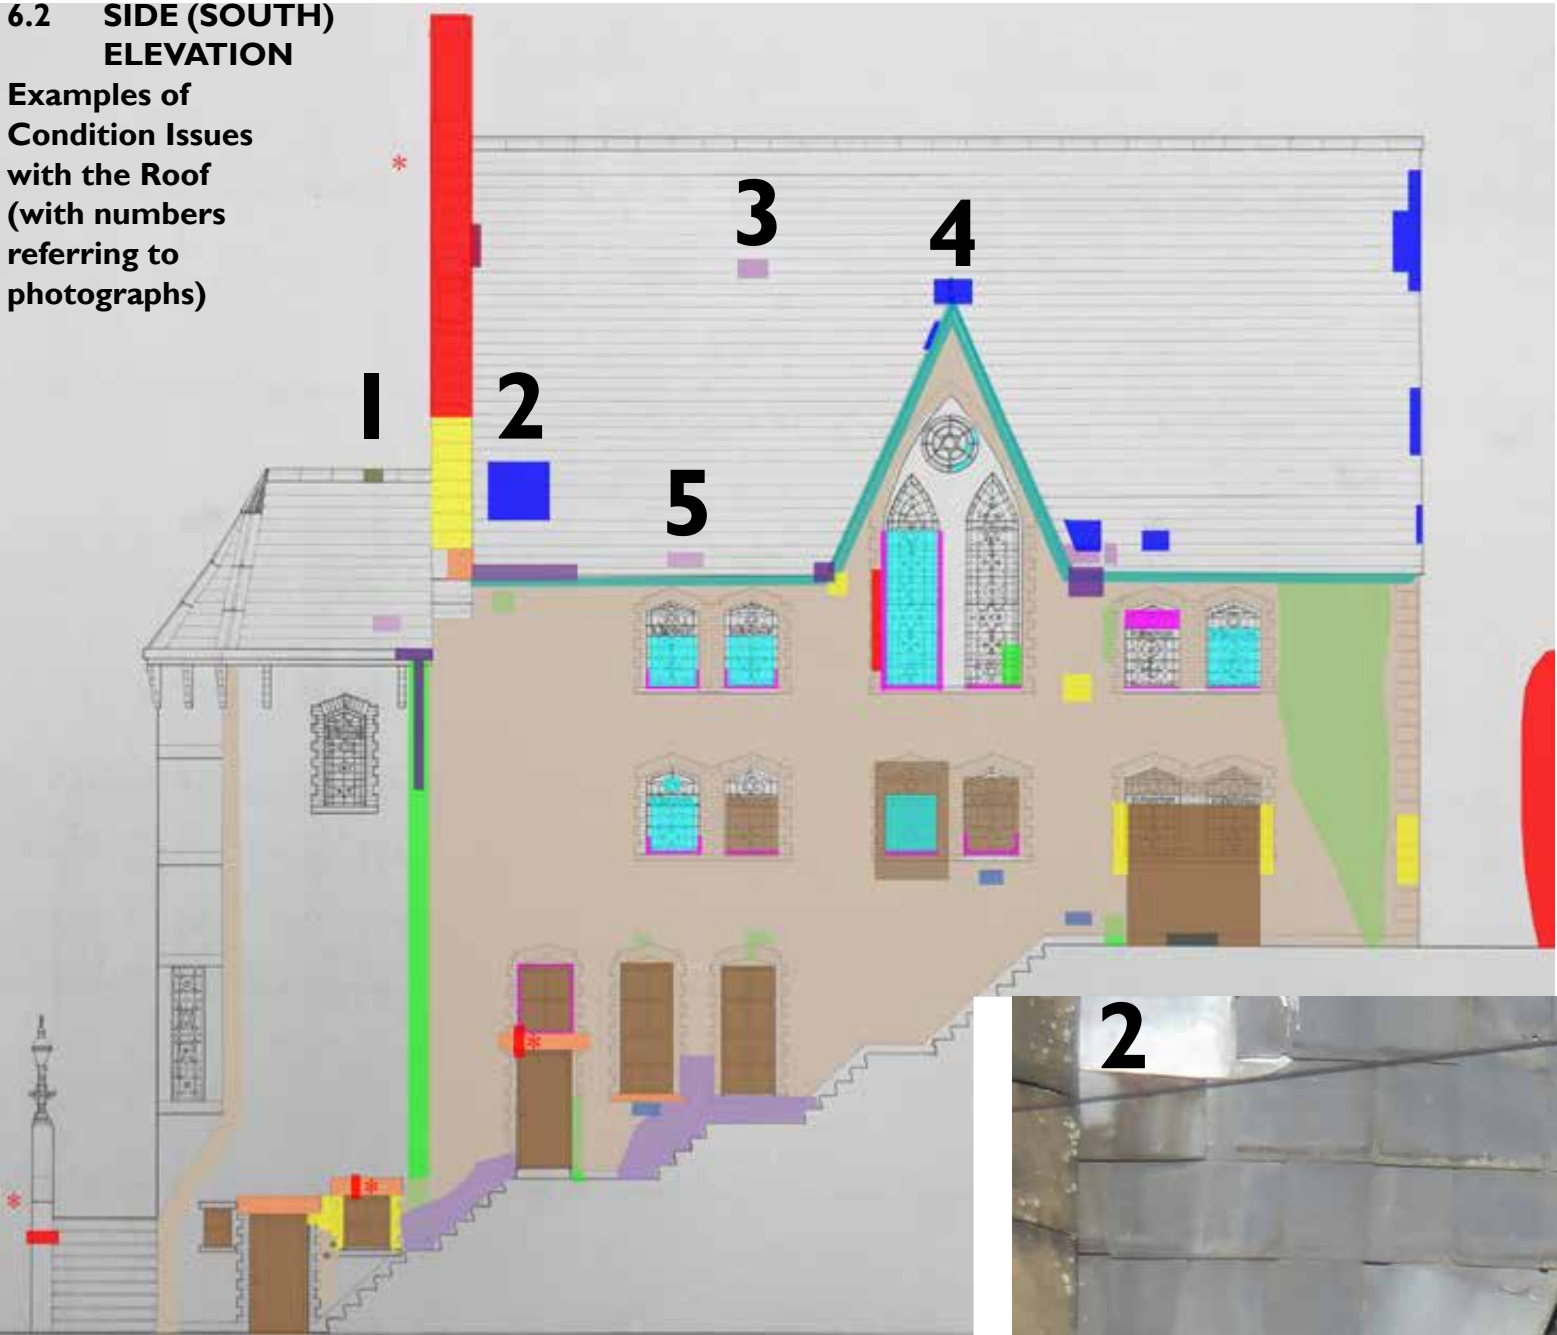
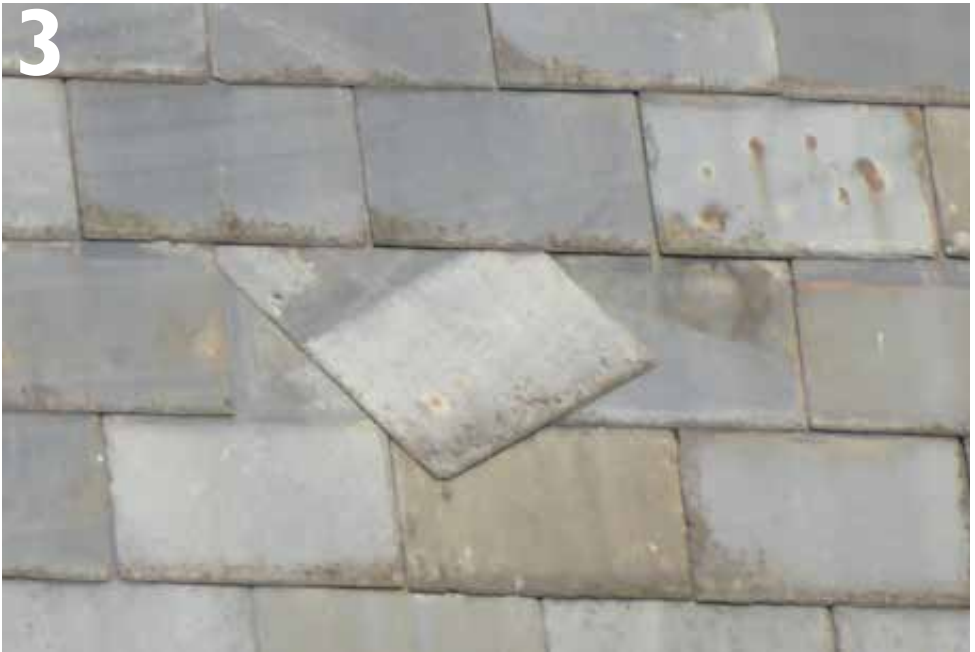
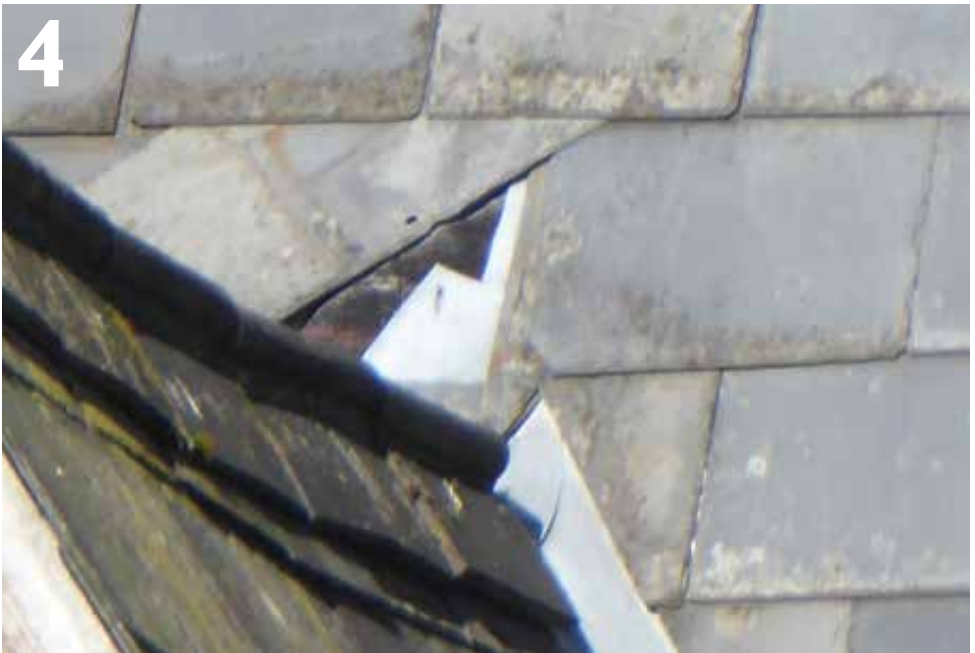
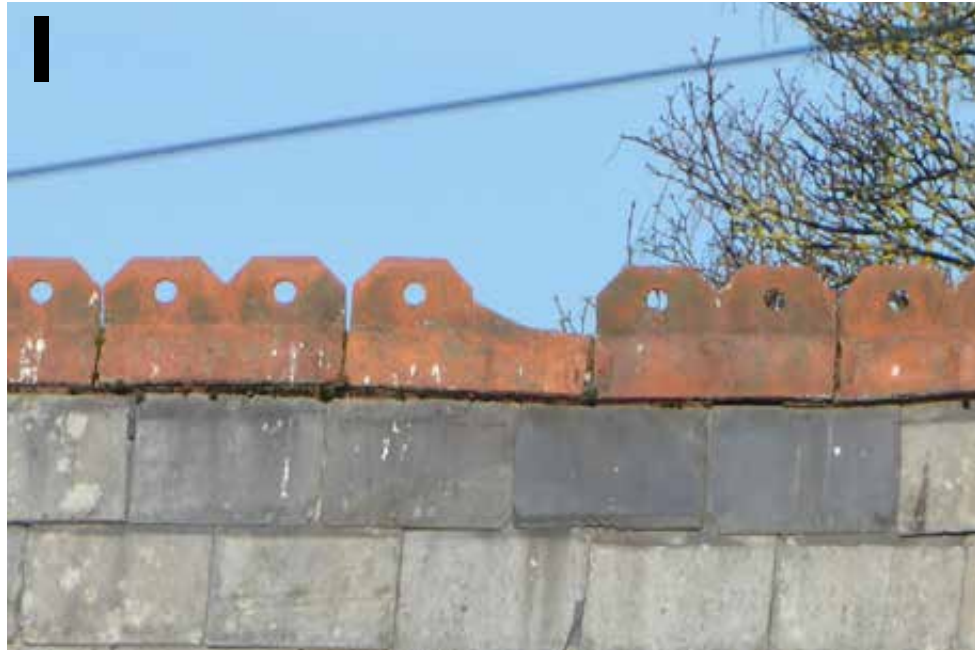
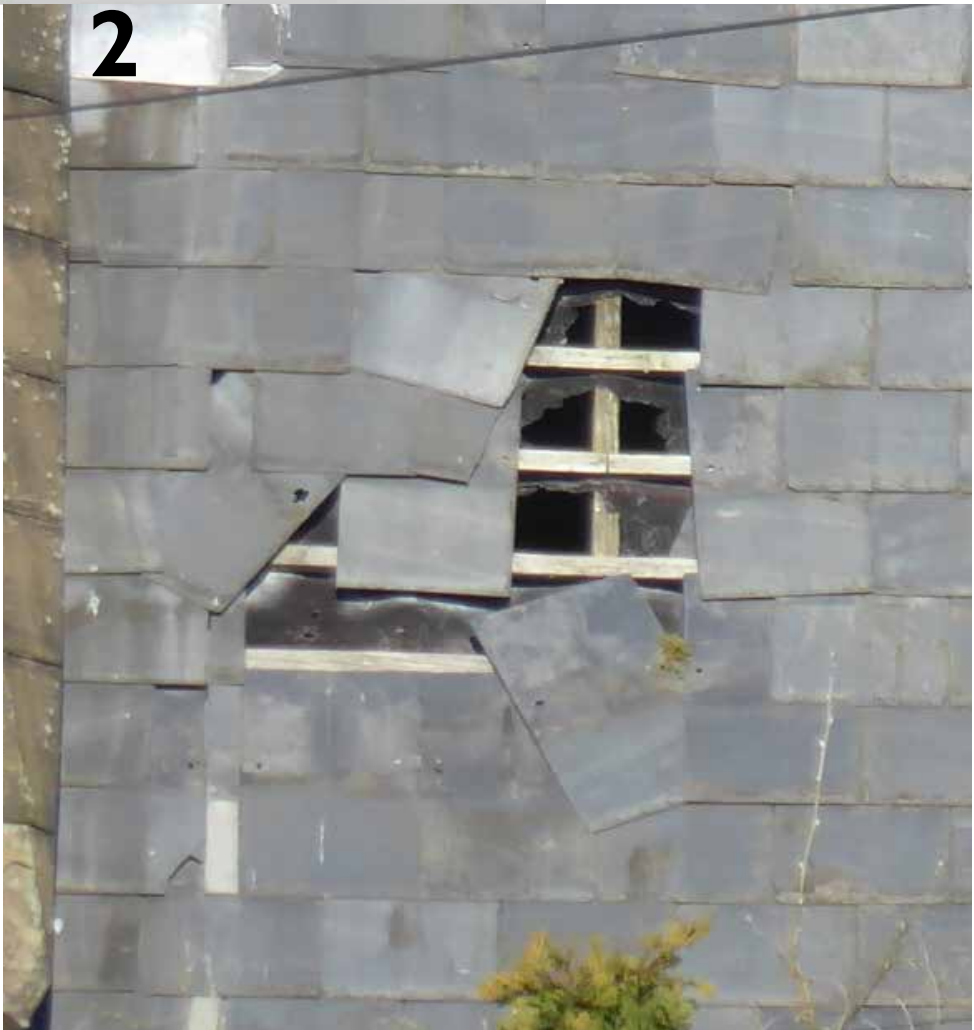
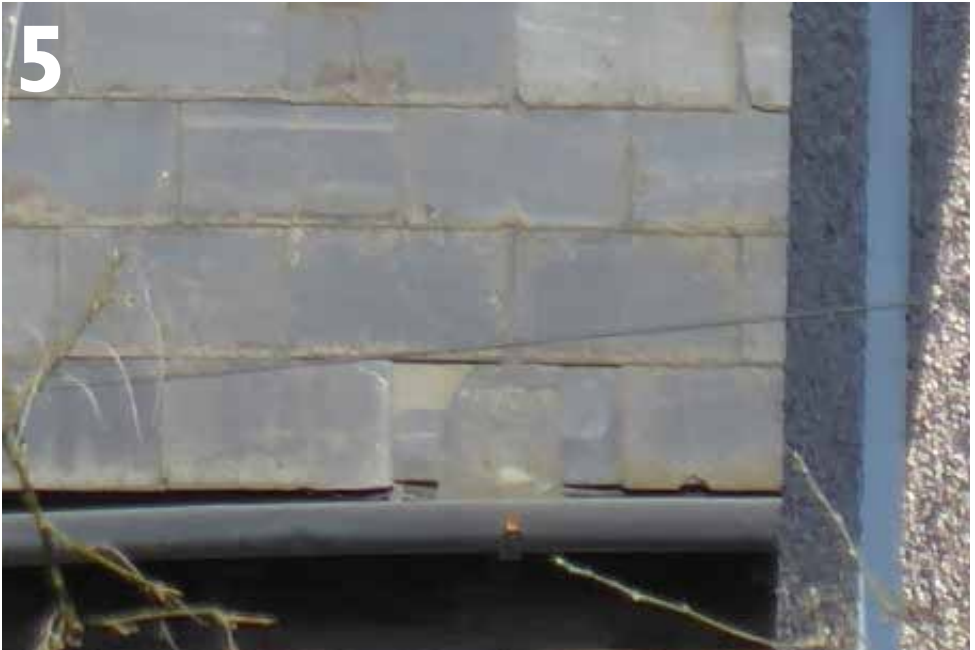
6.2 SIDE (SOUTH) ELEVATION

Examples of Condition Issues with the Roof (with numbers referring to photographs)
