# Synagogue, Merthyr Tydfil

## RECORD OF BUILDING AND CONDITION ASSESSMENT REPORT

.....  
(449)2503-GWP-A-HIS-P00

Date: 17.03.25

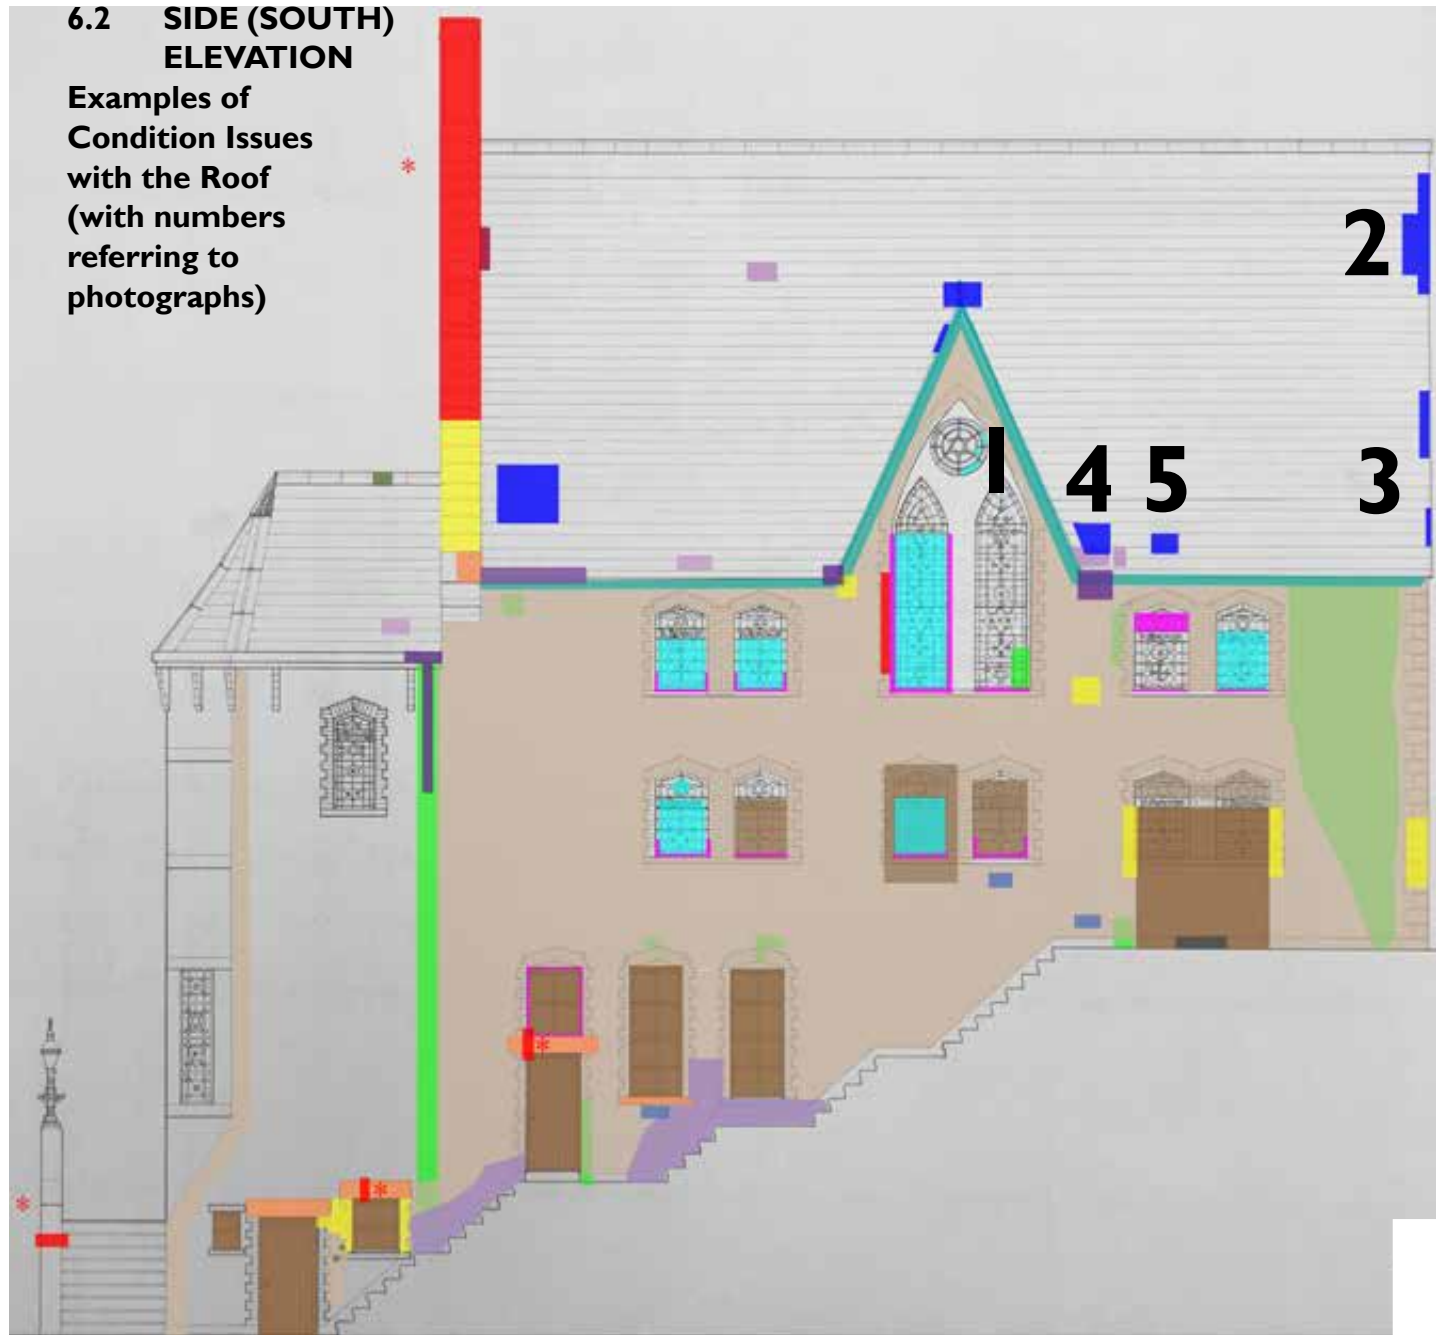
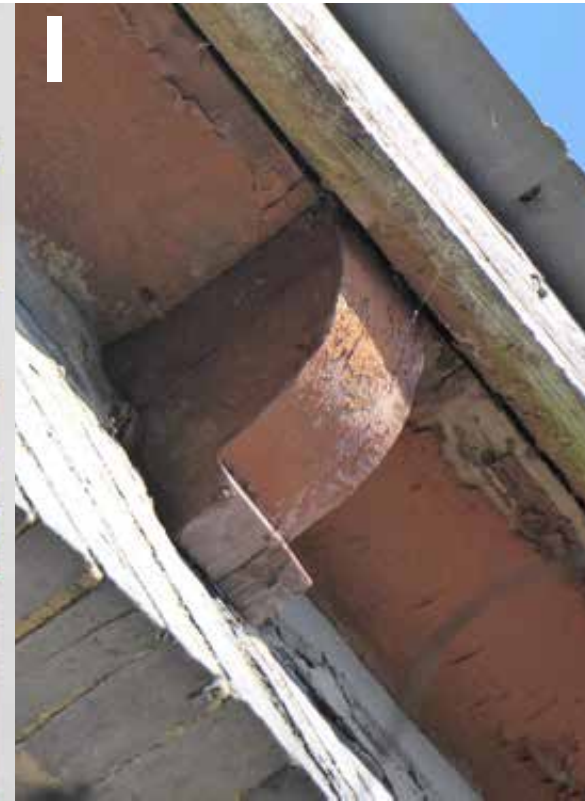
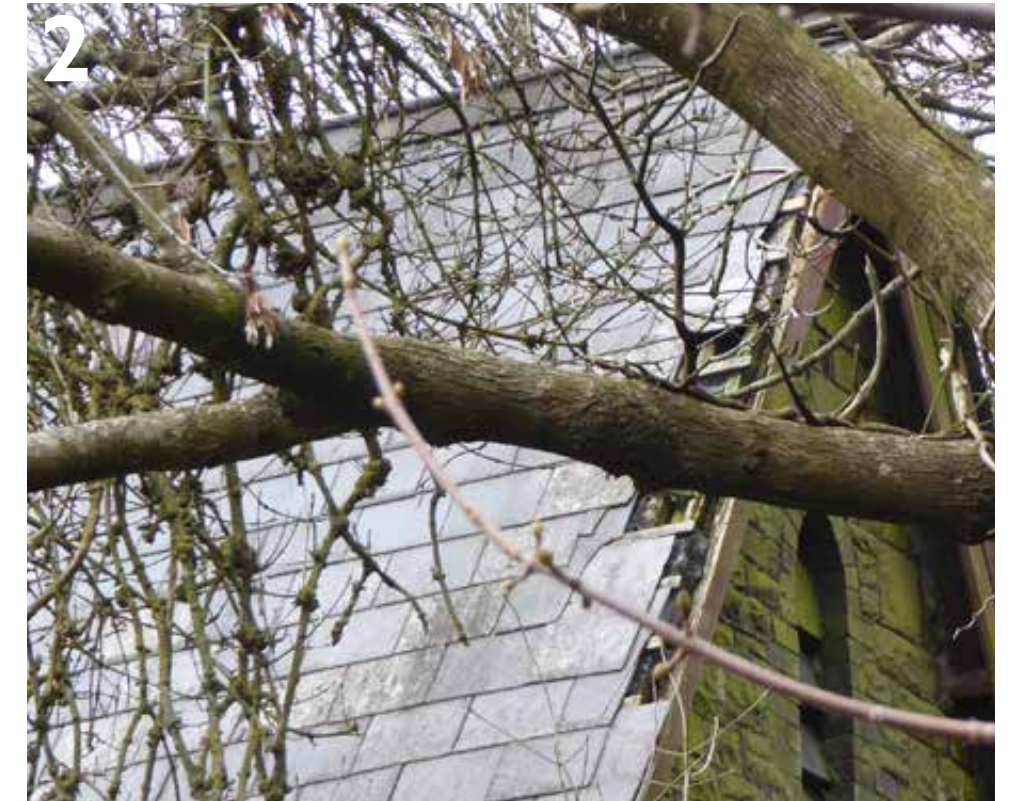
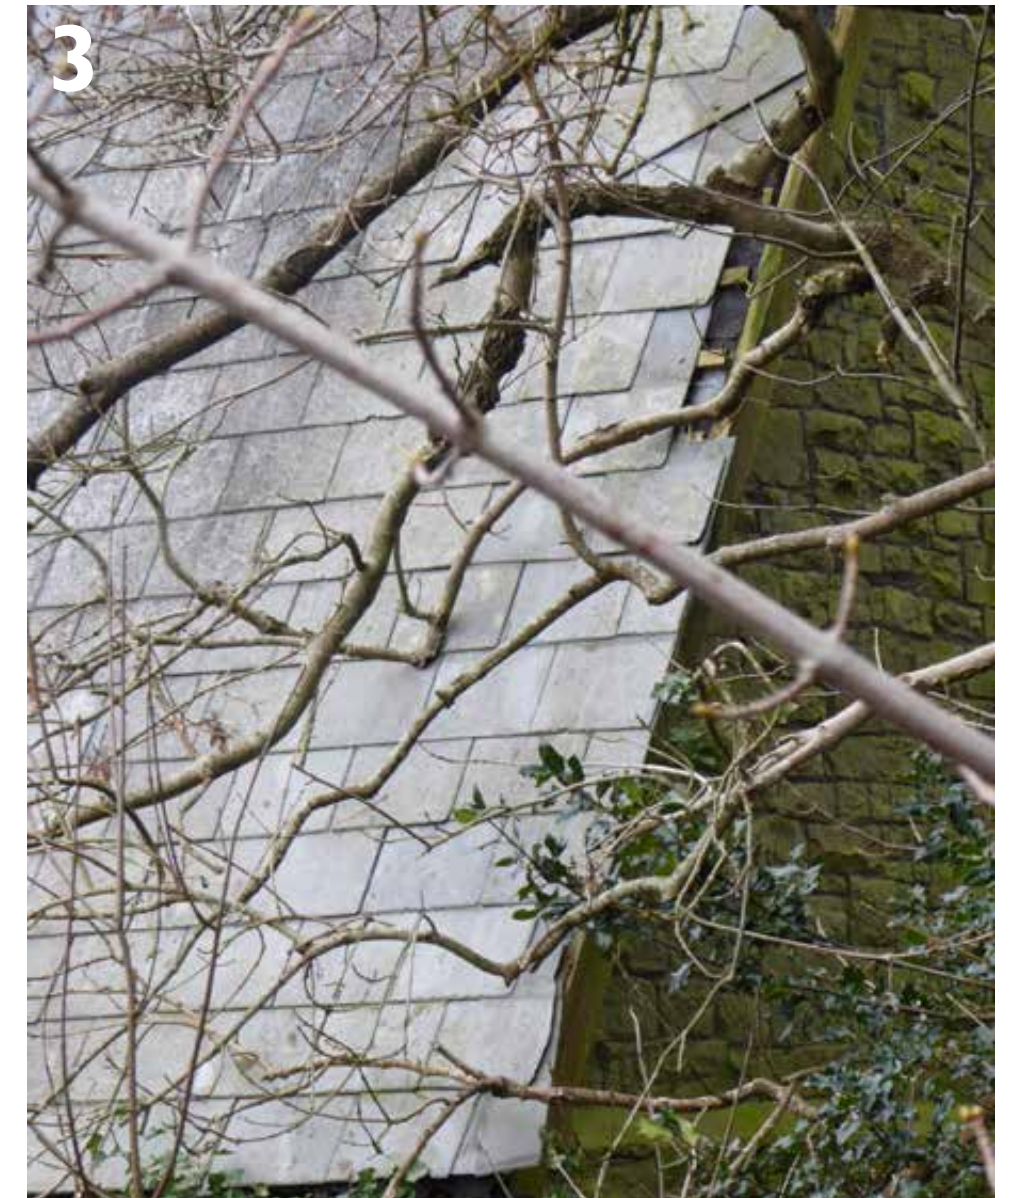
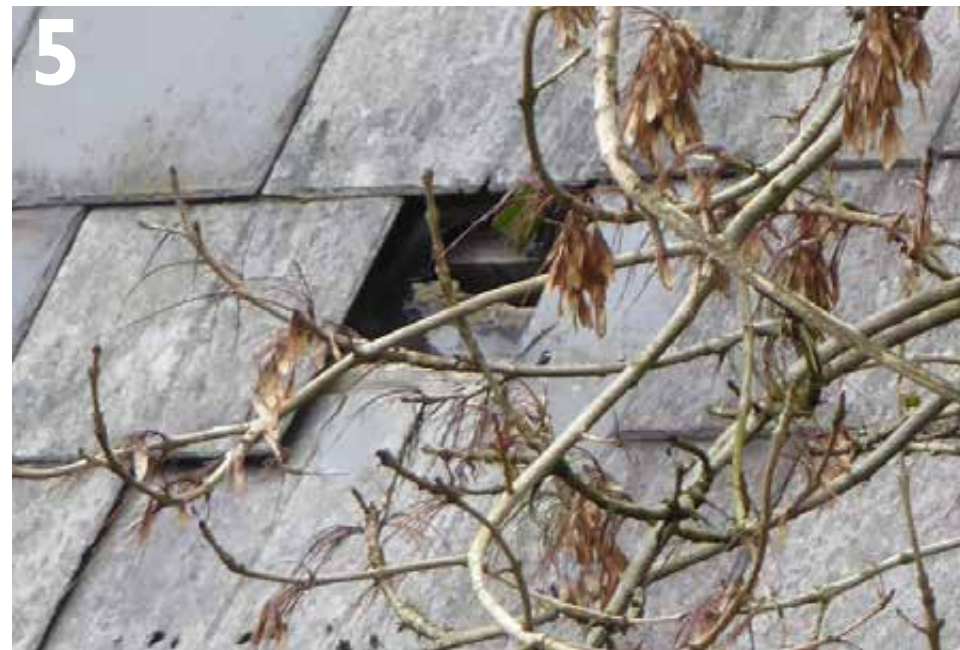
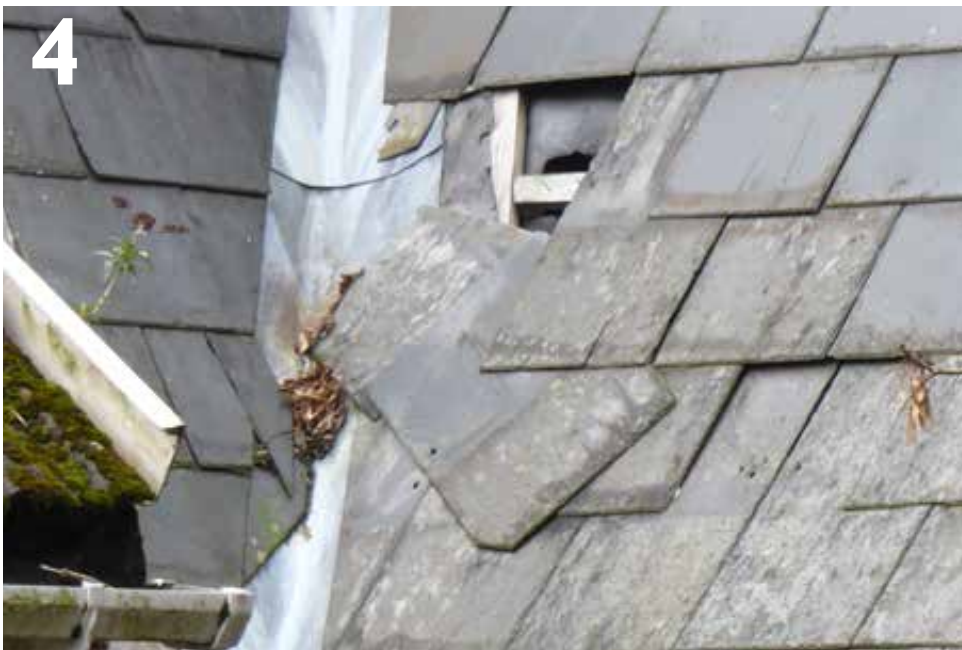
## 6.2 SIDE (SOUTH) ELEVATION

### Examples of Condition Issues with the Roof (with numbers referring to photographs)

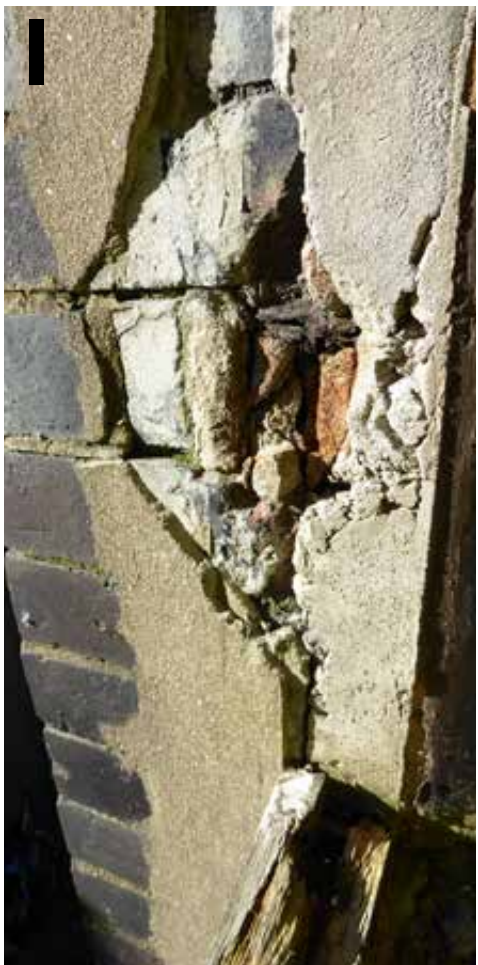
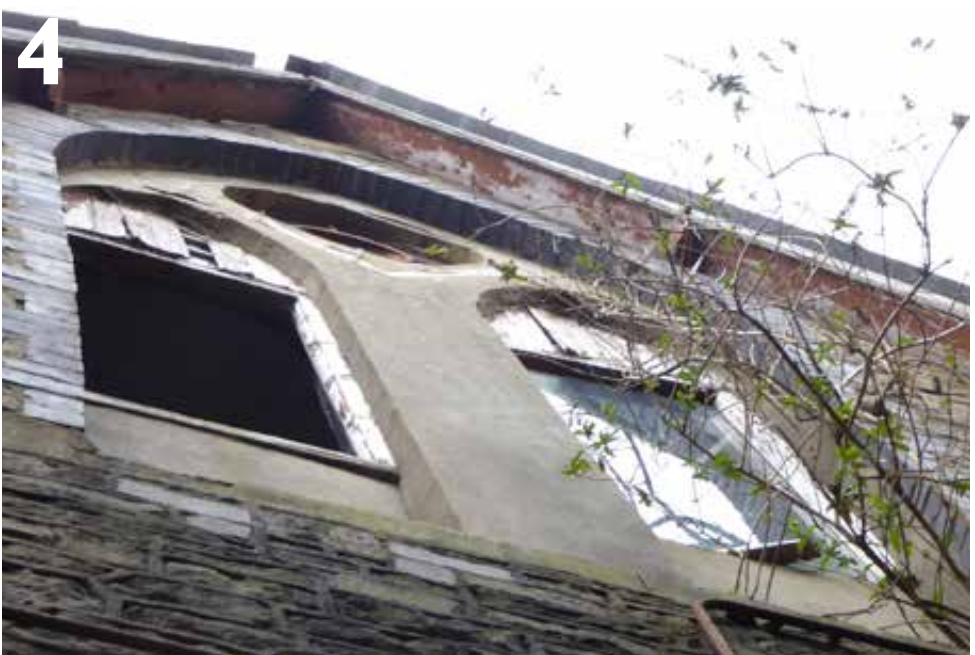
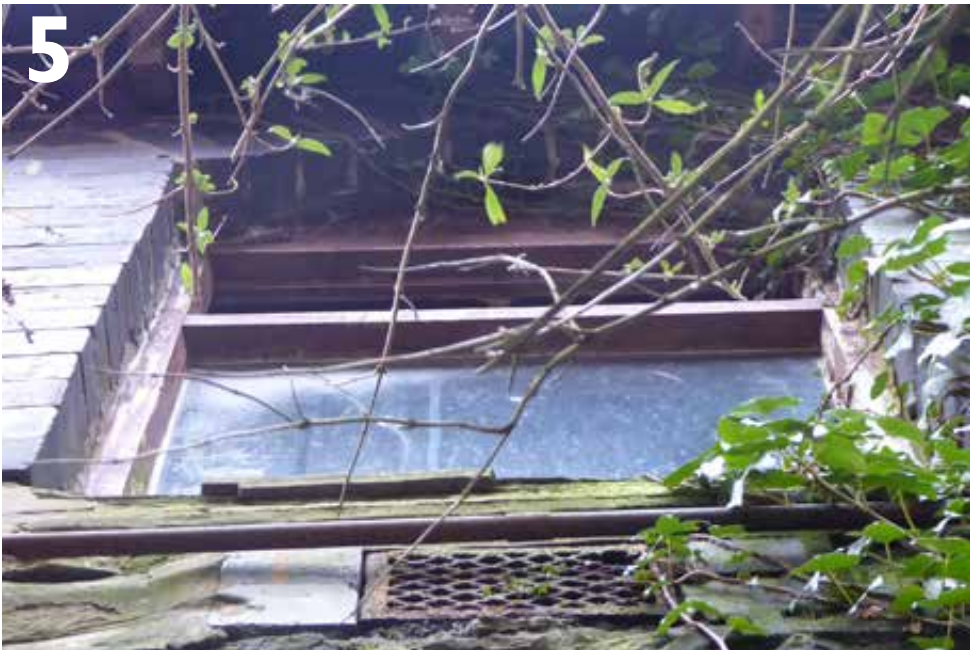
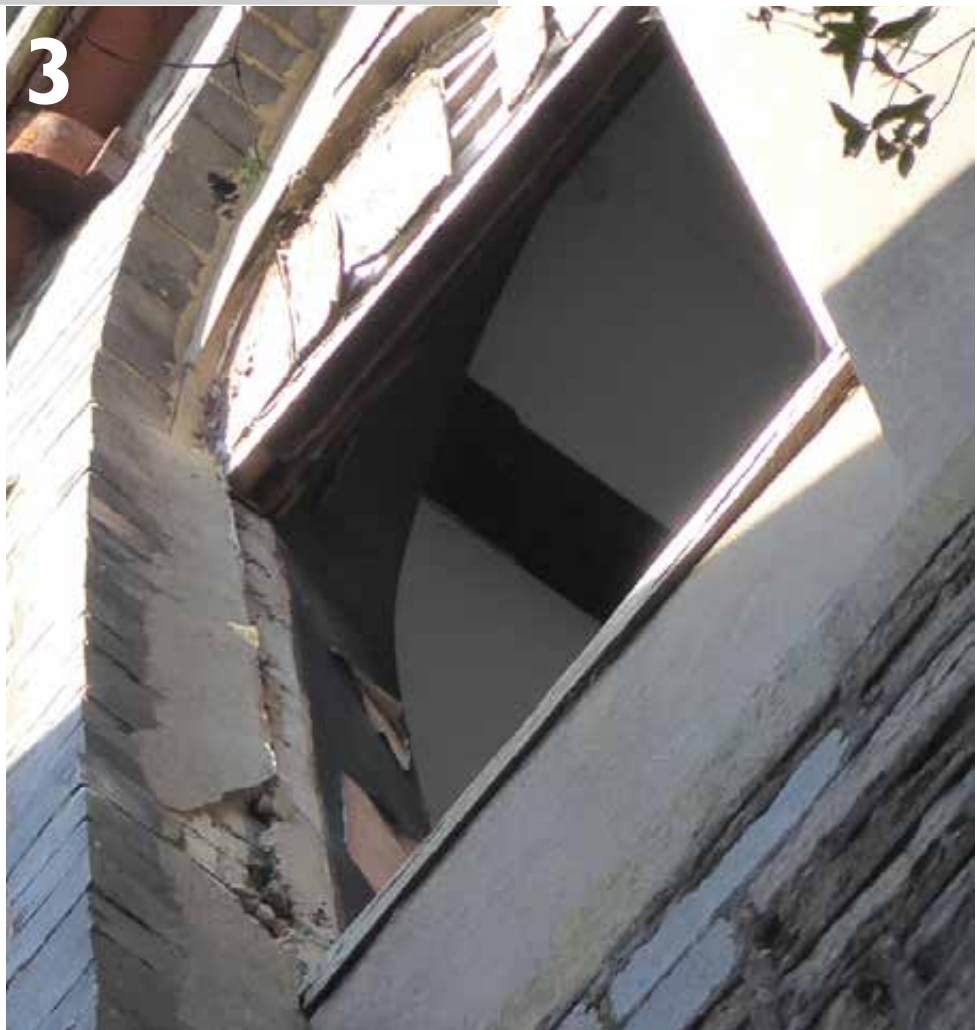
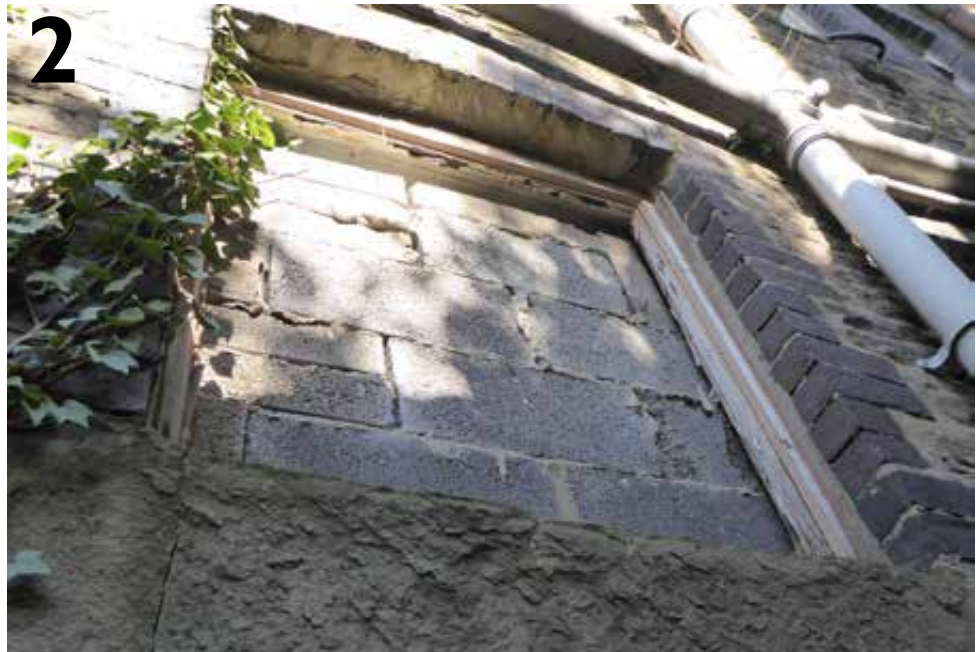
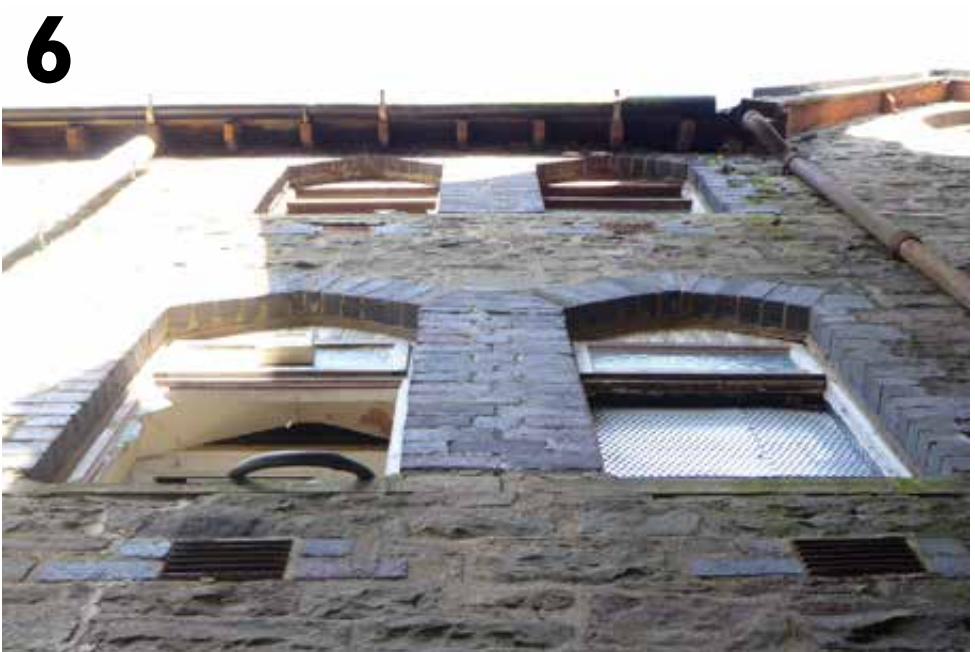
6.2 SIDE (SOUTH)  
ELEVATION

Examples of  
Condition Issues  
with the Windows  
(with numbers  
referring to  
photographs)

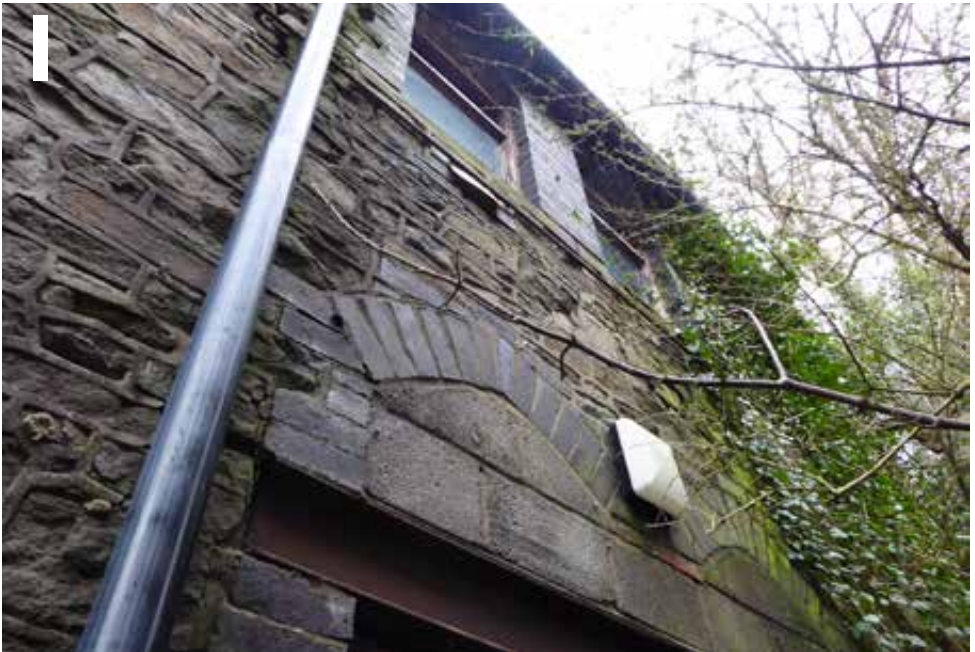
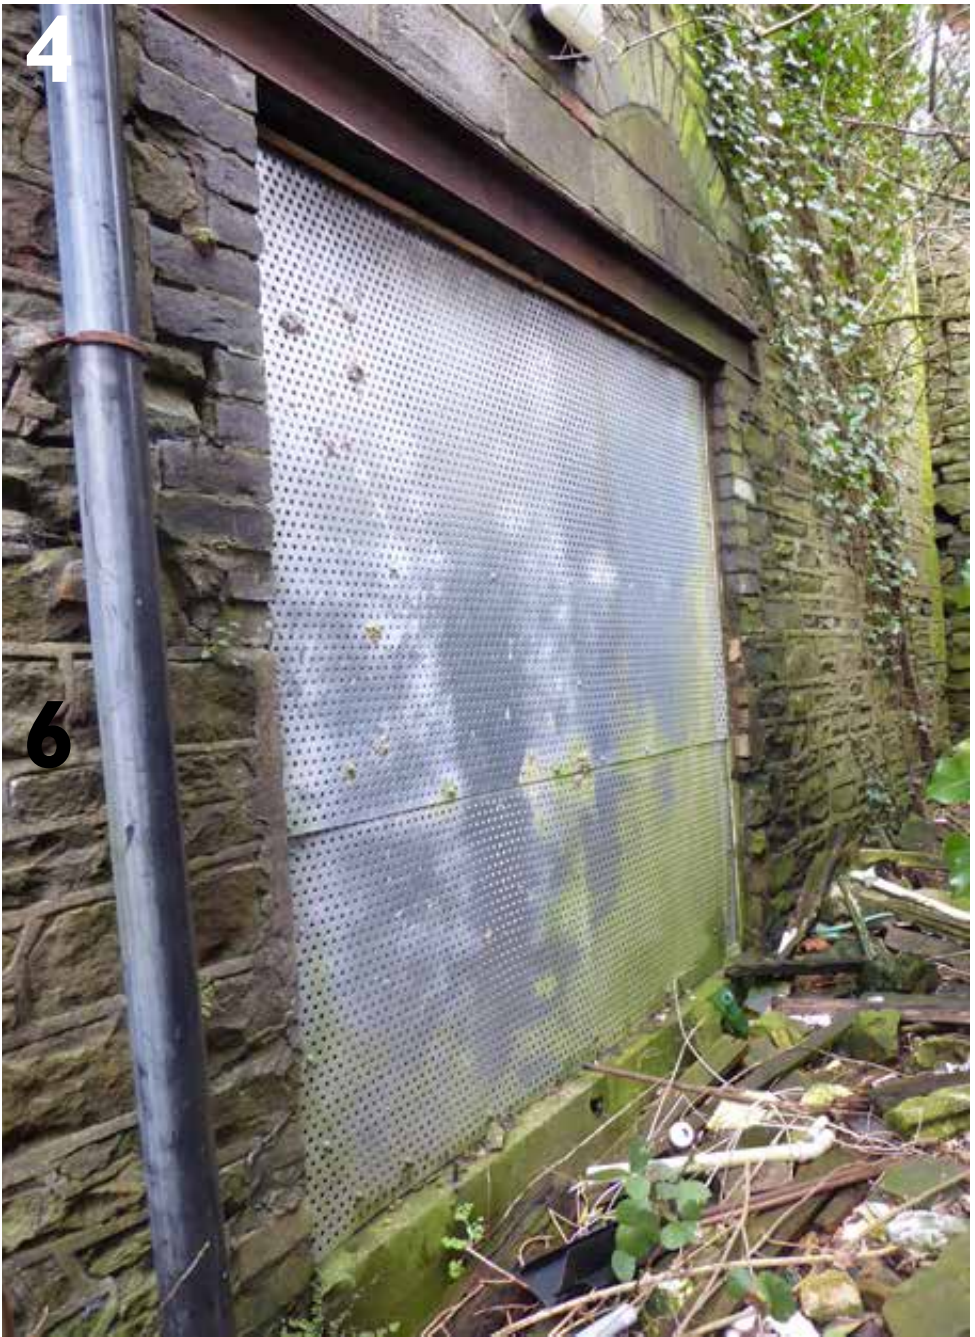
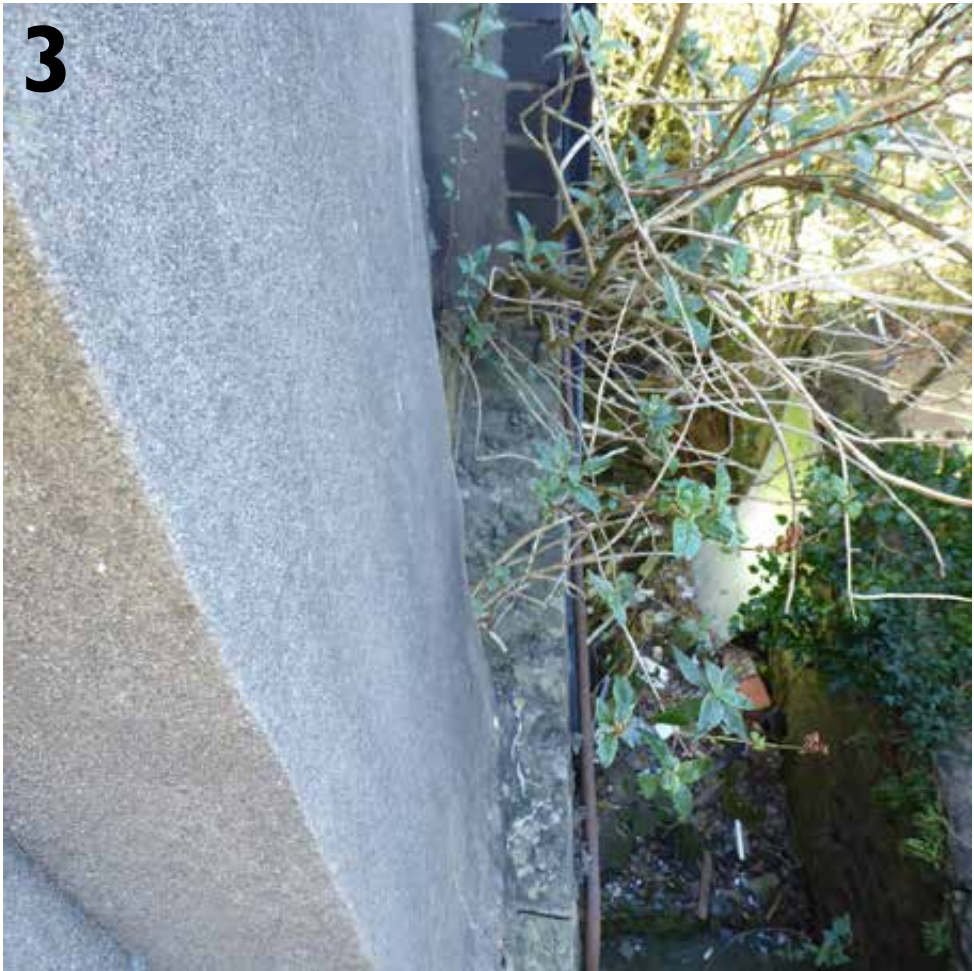
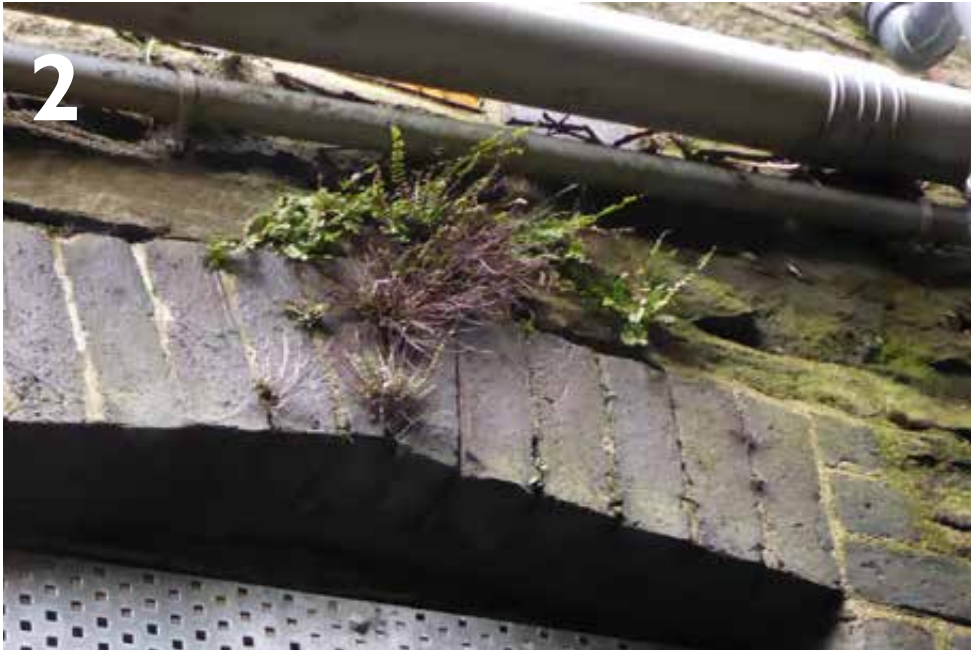
6.2 SIDE (SOUTH)  
ELEVATION

Examples of  
Condition Issues  
with Vegetation  
(with numbers  
referring to  
photographs)

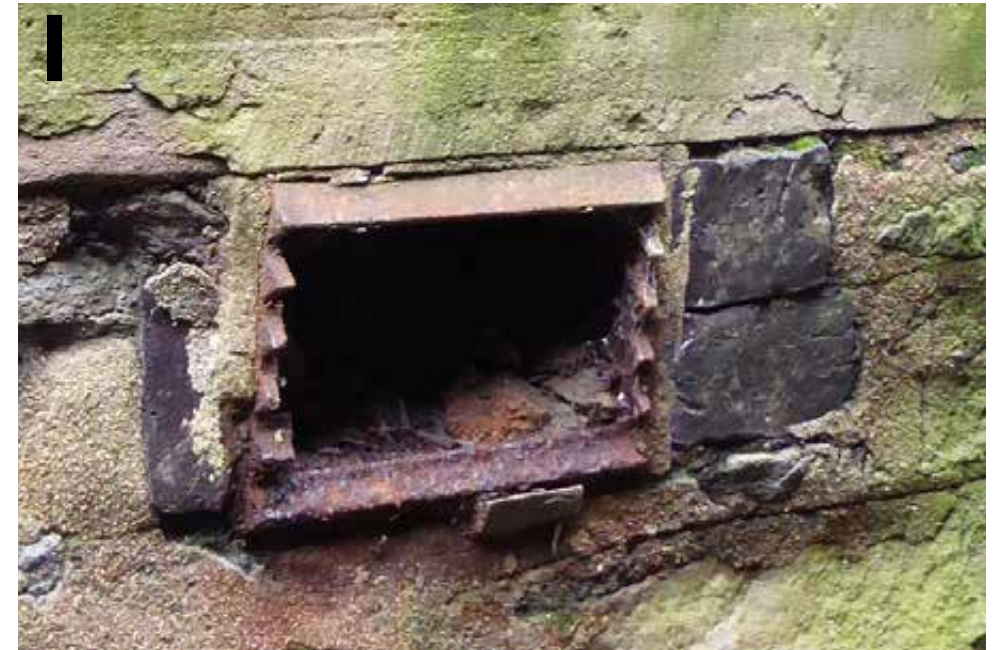
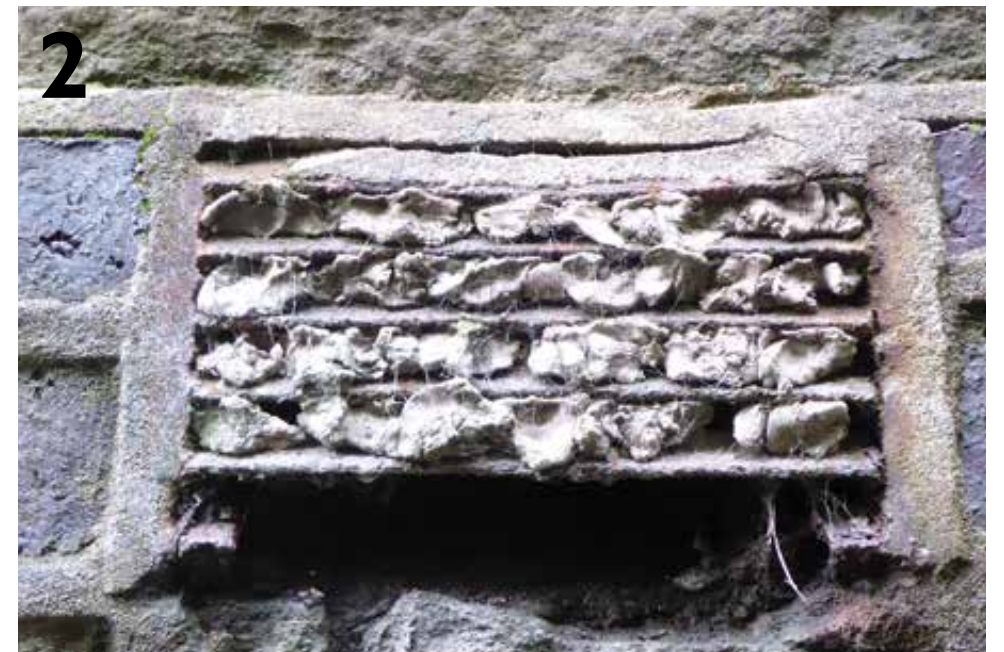
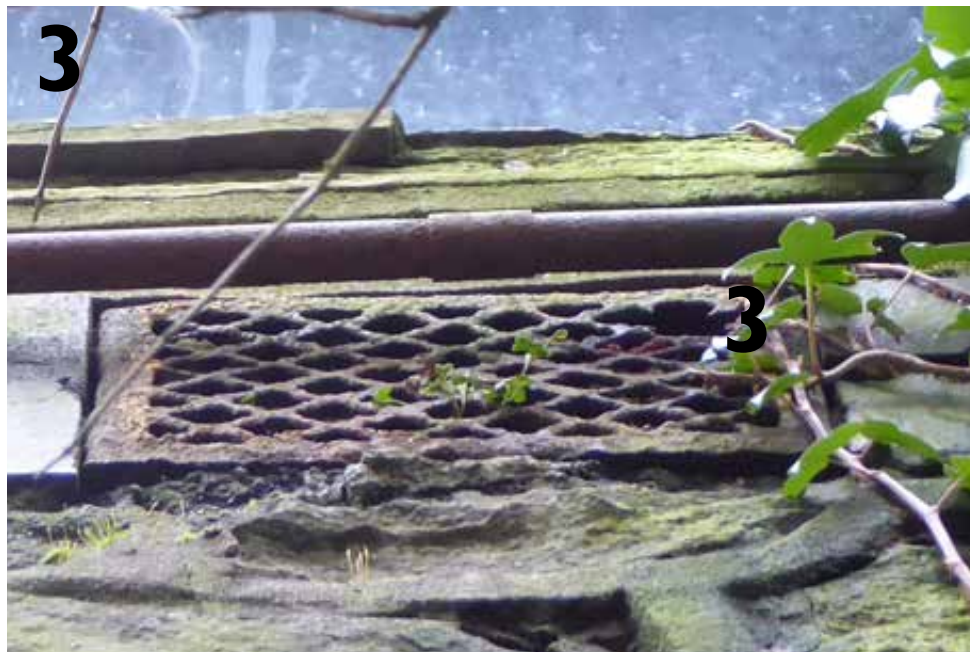
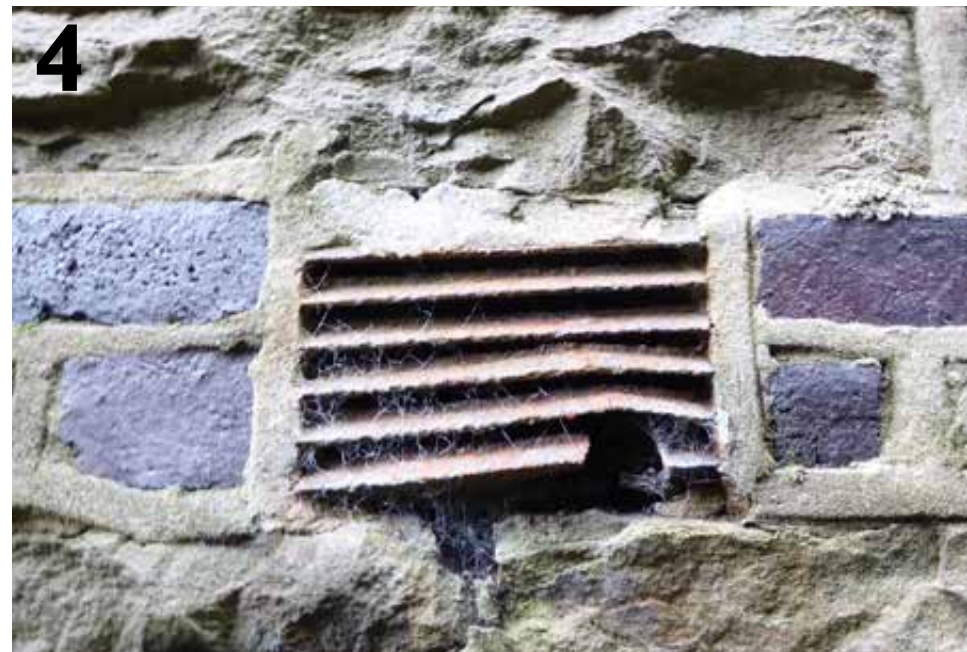
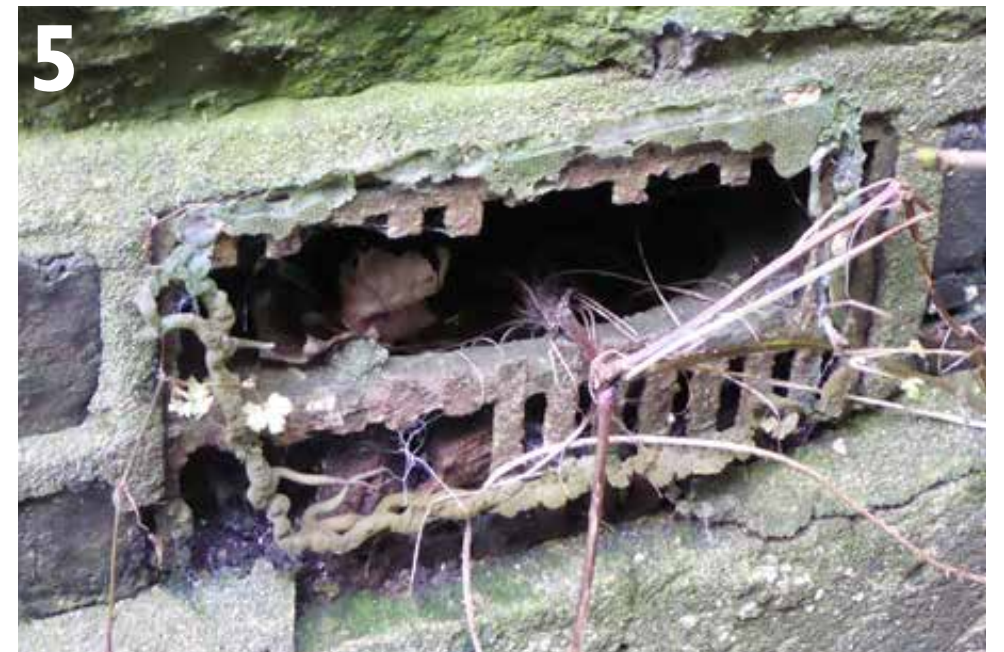
## 6.2 SIDE (SOUTH) ELEVATION

### Examples of Condition Issues with the Vents (with numbers referring to photographs)

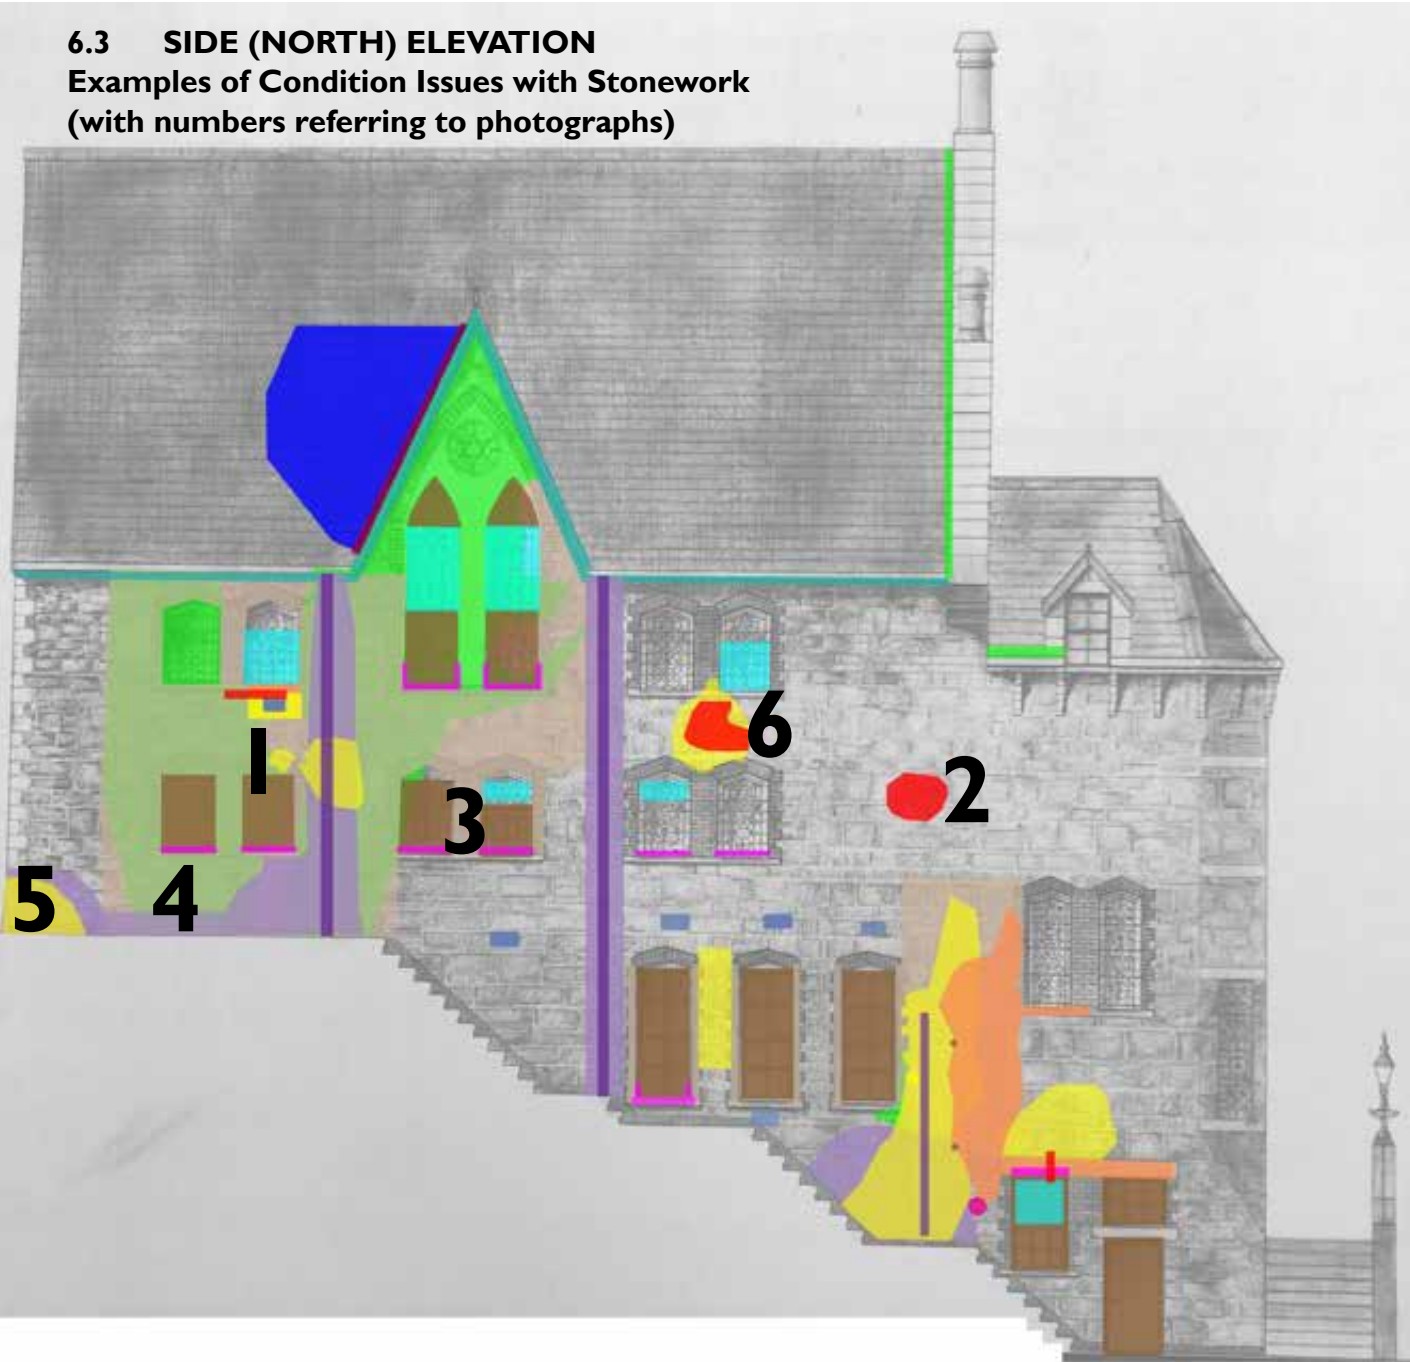
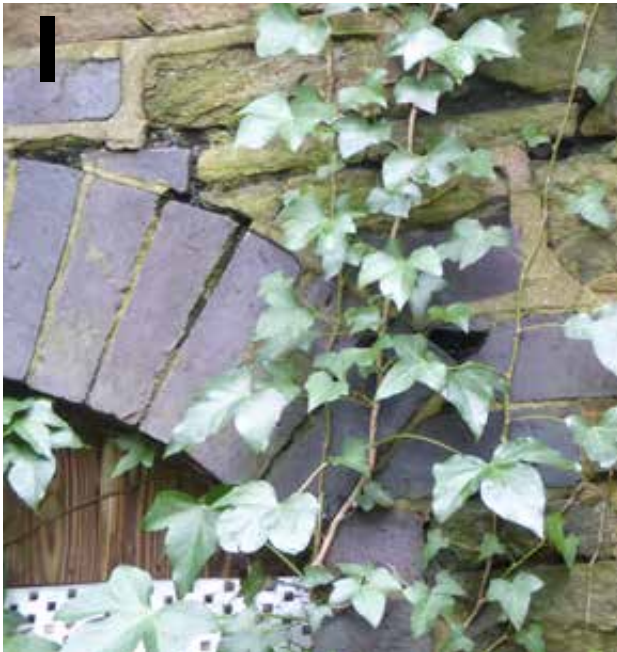
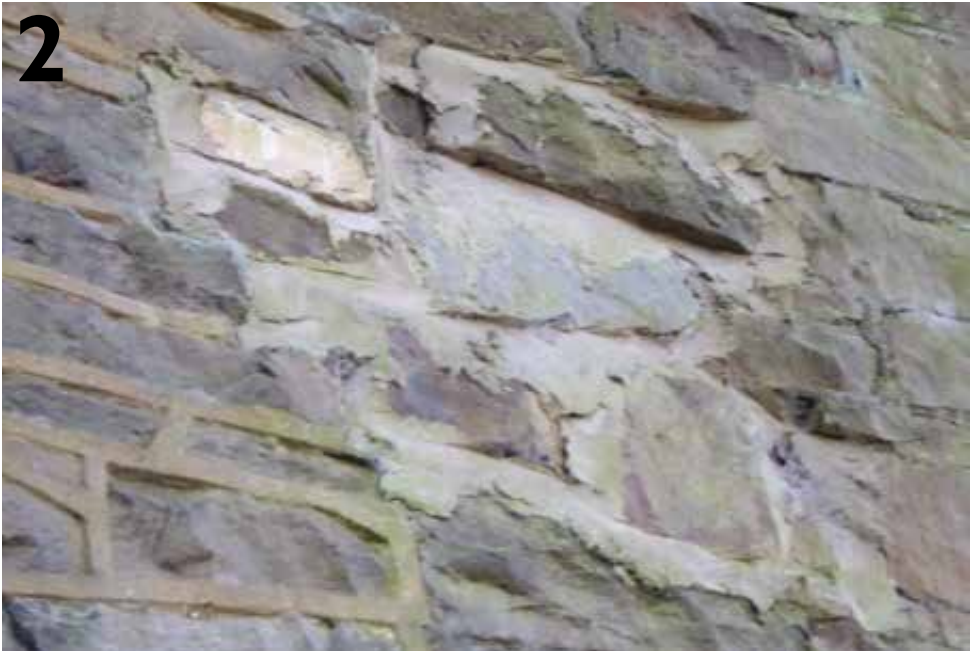
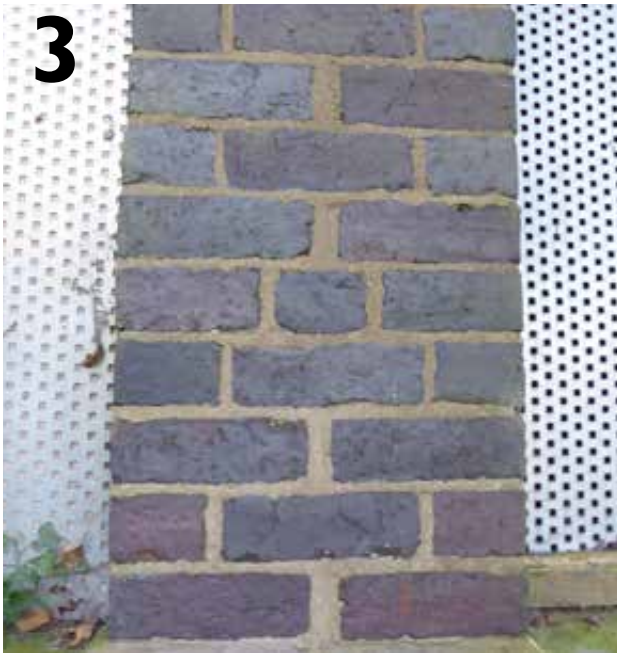
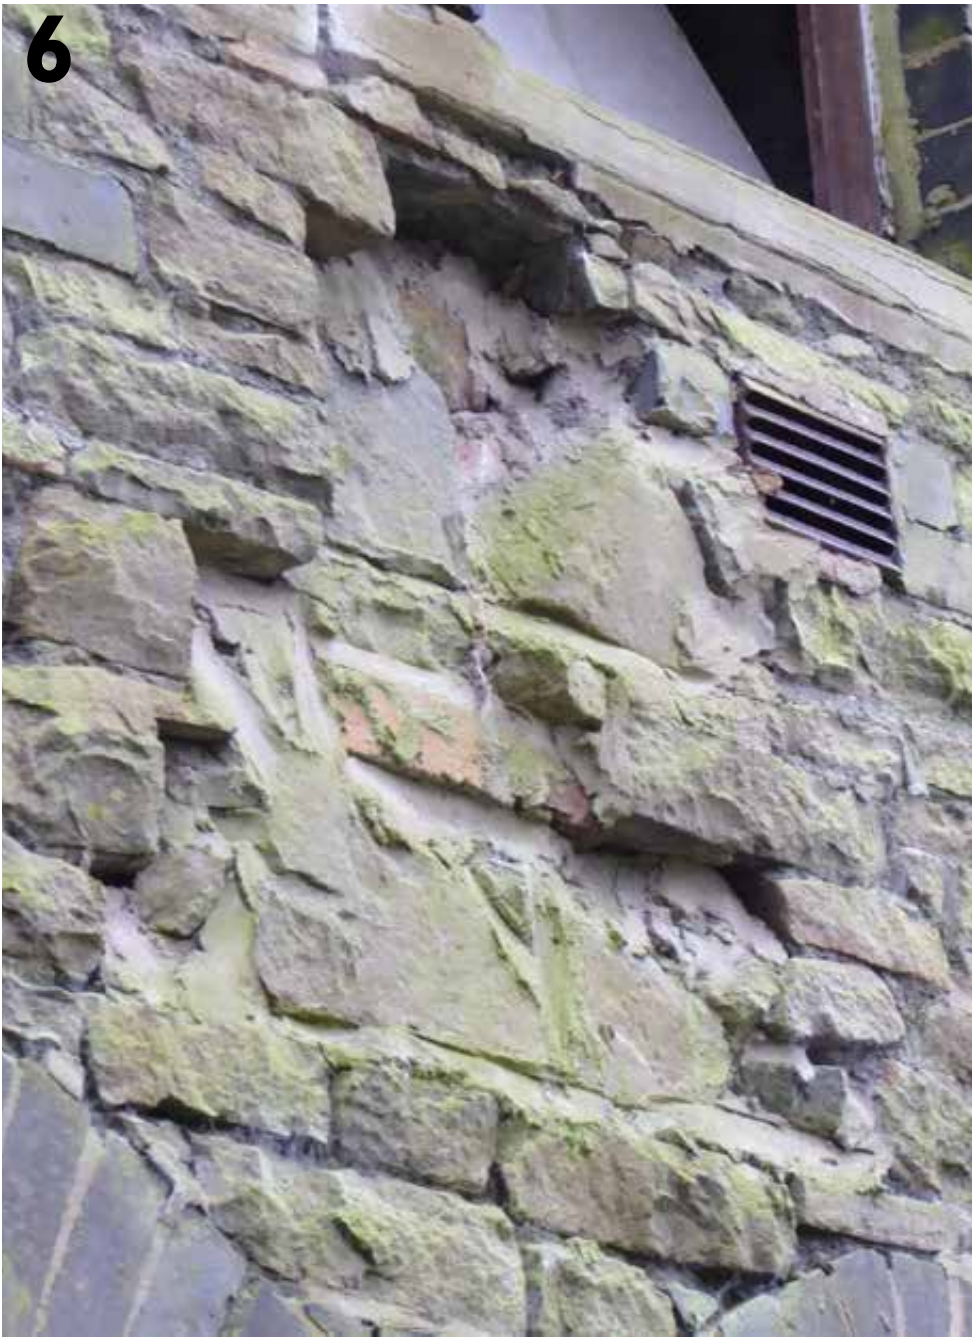
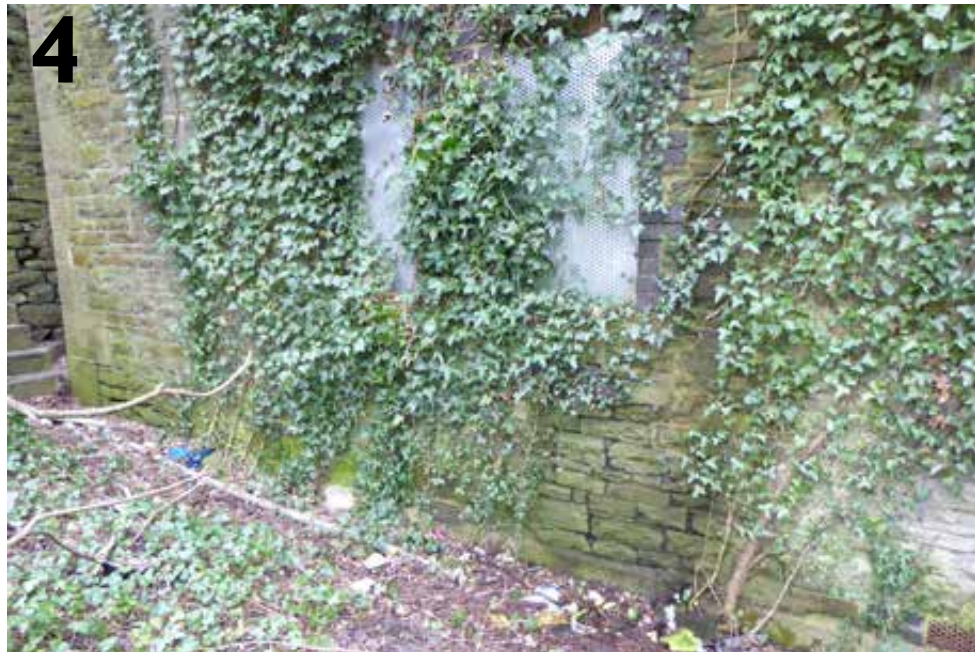
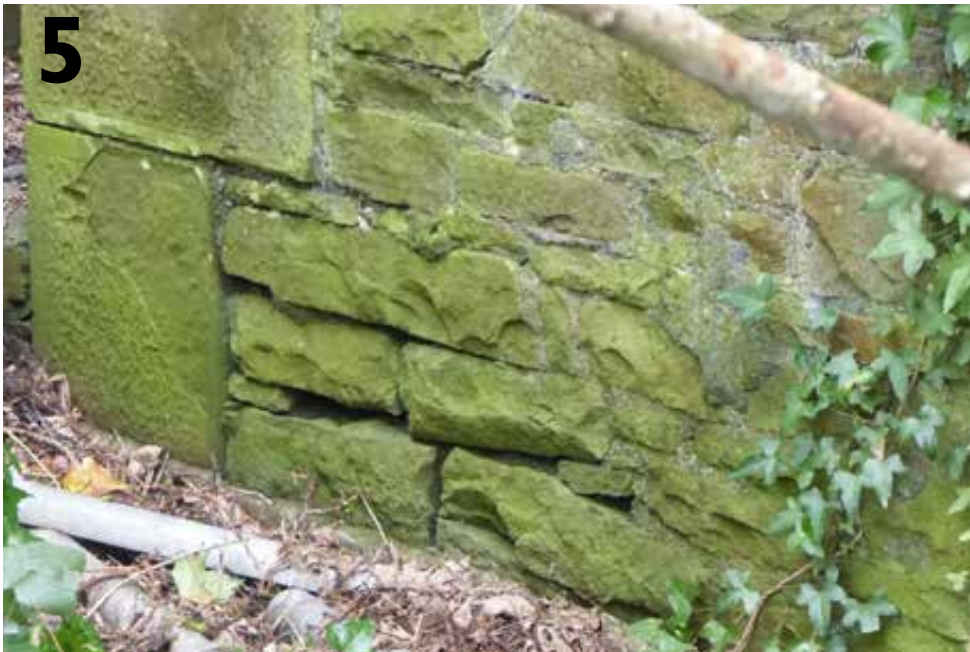
6.3 SIDE (NORTH) ELEVATION  
Examples of Condition Issues with Stonework  
(with numbers referring to photographs)
