# Synagogue, Merthyr Tydfil

## RECORD OF BUILDING AND CONDITION ASSESSMENT REPORT

.....  
(449)2503-GWP-A-HIS-P00

Date: 17.03.25

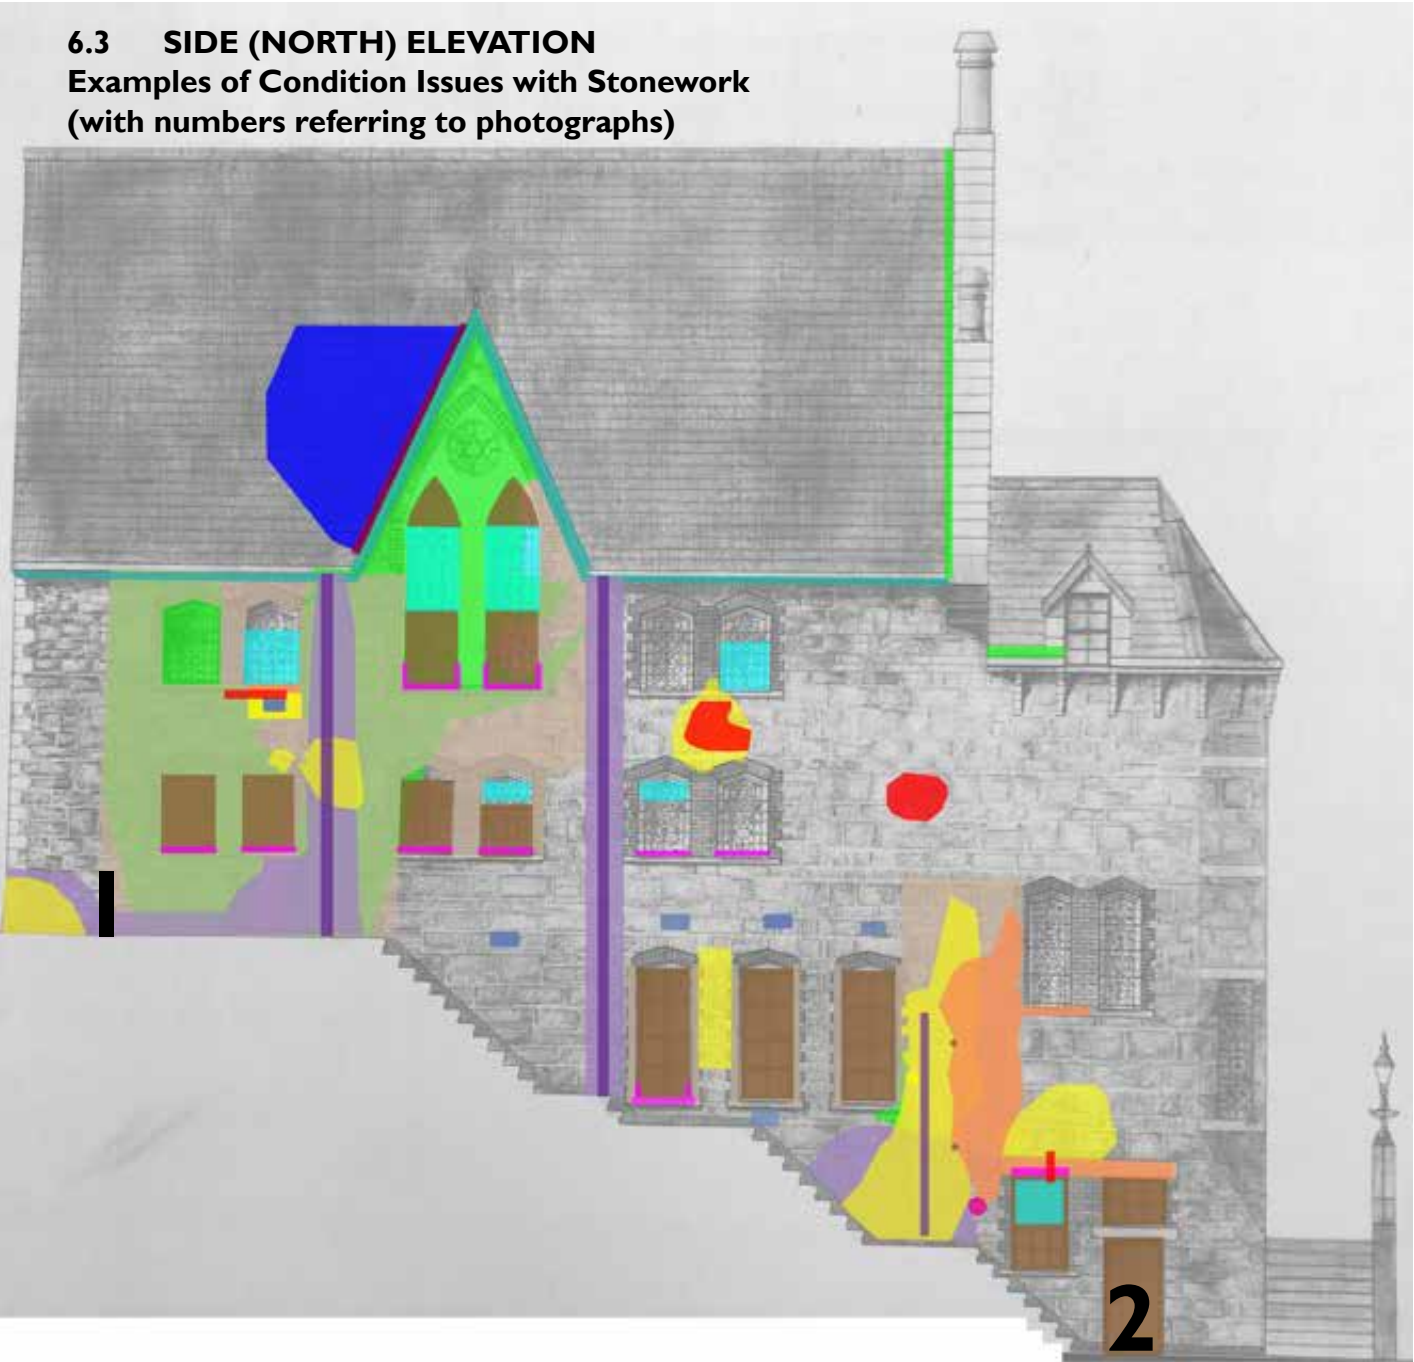
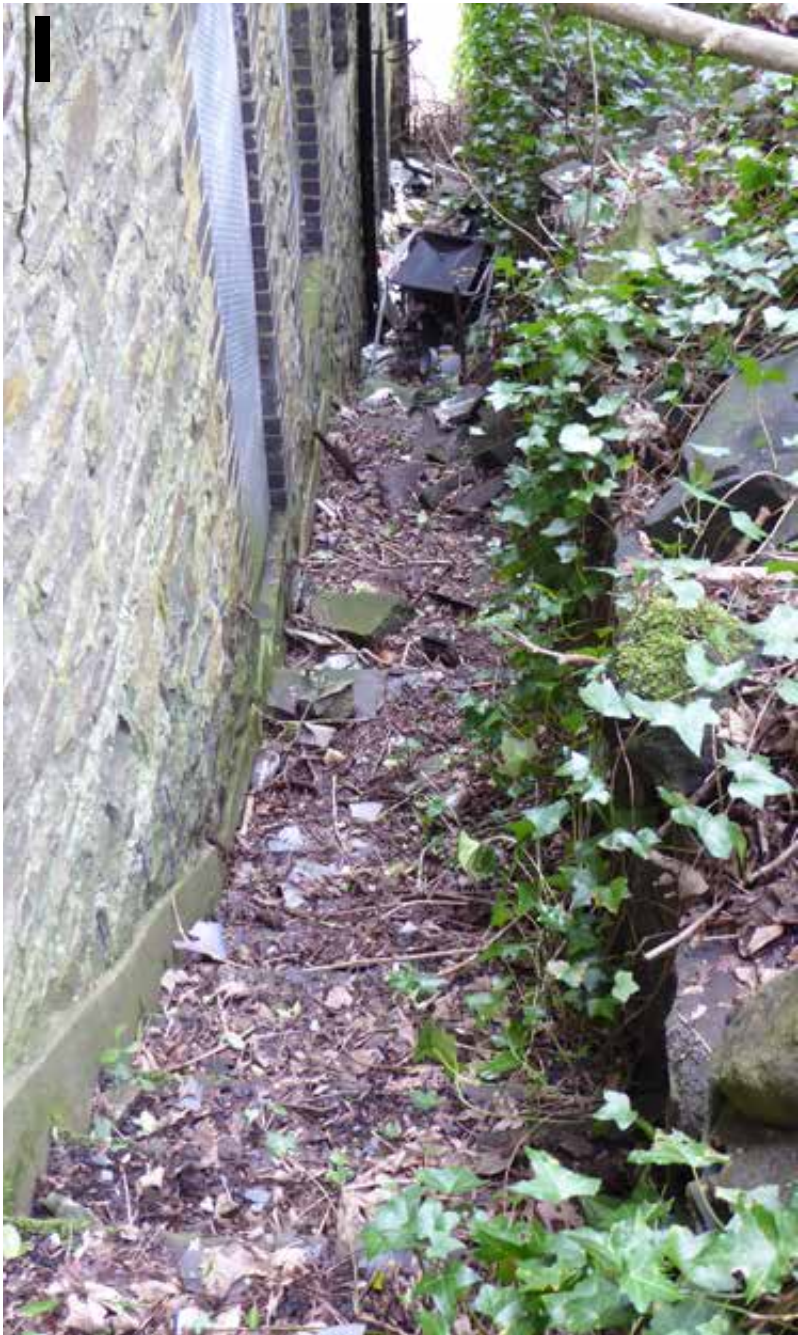
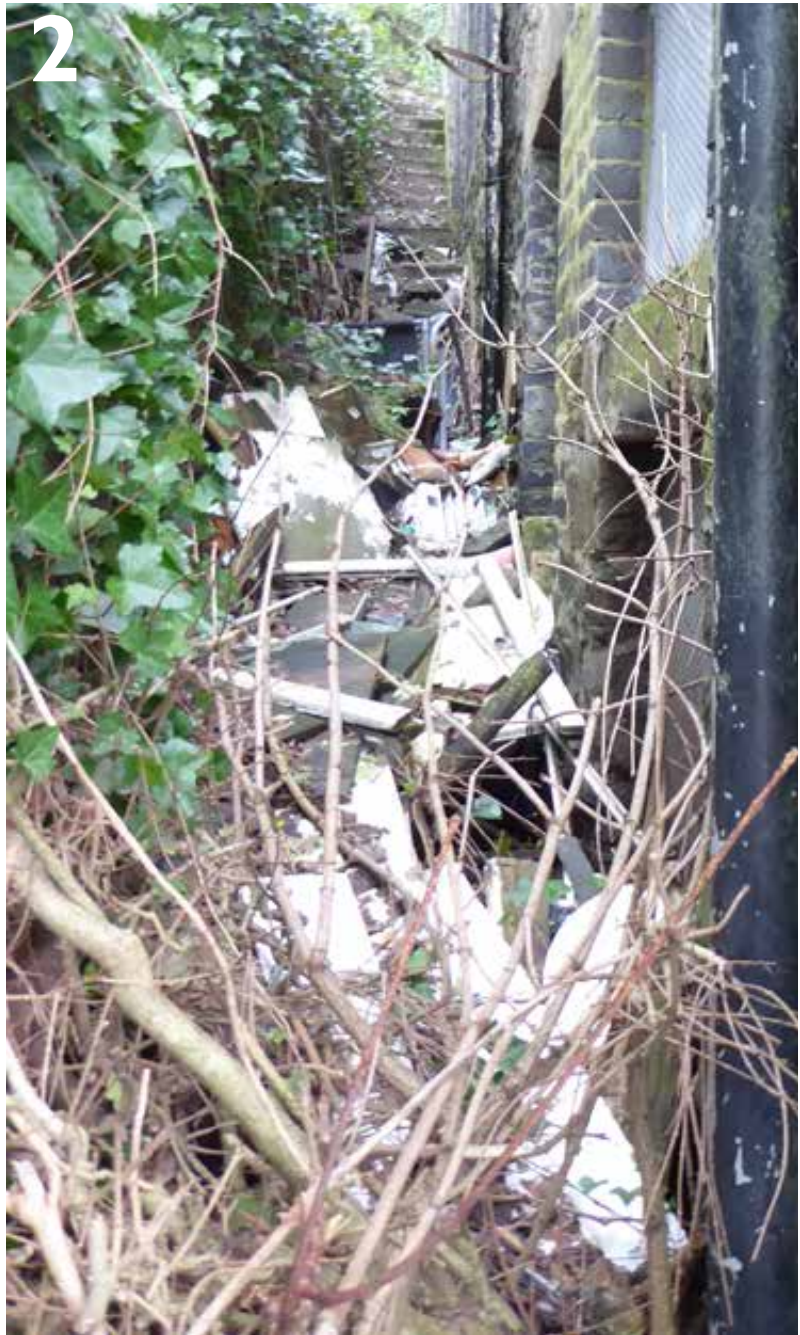
6.3 SIDE (NORTH) ELEVATION  
Examples of Condition Issues with Stonework  
(with numbers referring to photographs)

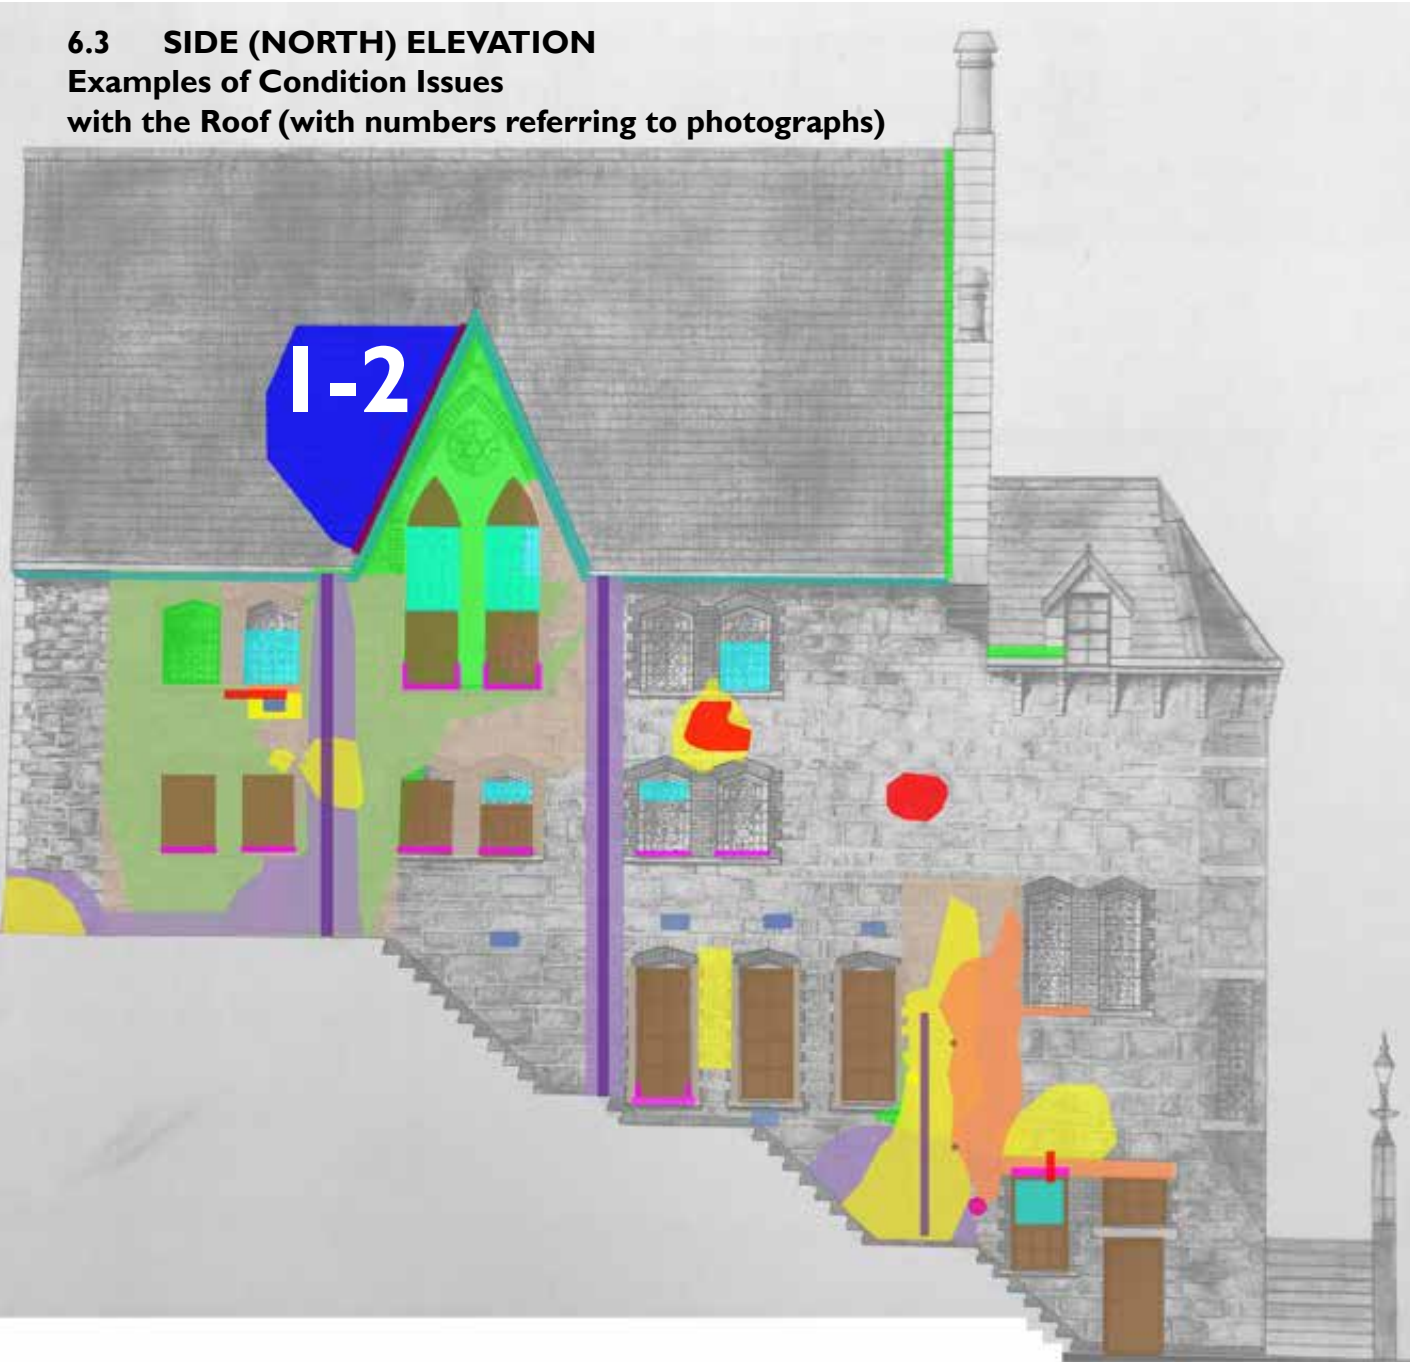
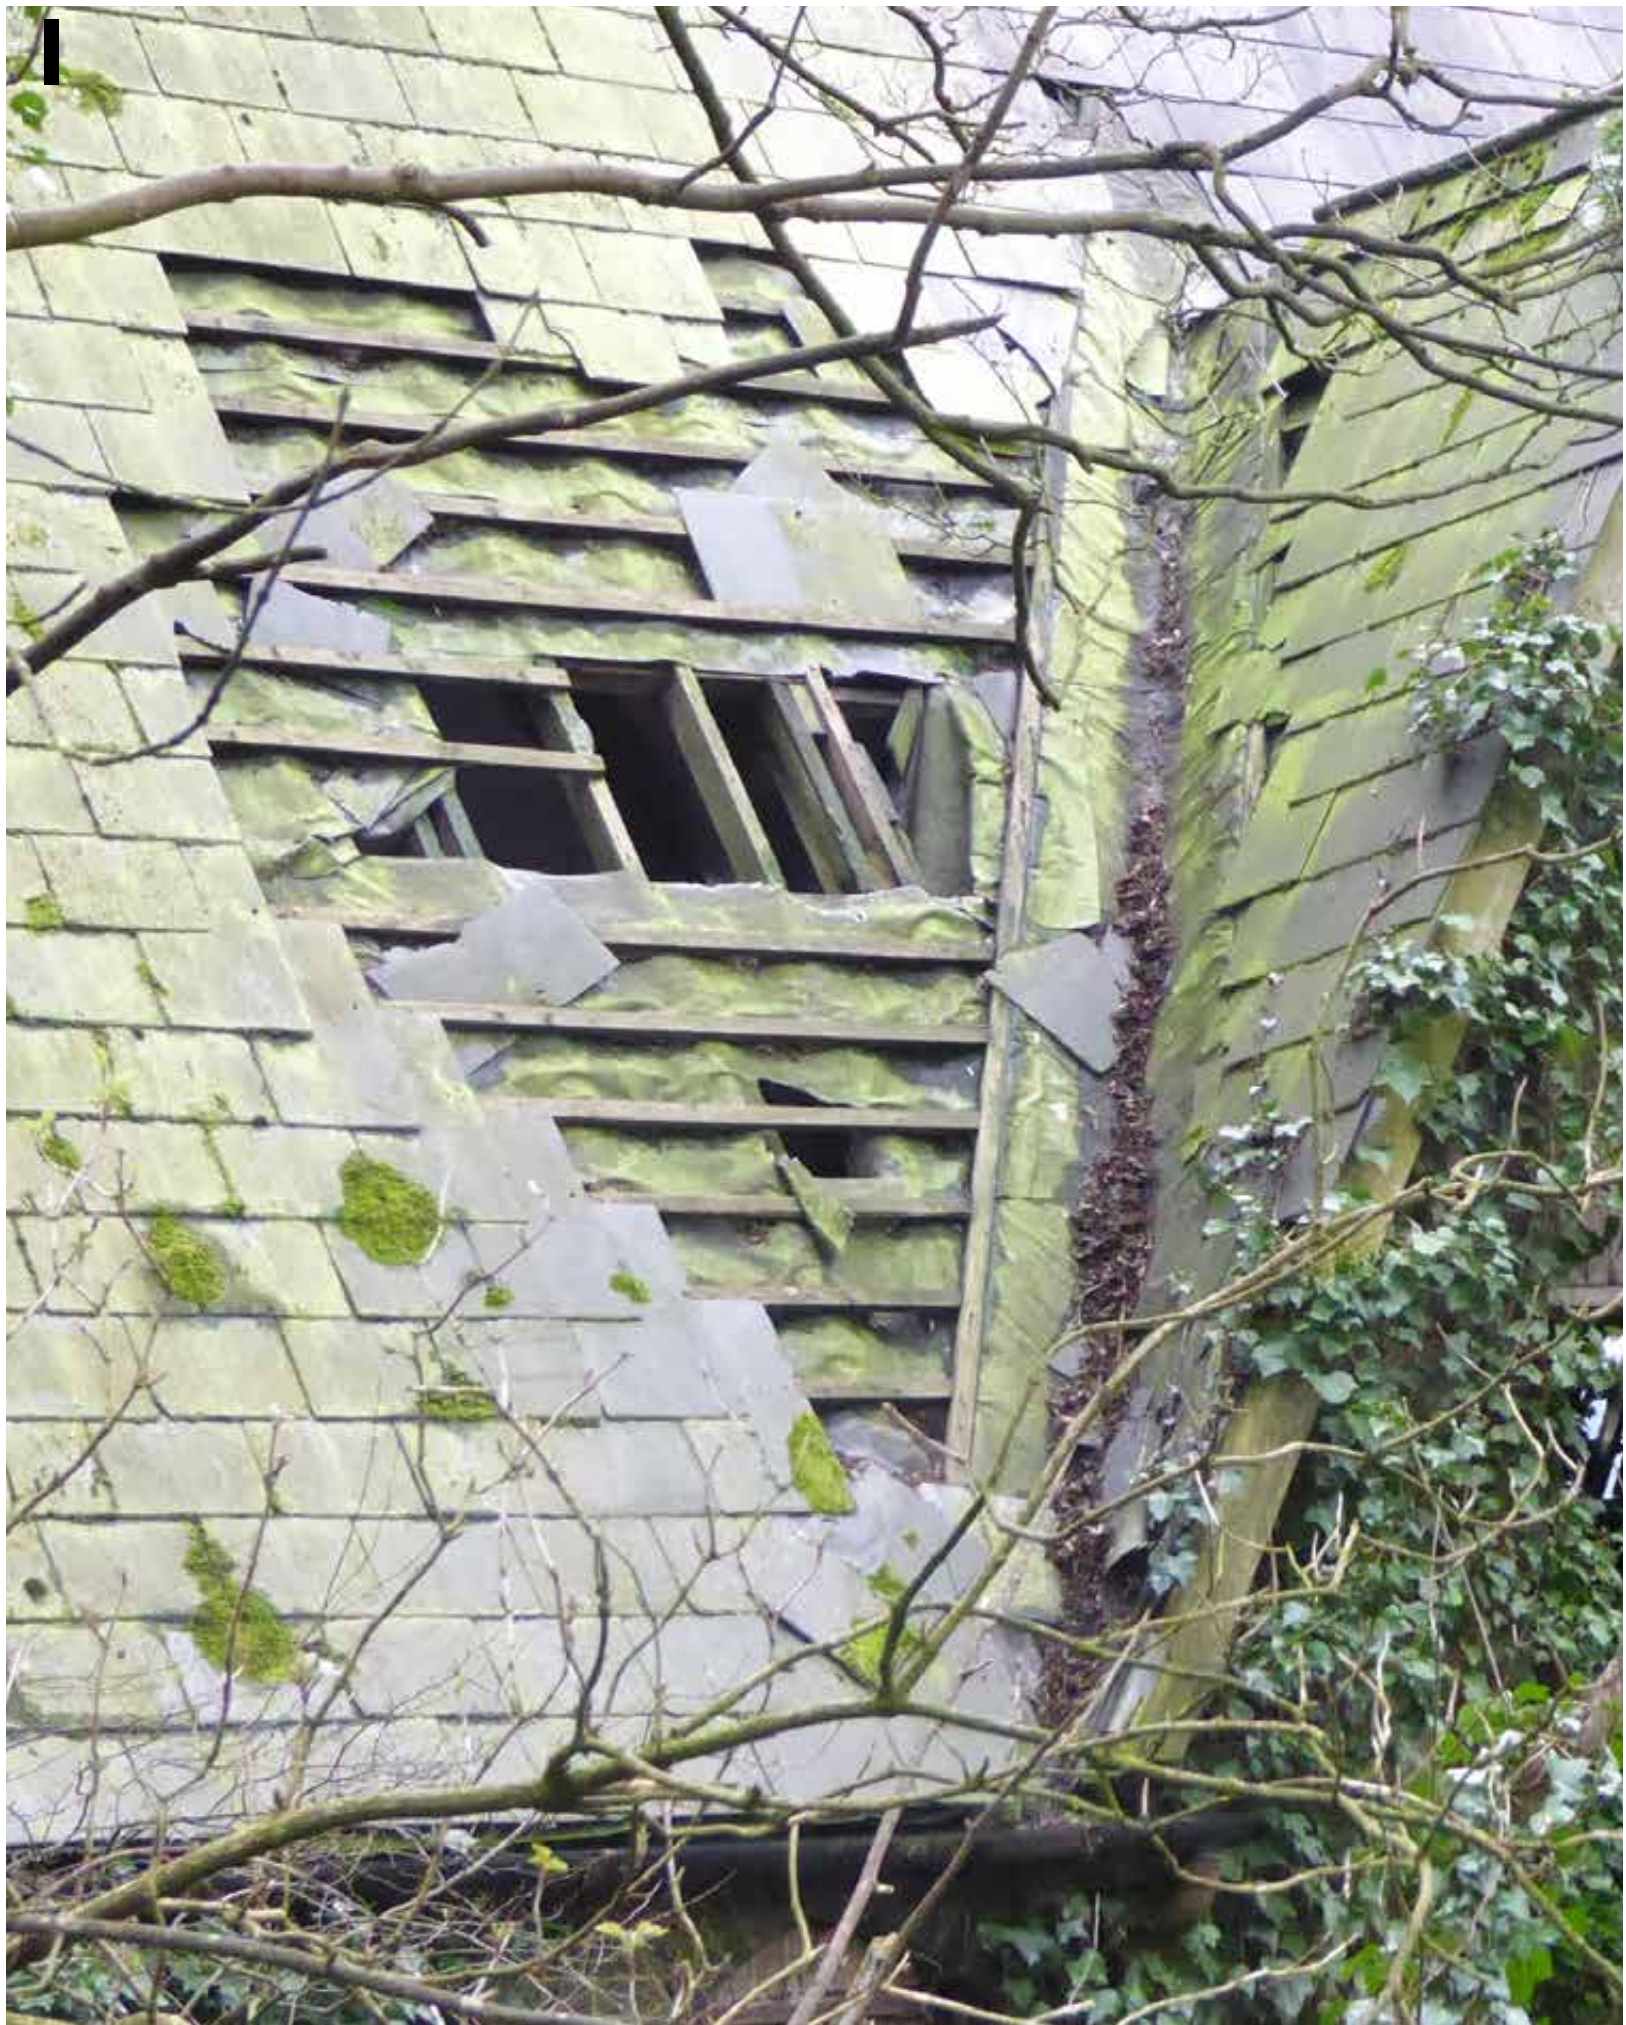
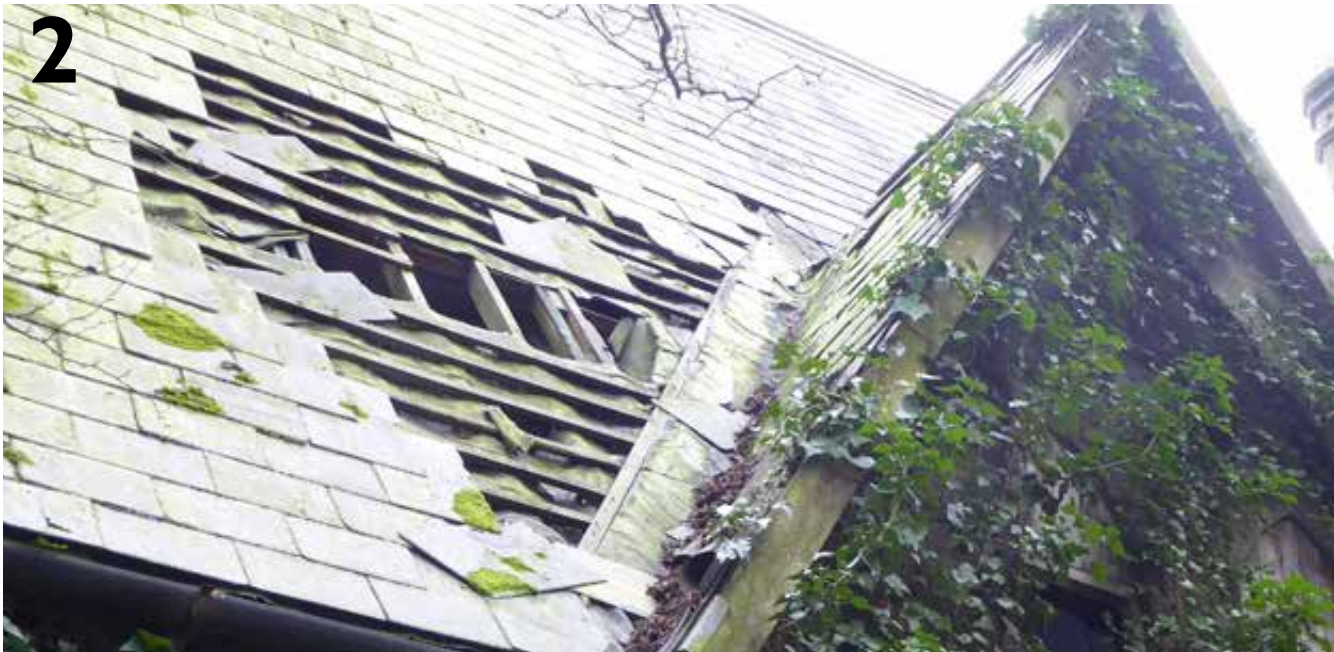
6.3 SIDE (NORTH) ELEVATION  
Examples of Condition Issues  
with the Roof (with numbers referring to photographs)

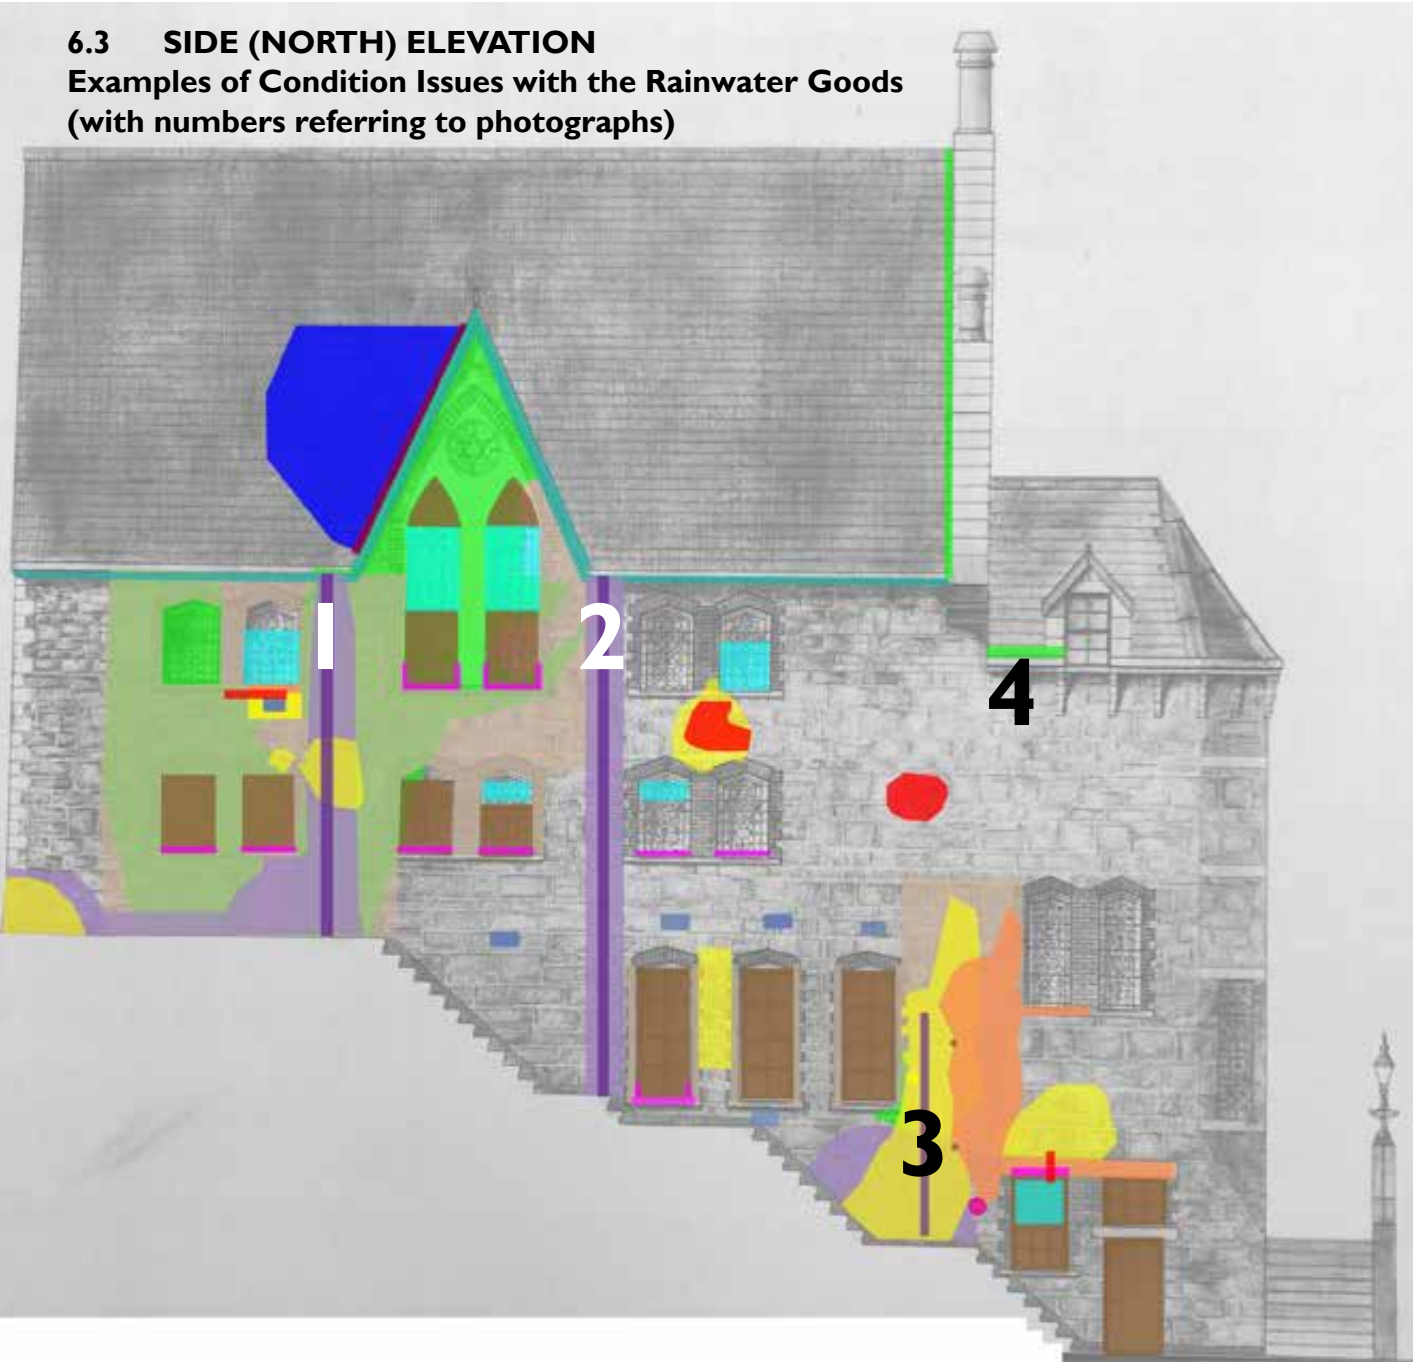
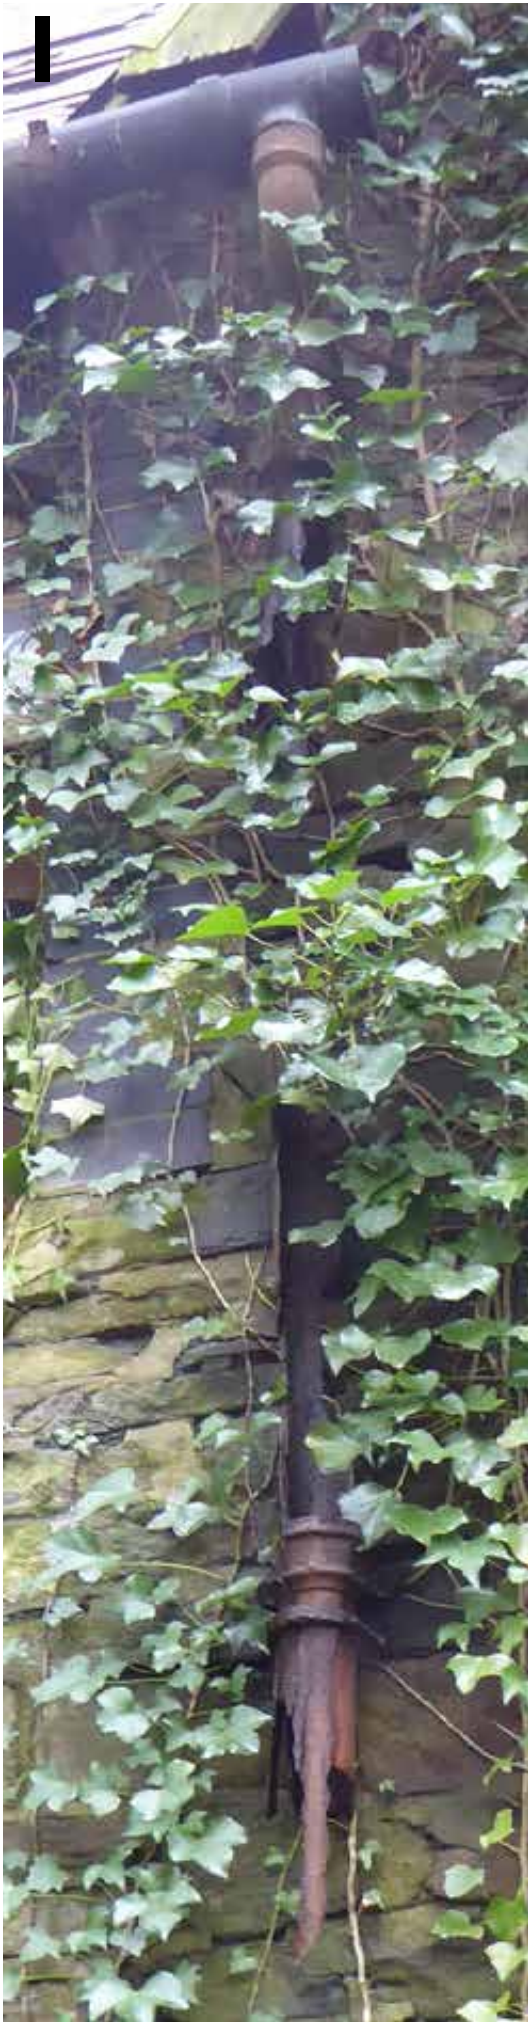
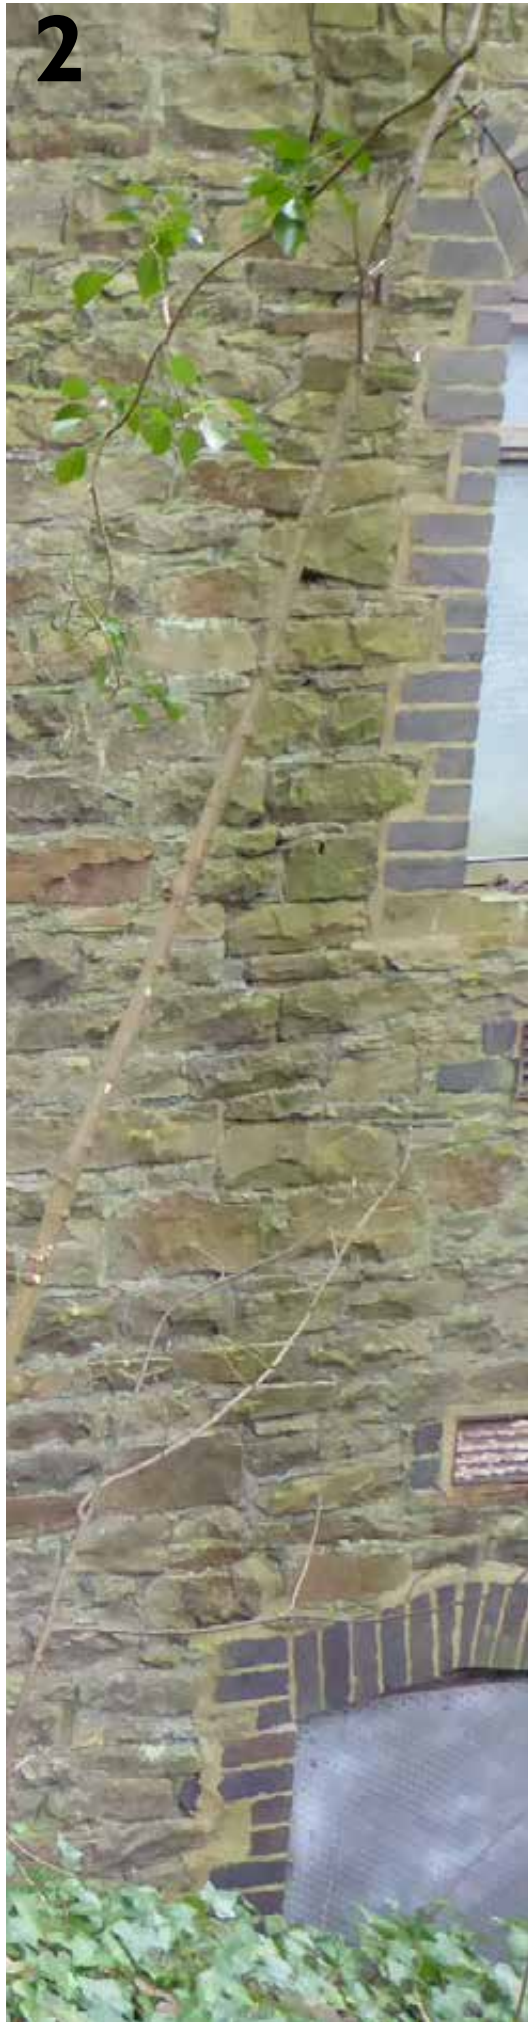
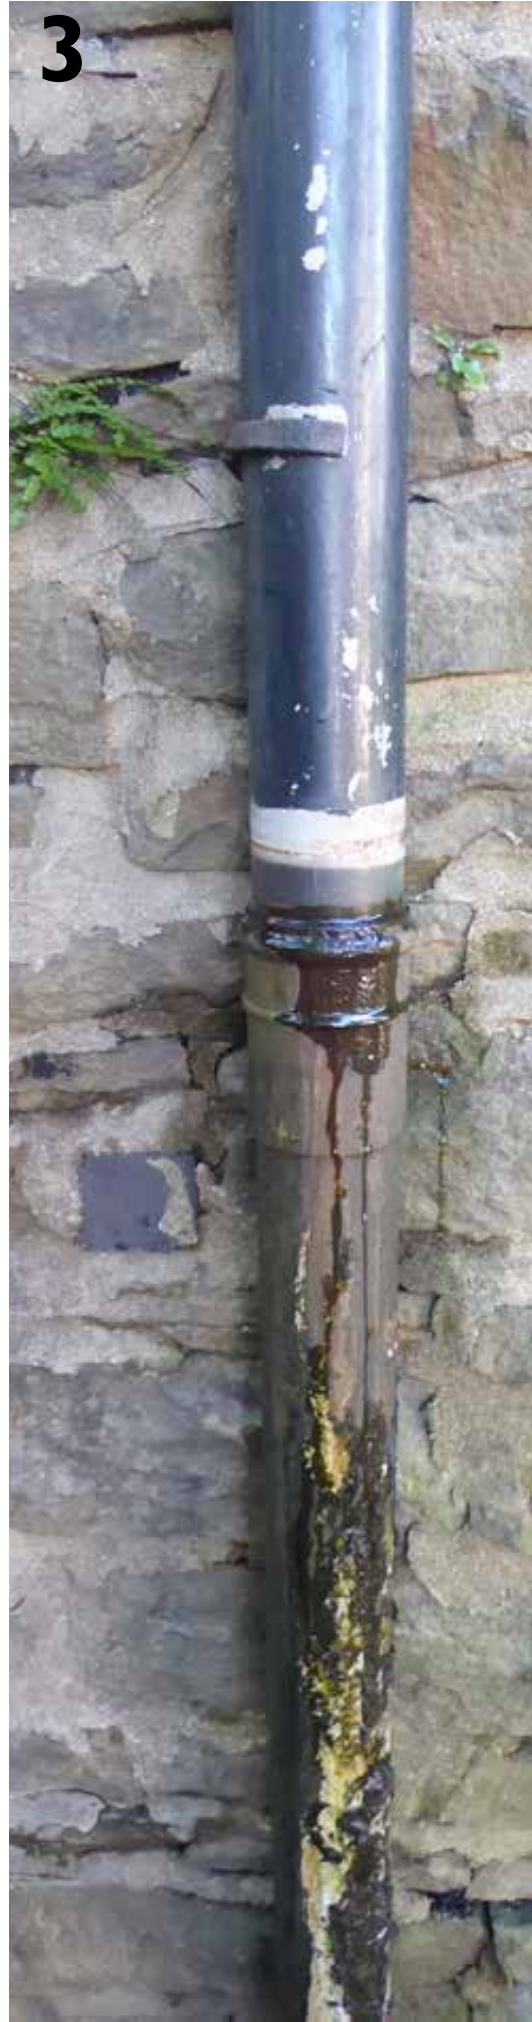
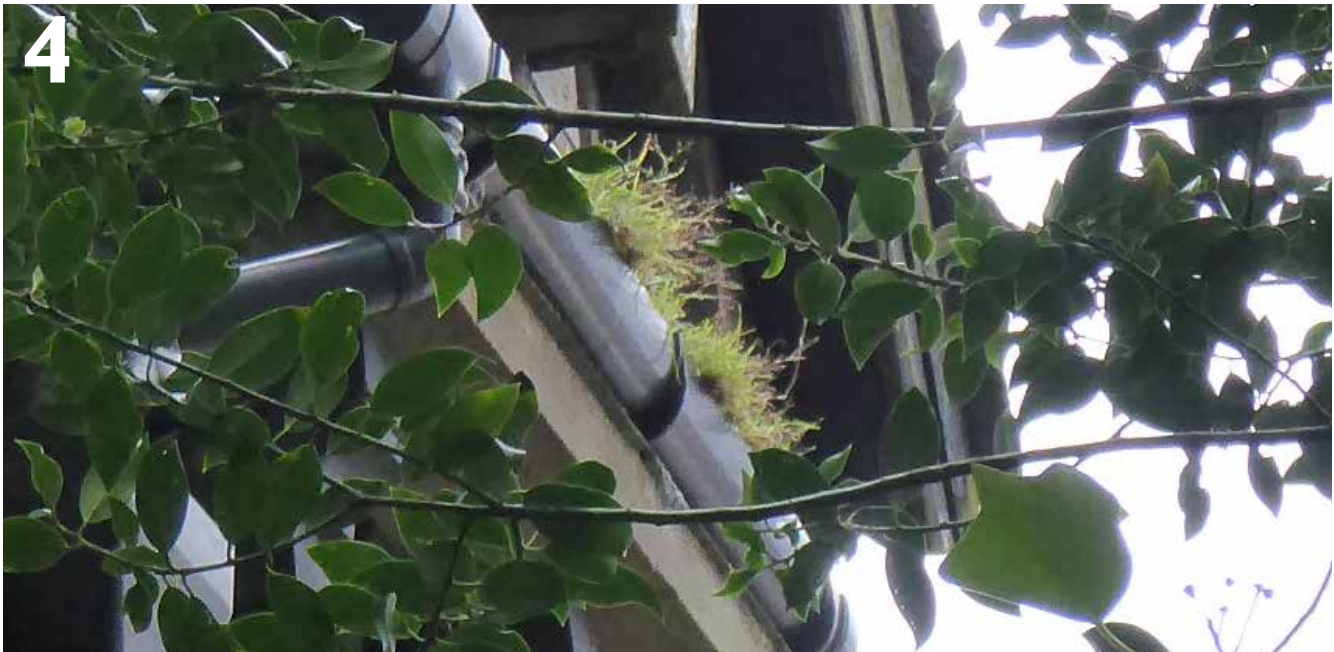
**6.3 SIDE (NORTH) ELEVATION**  
**Examples of Condition Issues with the Rainwater Goods**  
**(with numbers referring to photographs)**

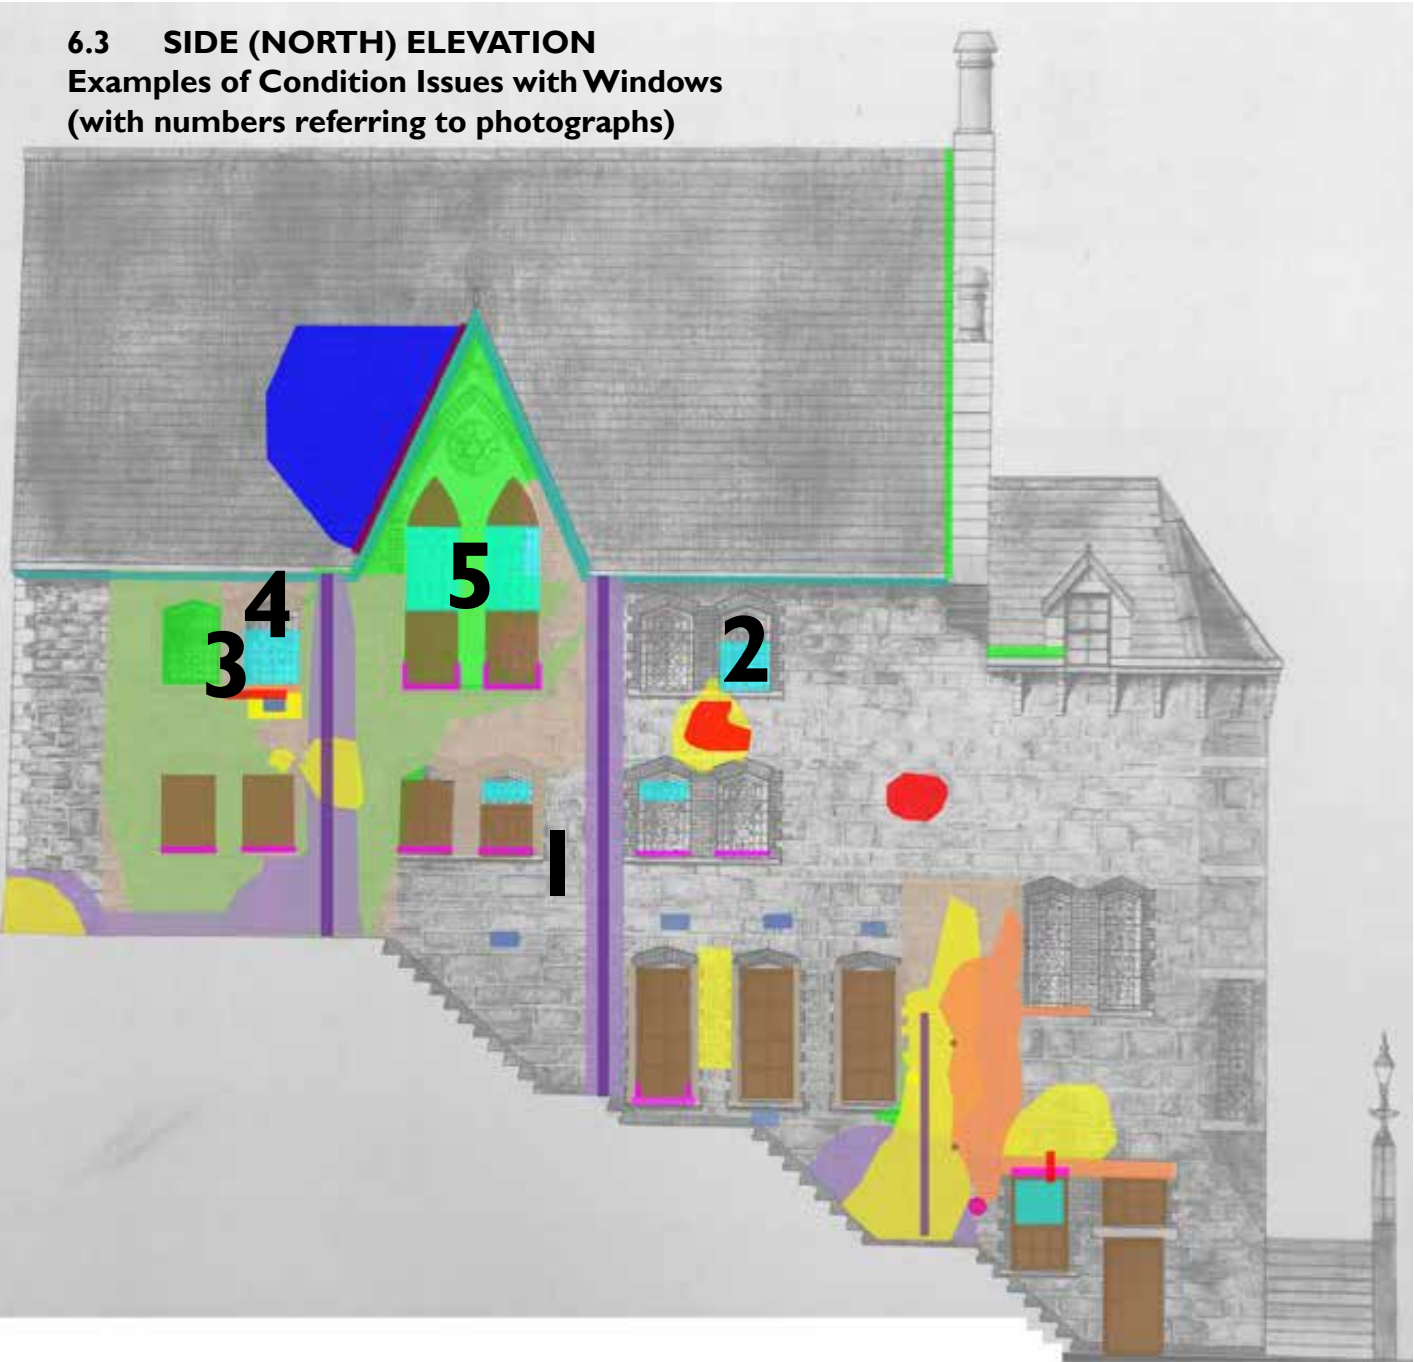
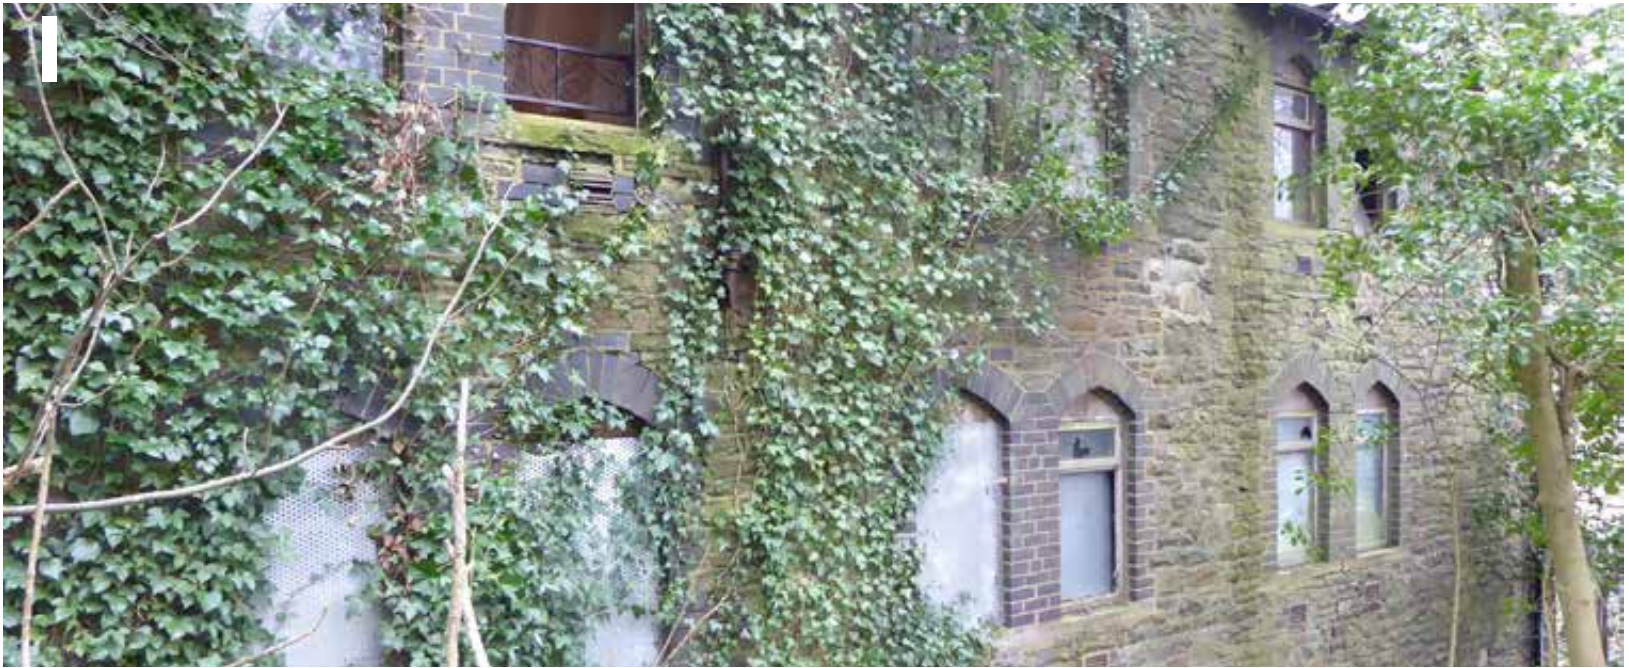
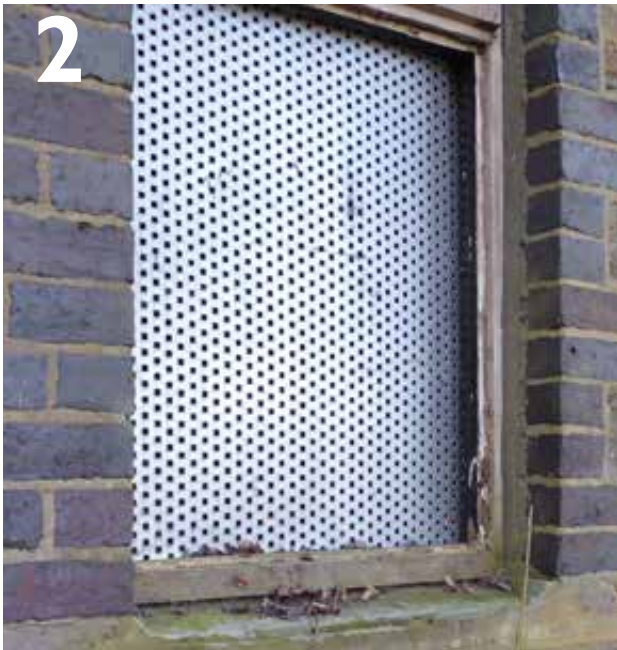
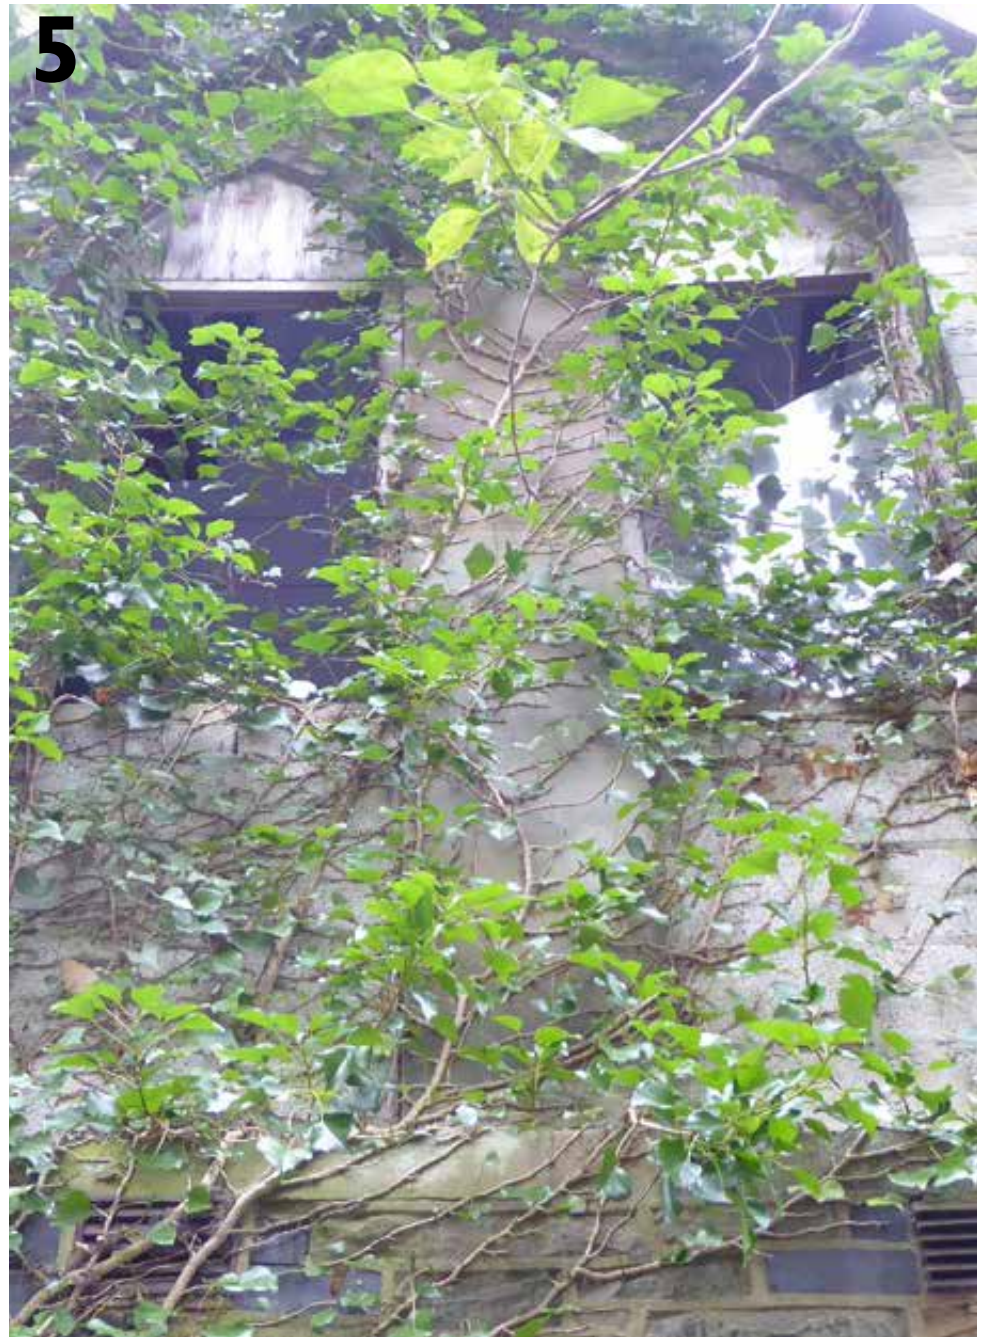
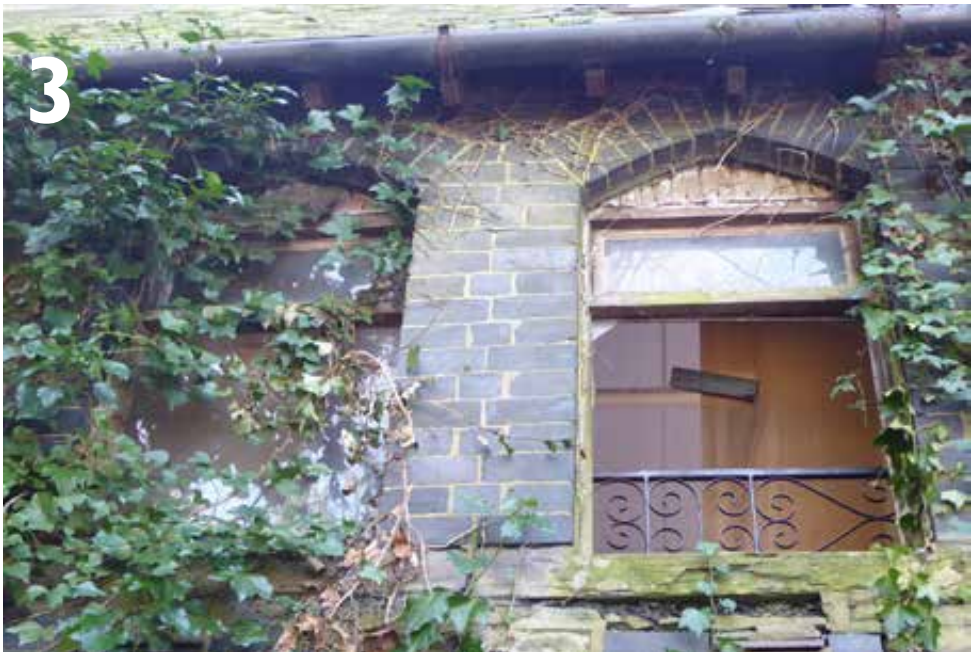
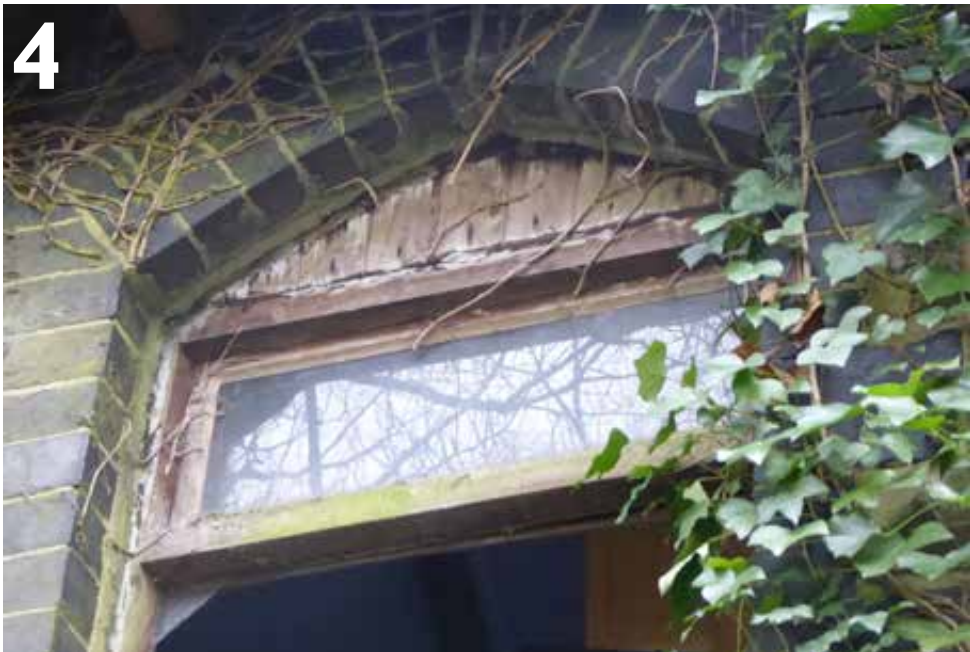
6.3 SIDE (NORTH) ELEVATION  
Examples of Condition Issues with Windows  
(with numbers referring to photographs)
