# Synagogue, Merthyr Tydfil

## RECORD OF BUILDING AND CONDITION ASSESSMENT REPORT

.....  
(449)2503-GWP-A-HIS-P00

Date: 17.03.25

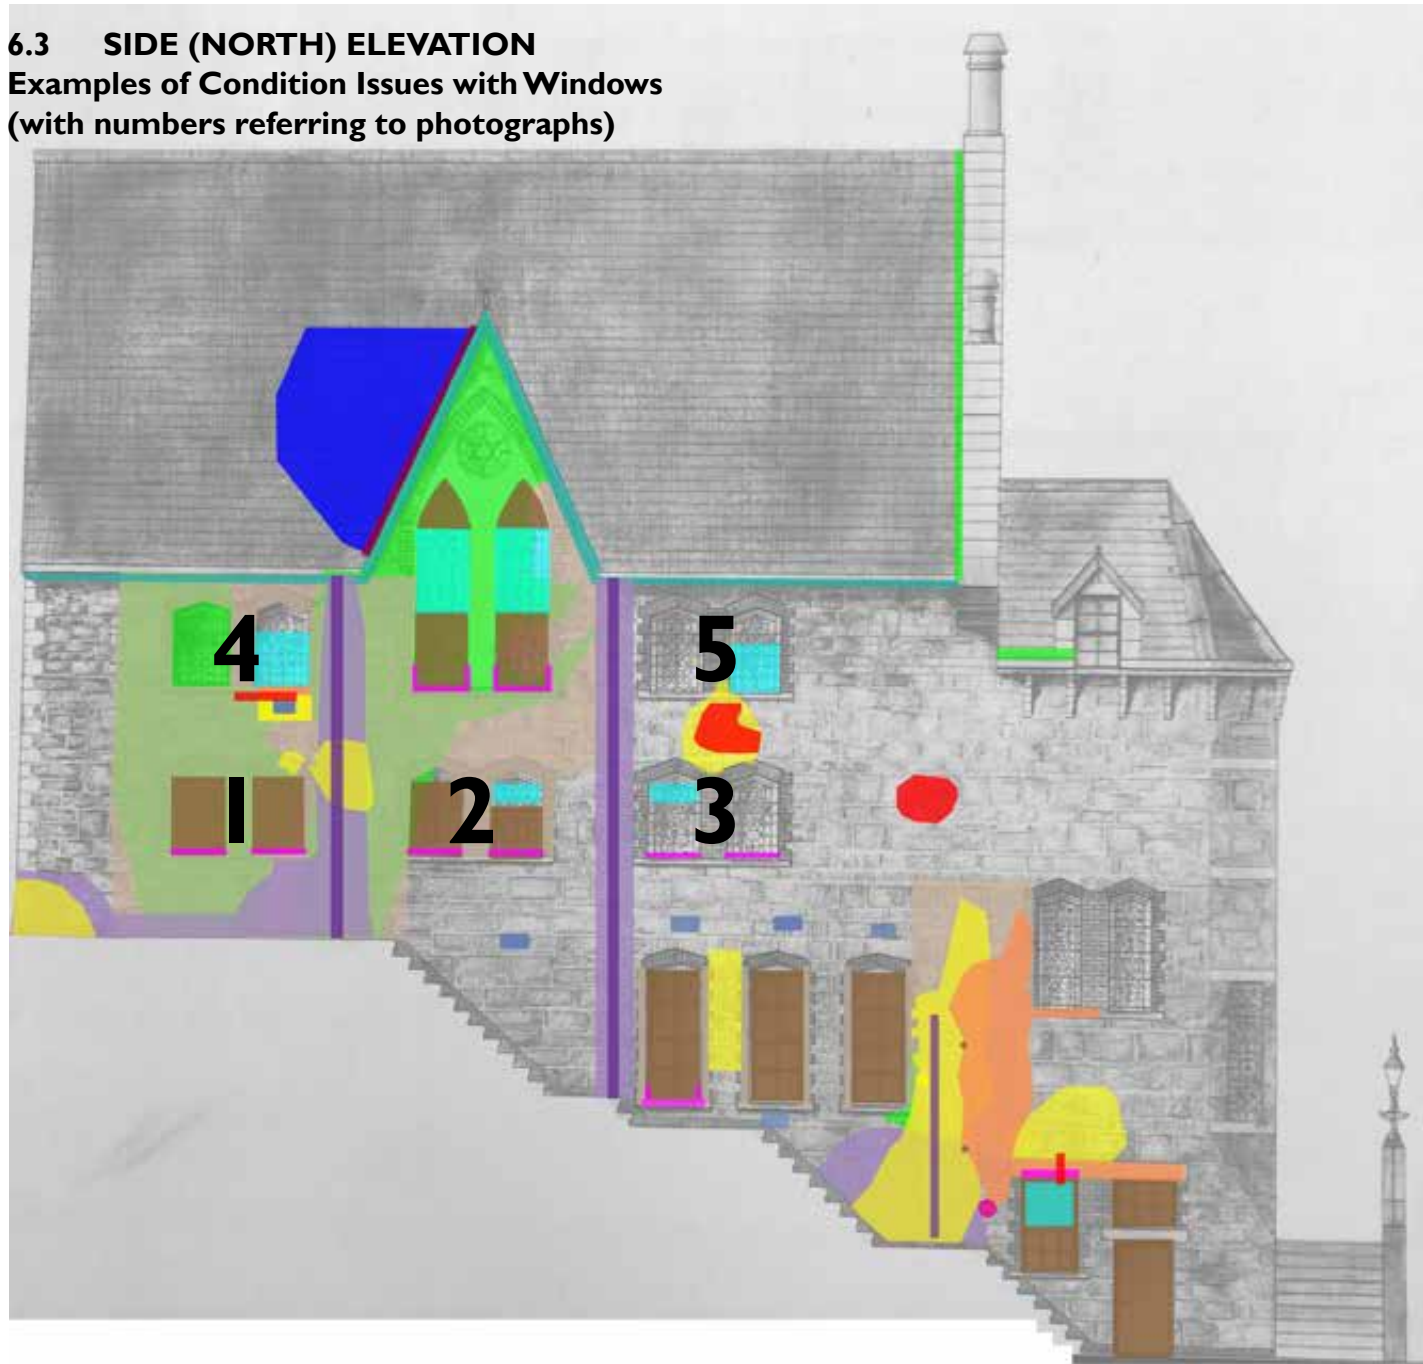
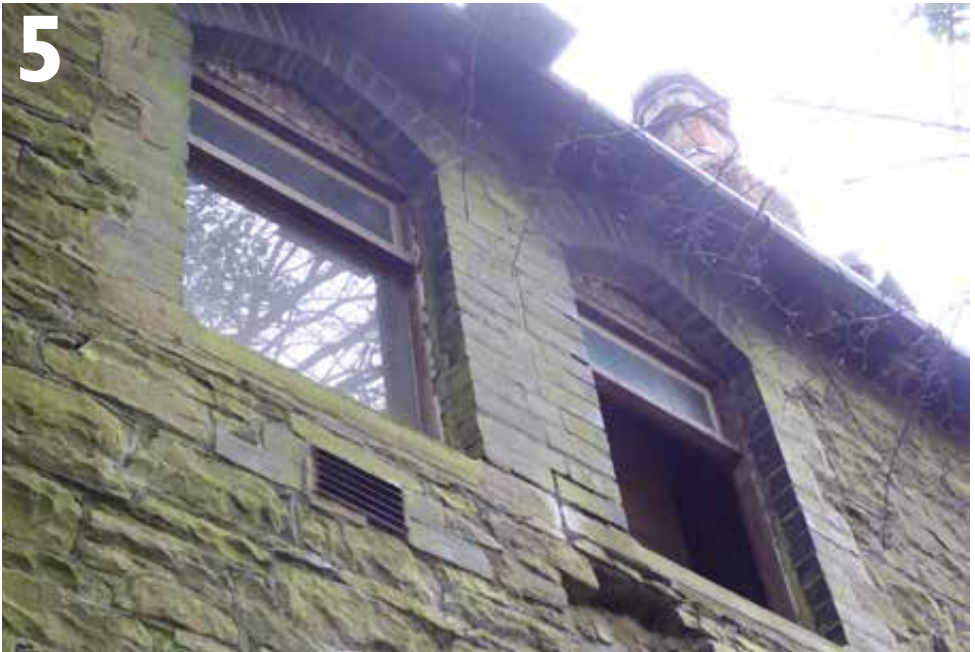
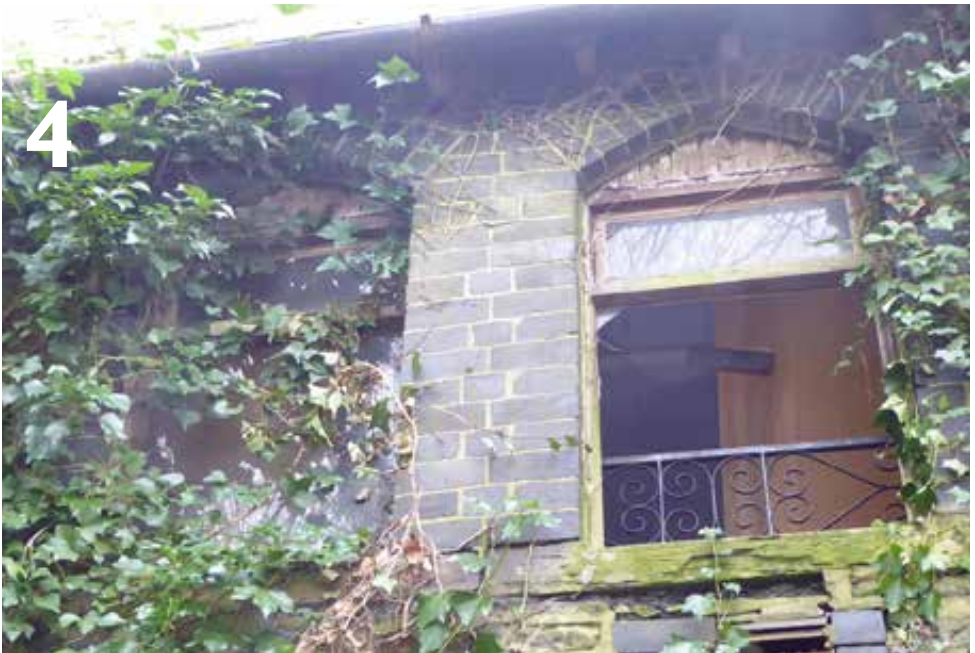
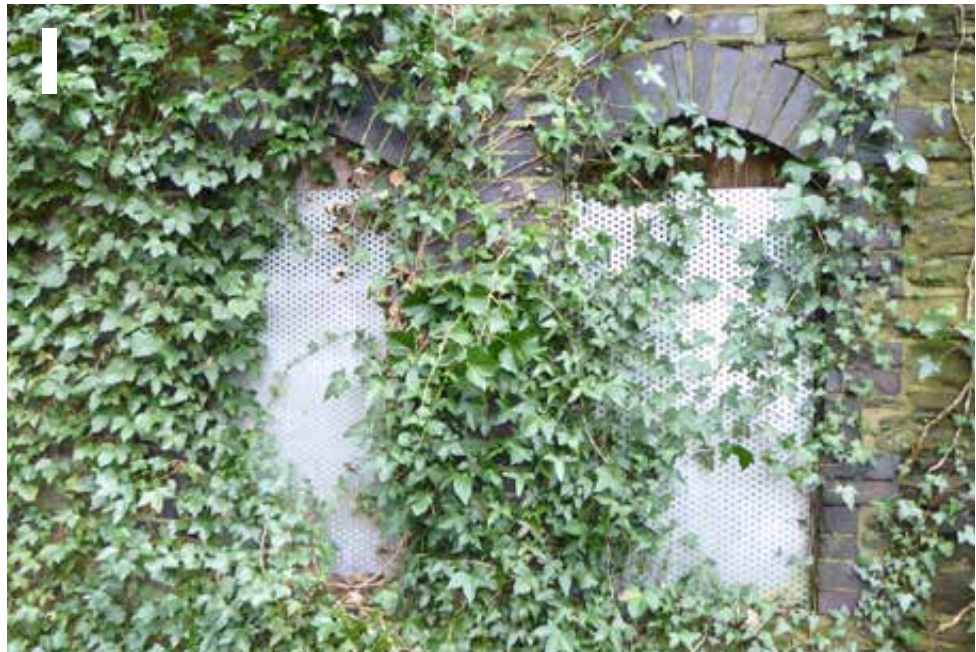
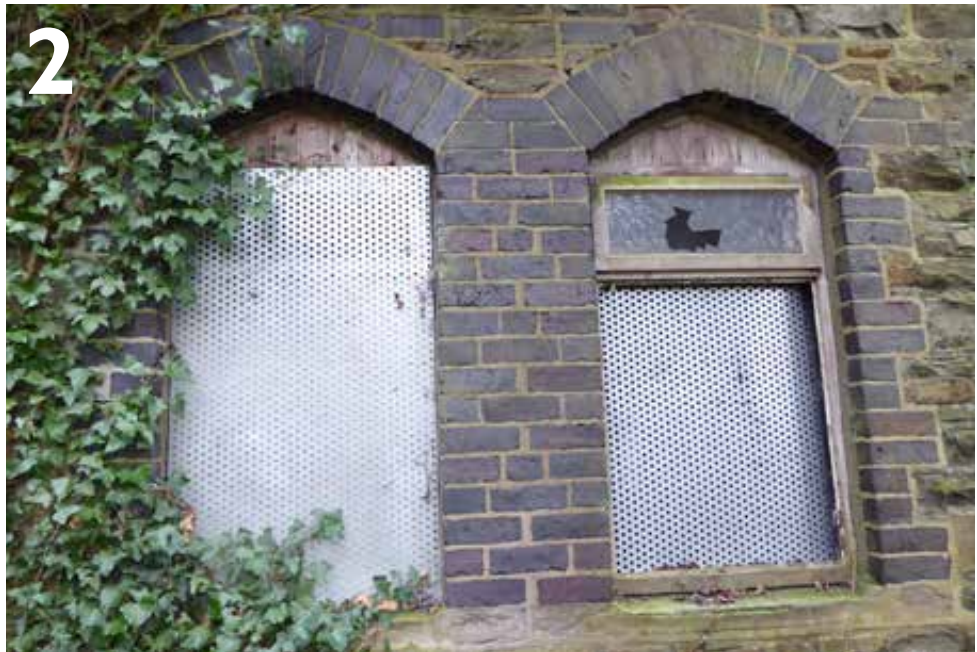
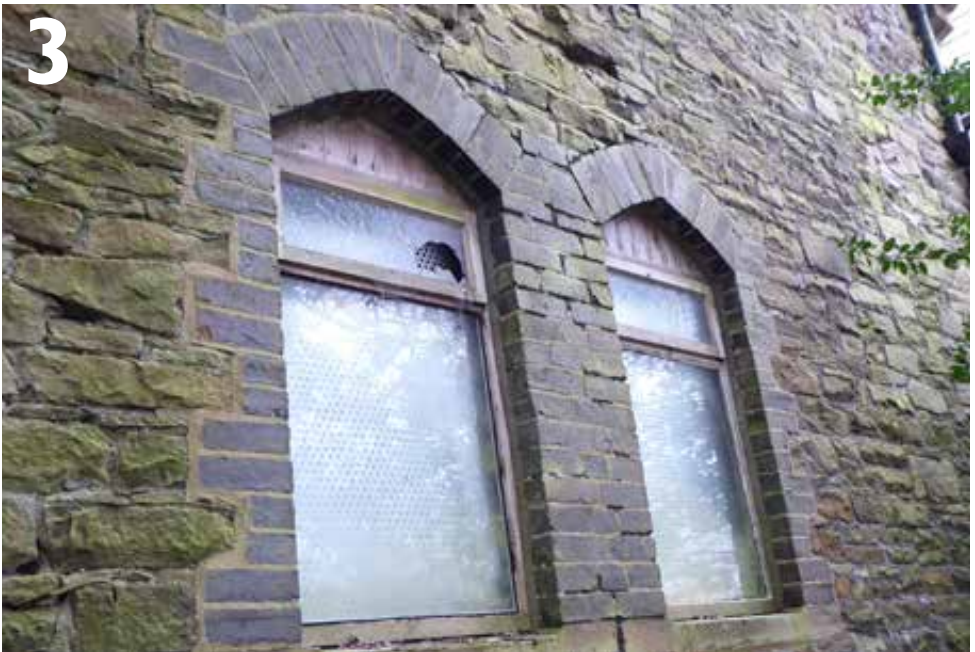
6.3 SIDE (NORTH) ELEVATION  
Examples of Condition Issues with Windows  
(with numbers referring to photographs)

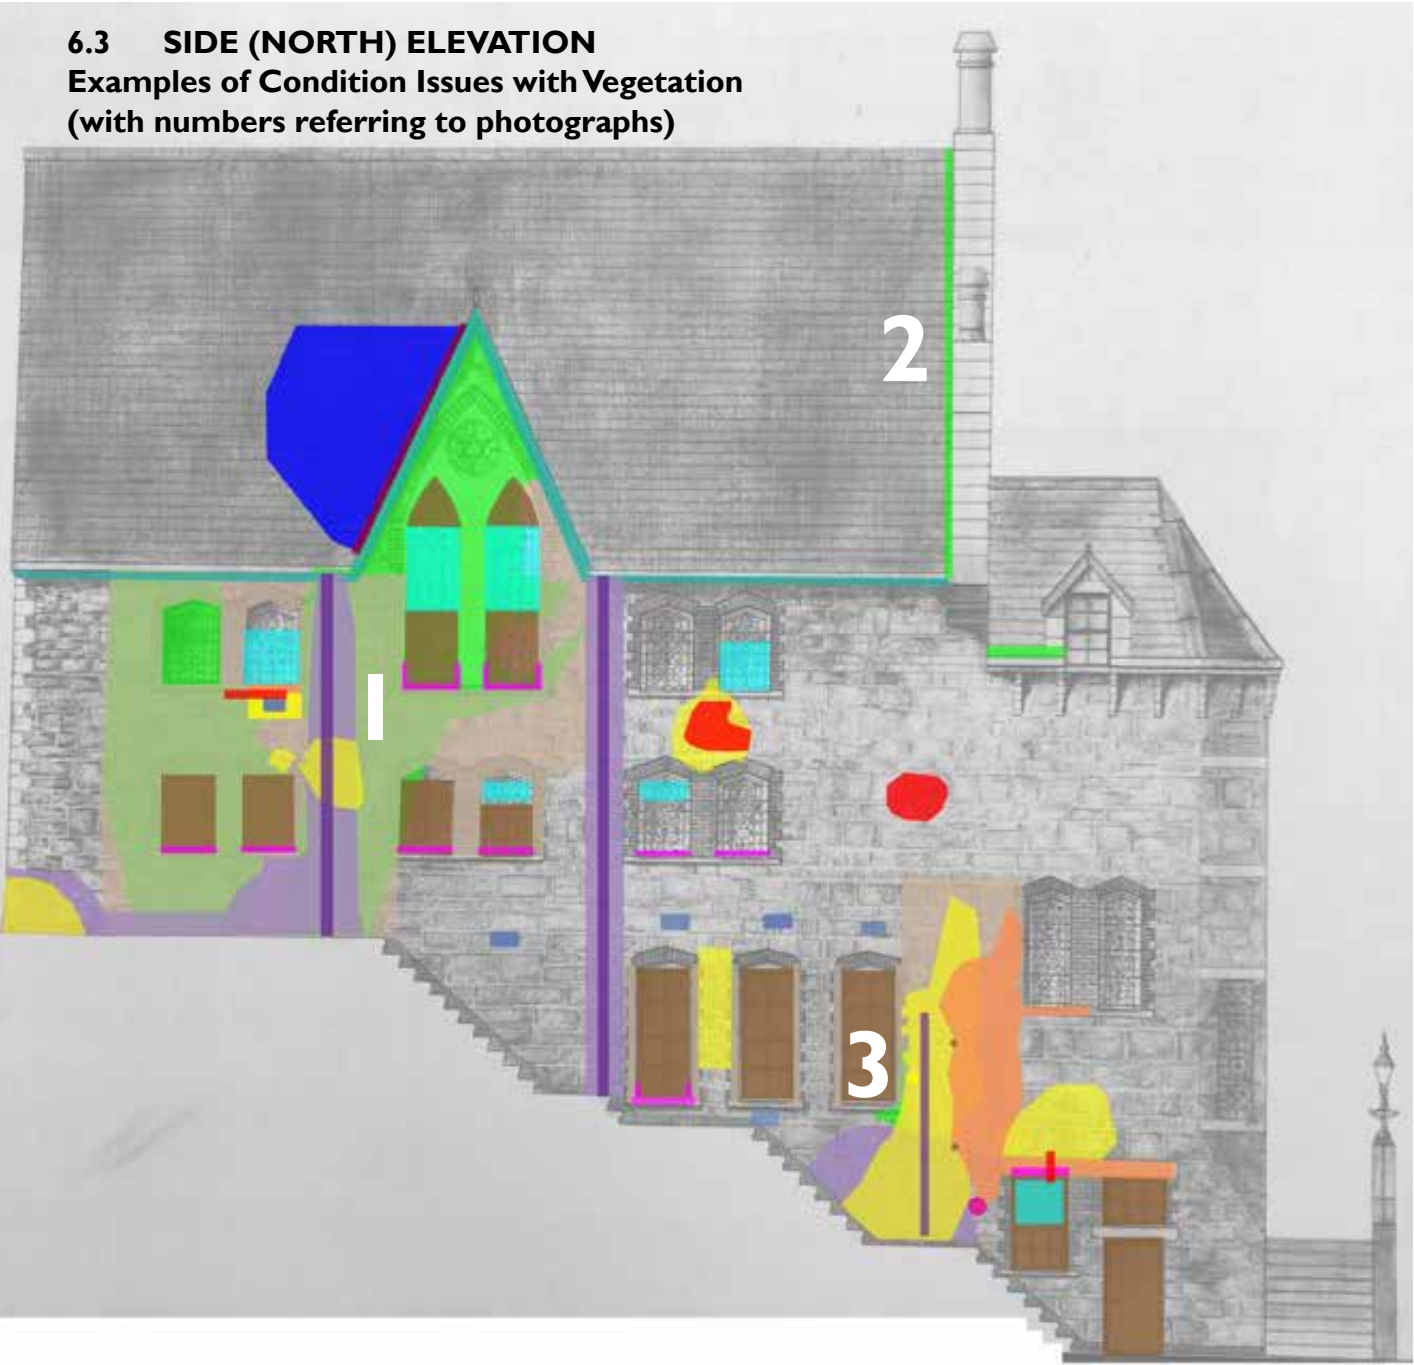
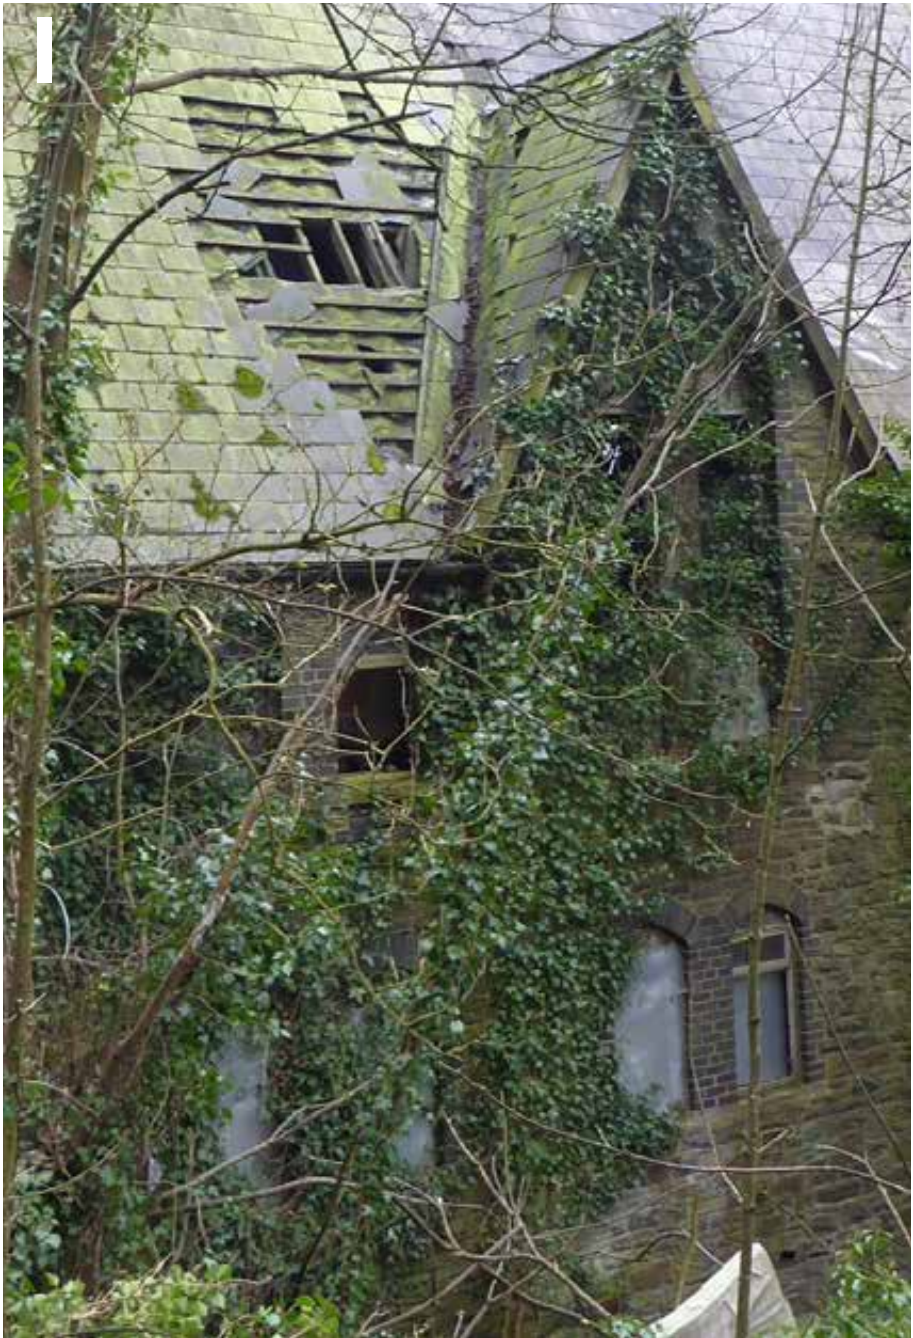
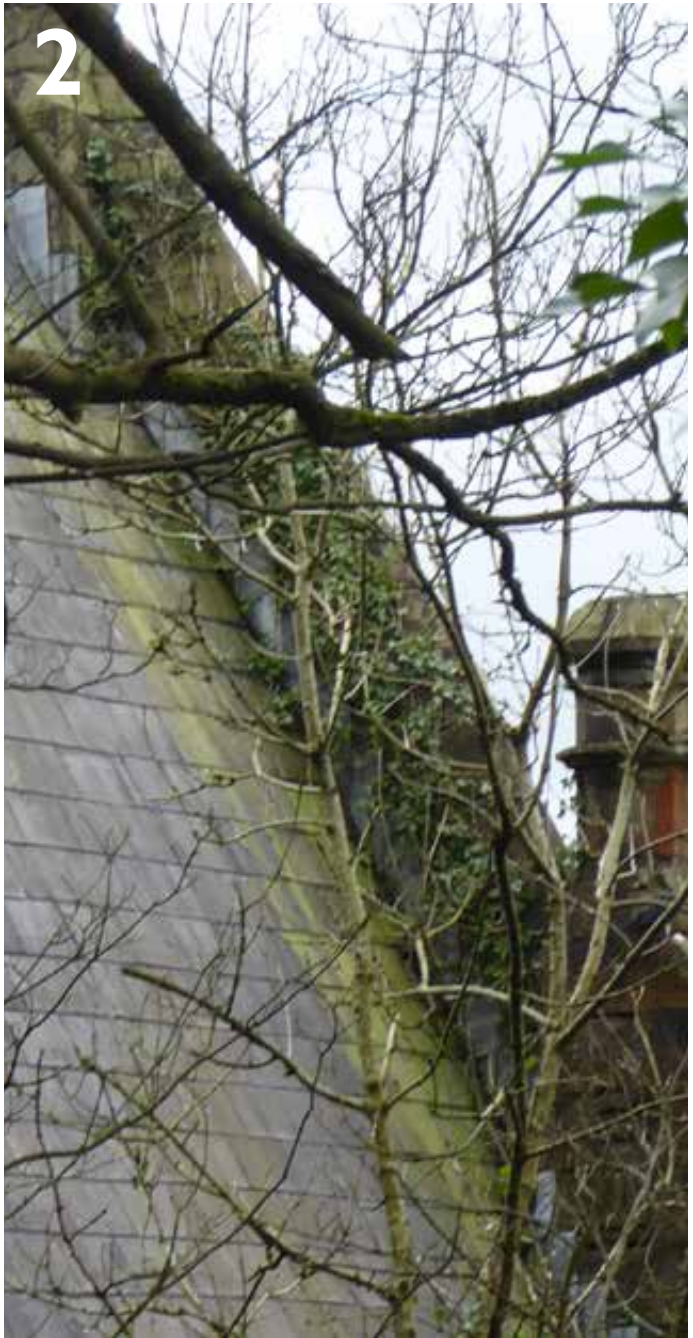
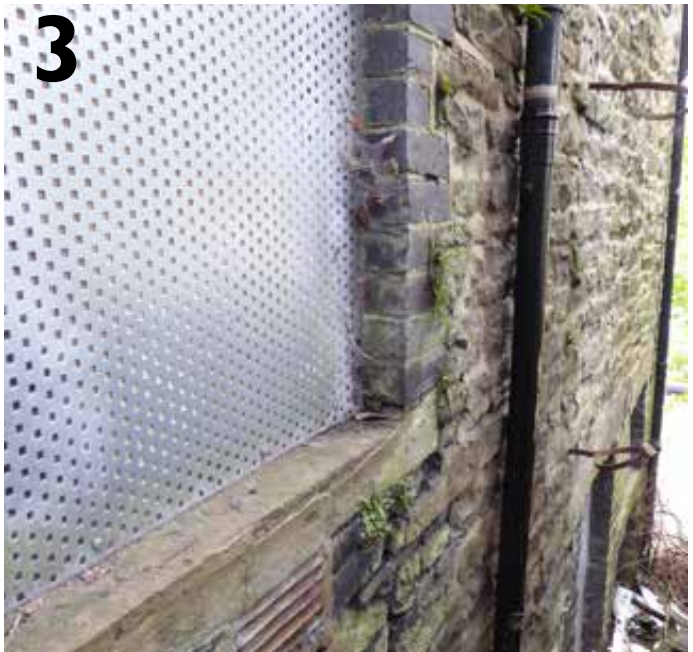
**6.3 SIDE (NORTH) ELEVATION**  
**Examples of Condition Issues with Vegetation**  
**(with numbers referring to photographs)**

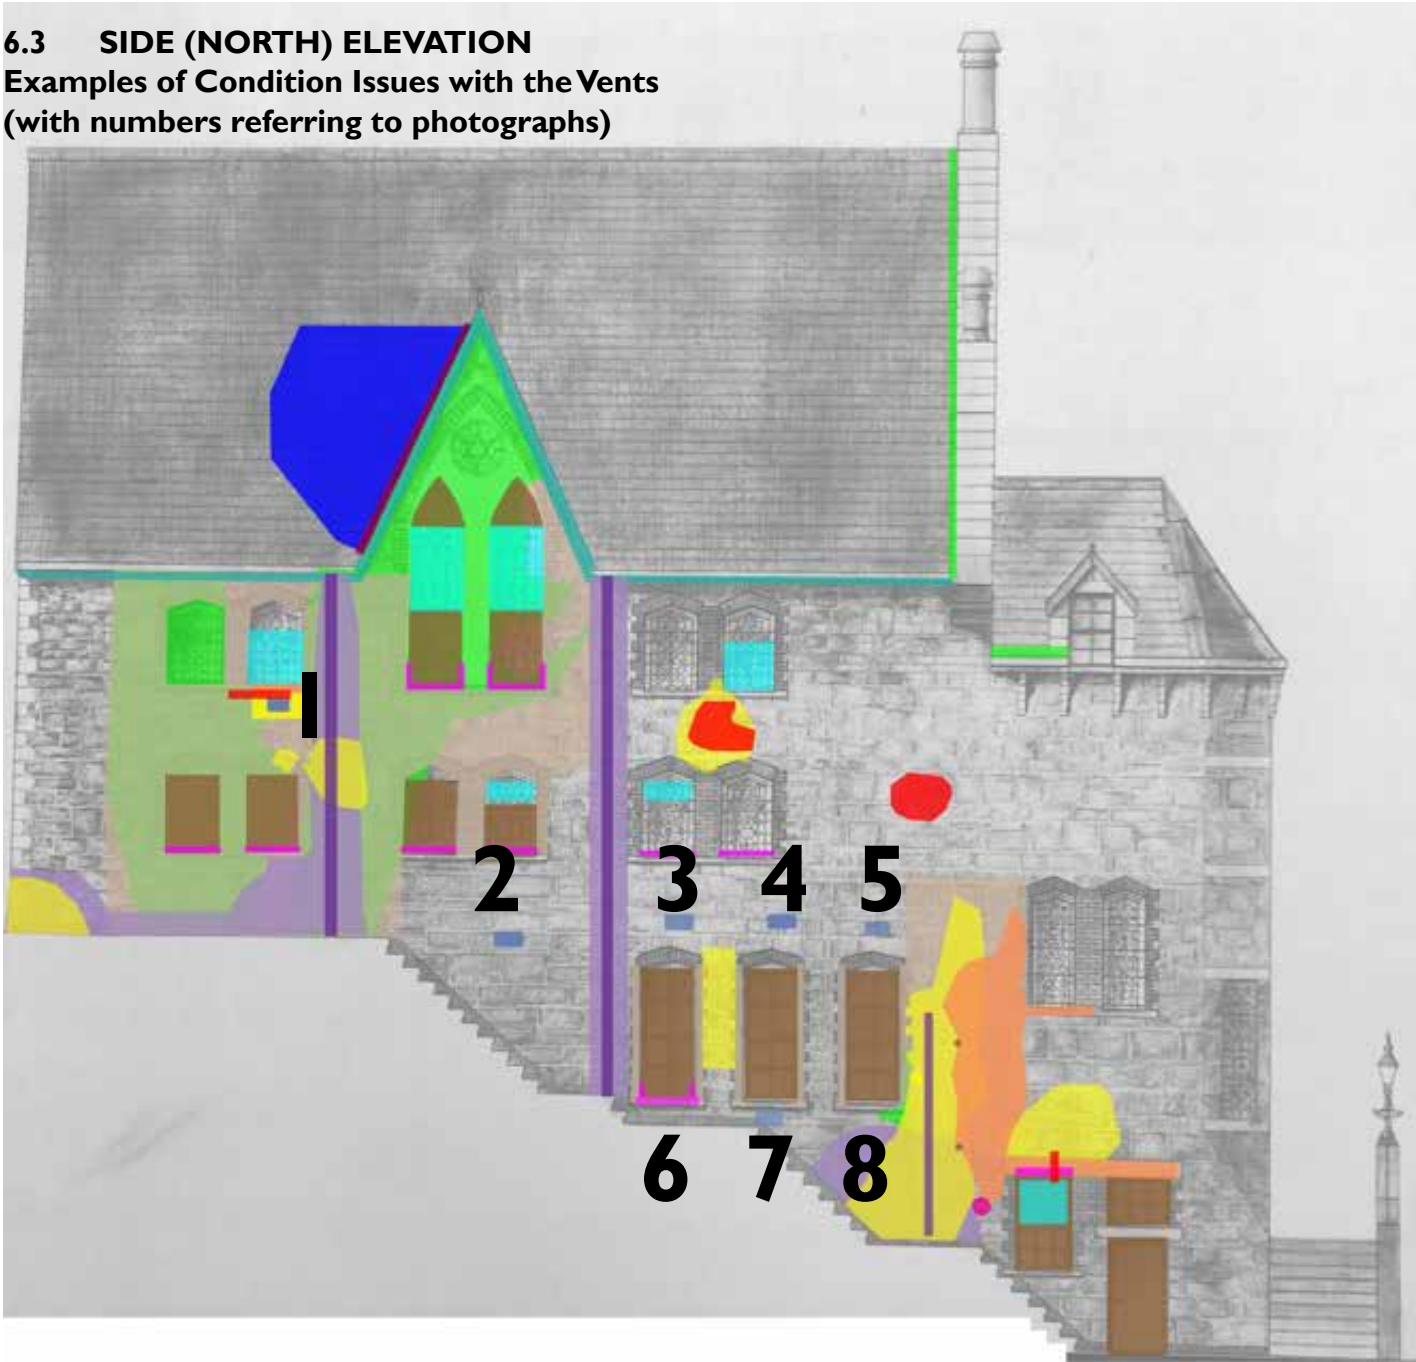
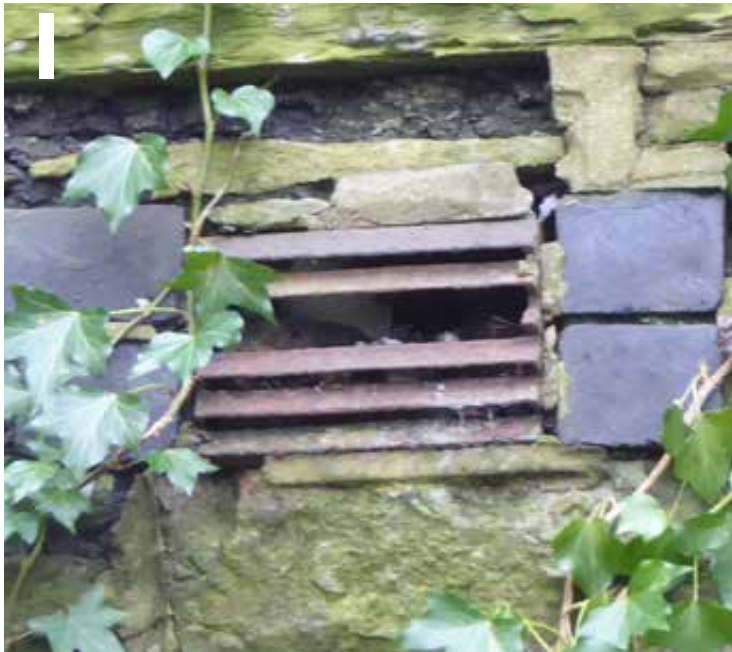
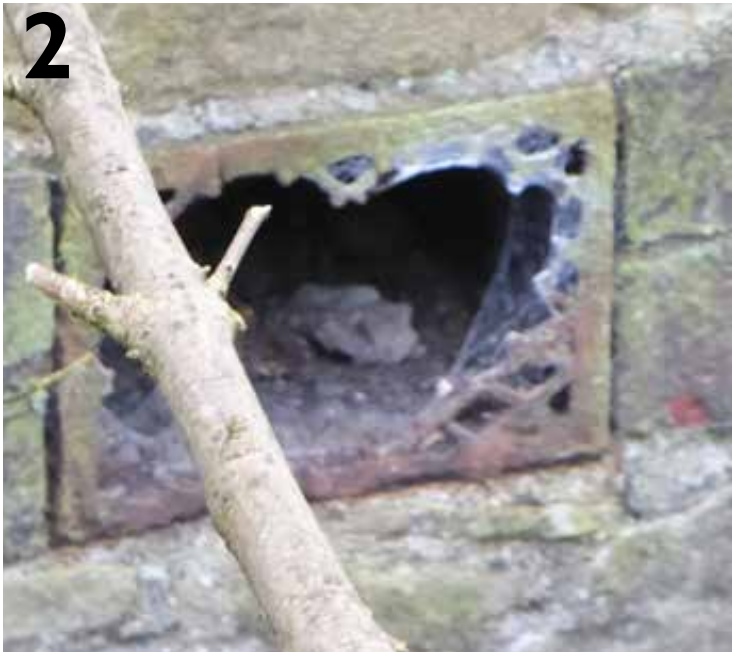
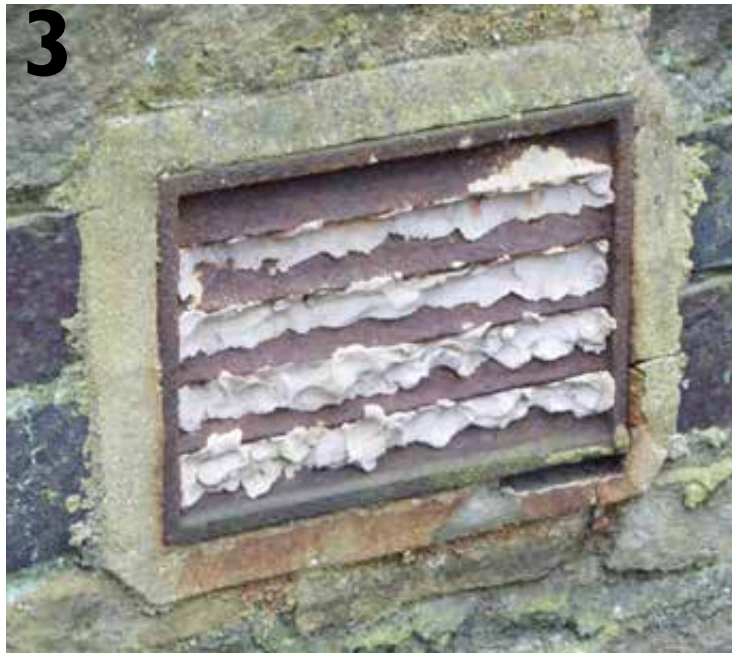
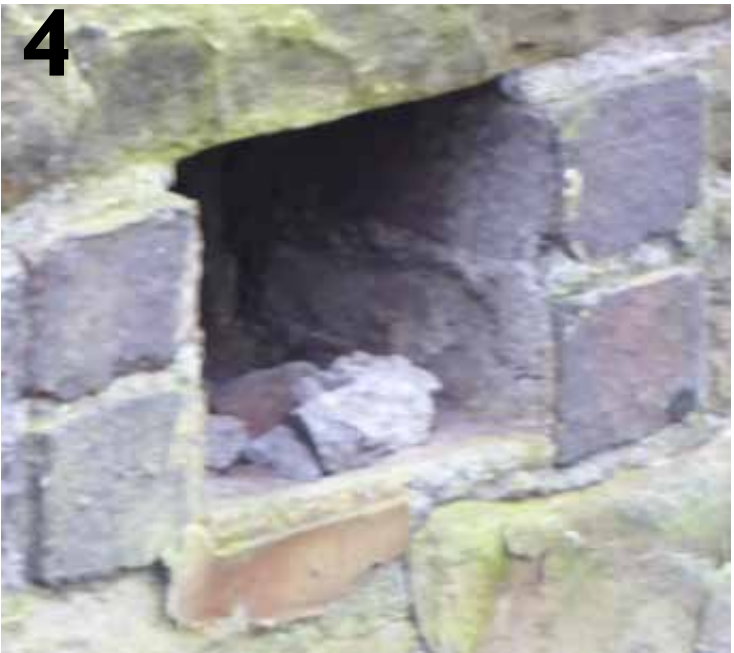
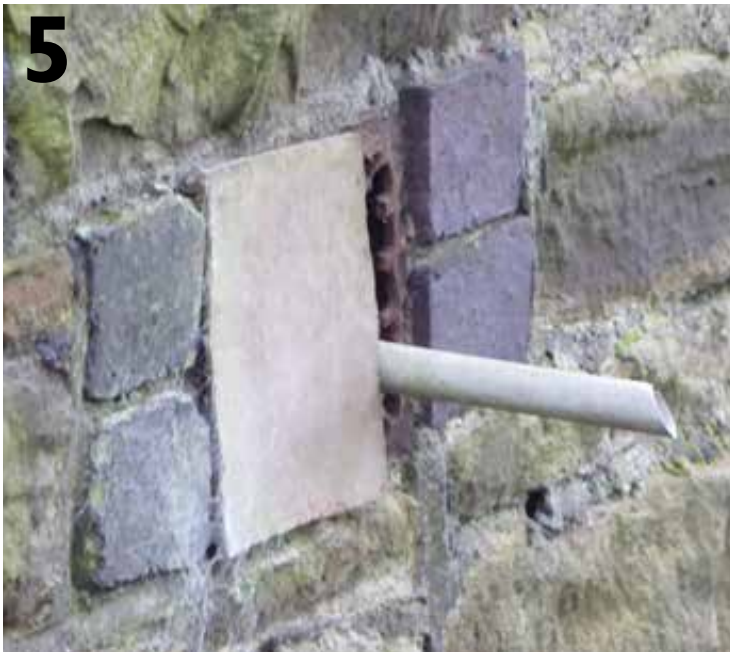
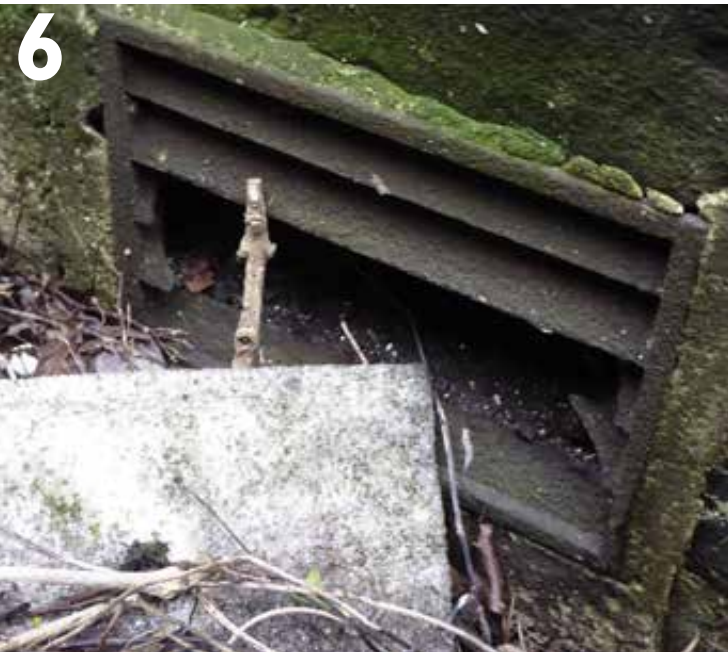
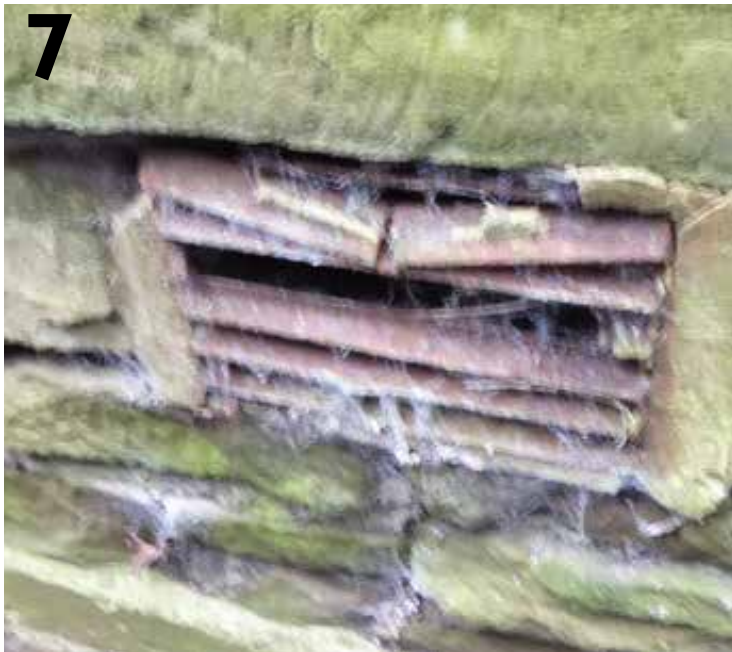
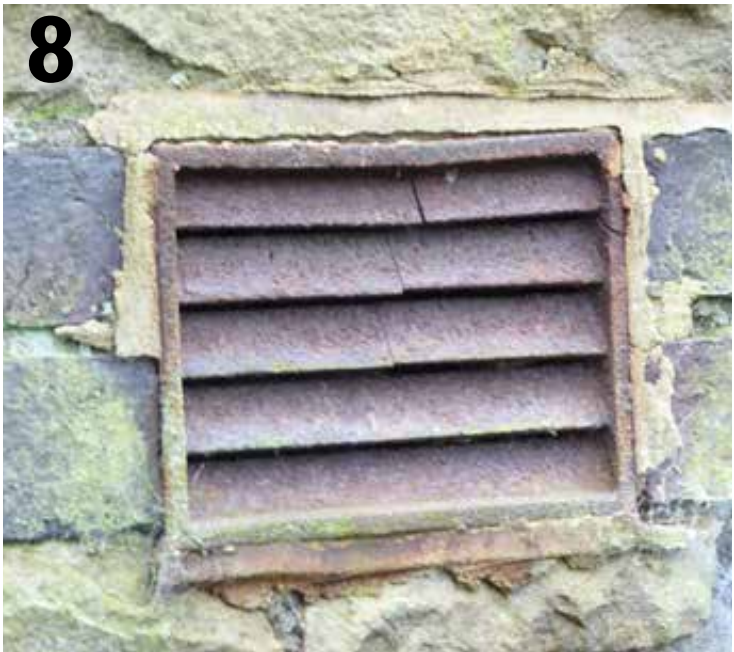
6.3 SIDE (NORTH) ELEVATION  
Examples of Condition Issues with the Vents  
(with numbers referring to photographs)

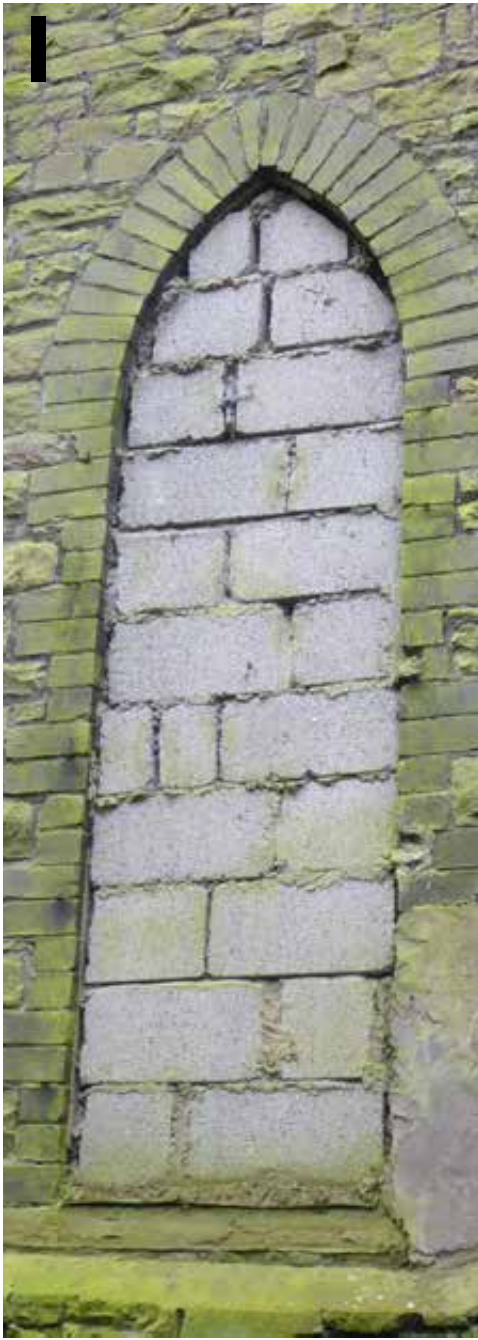
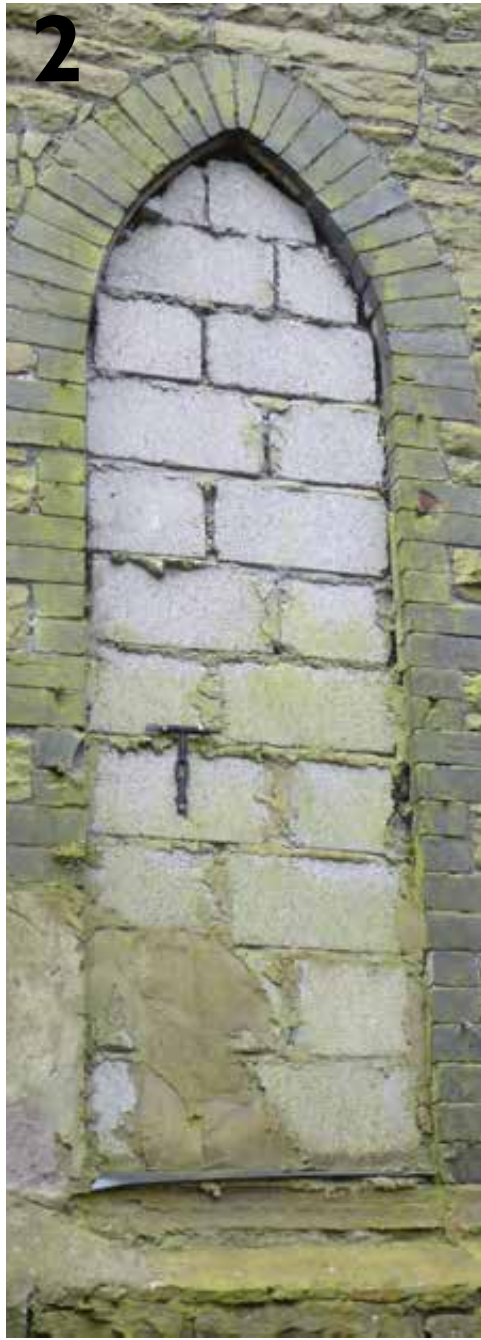
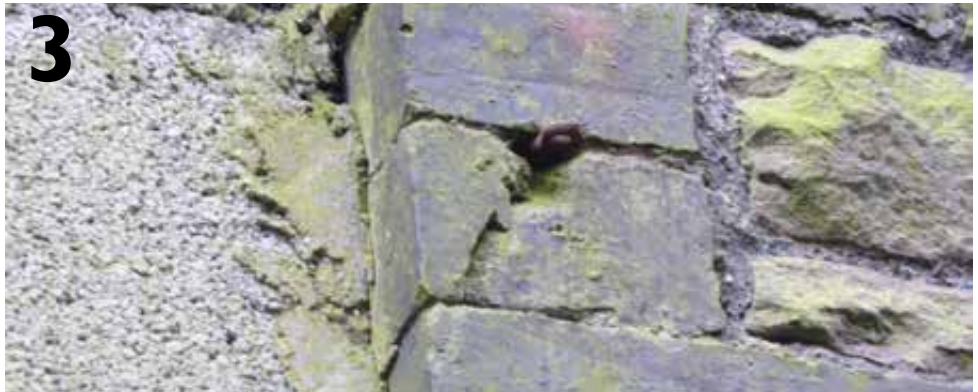
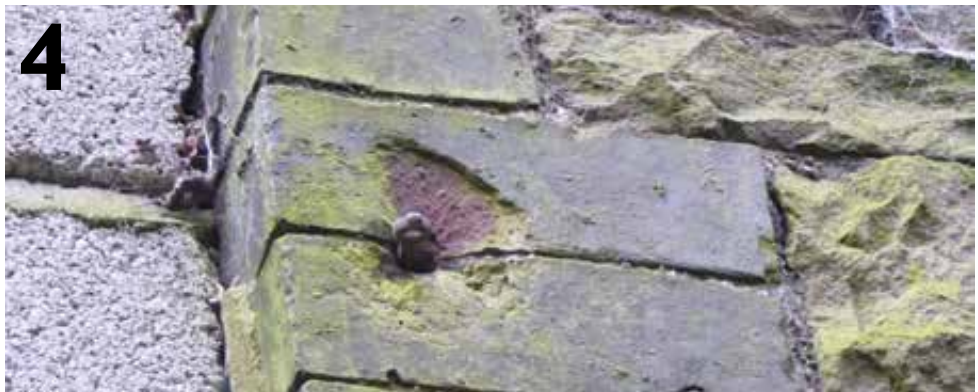
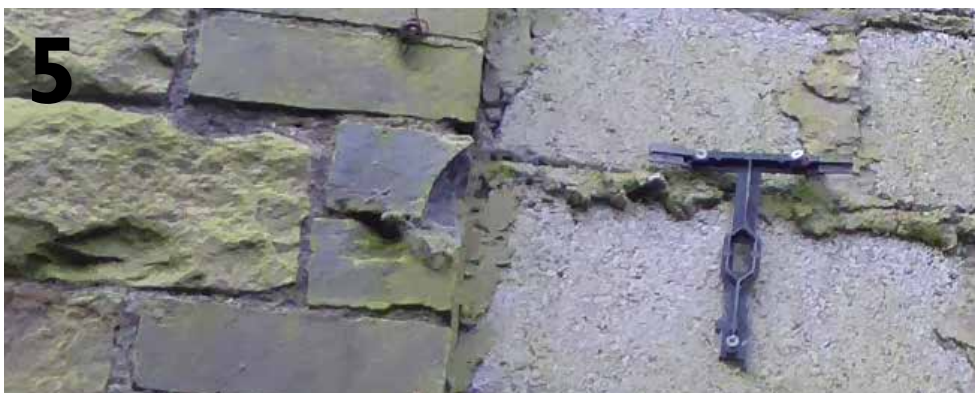
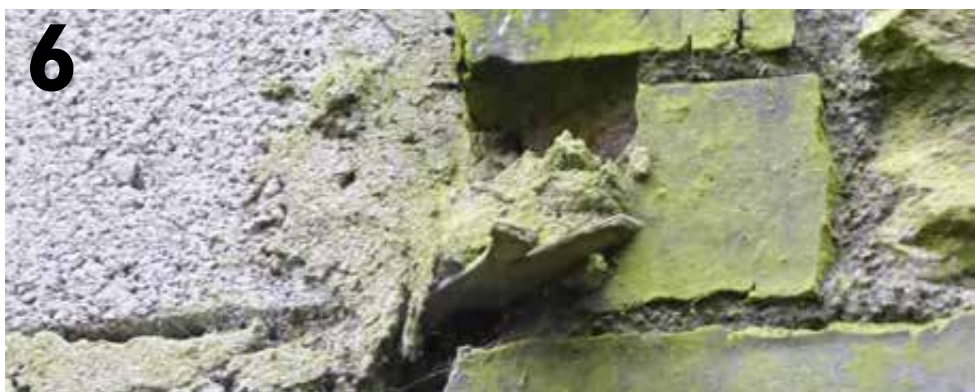
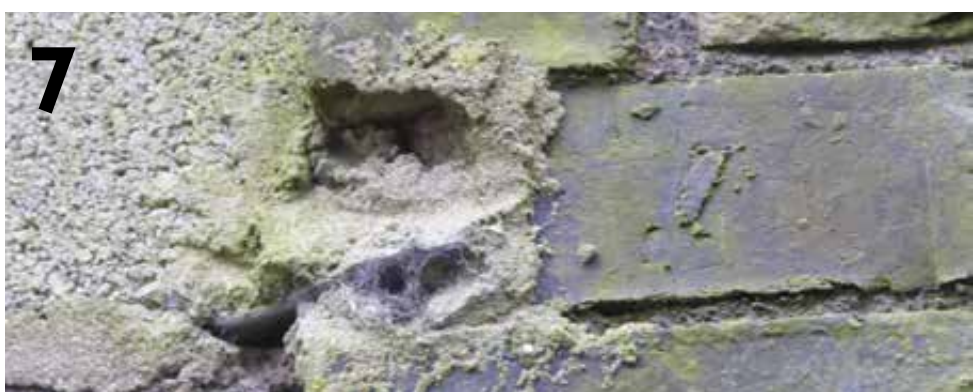
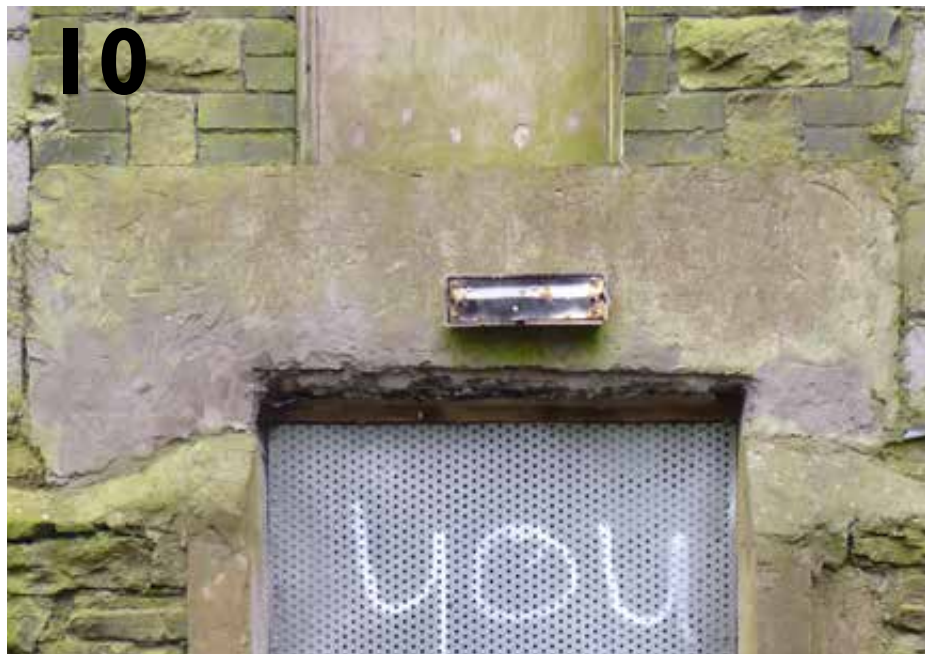
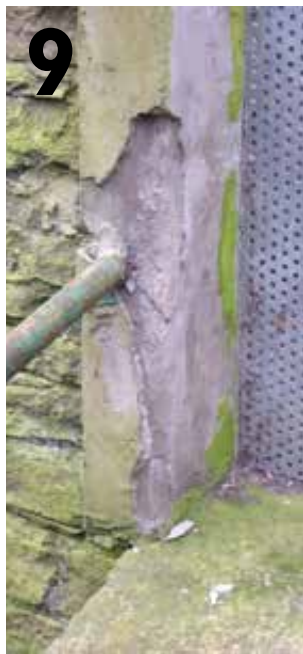
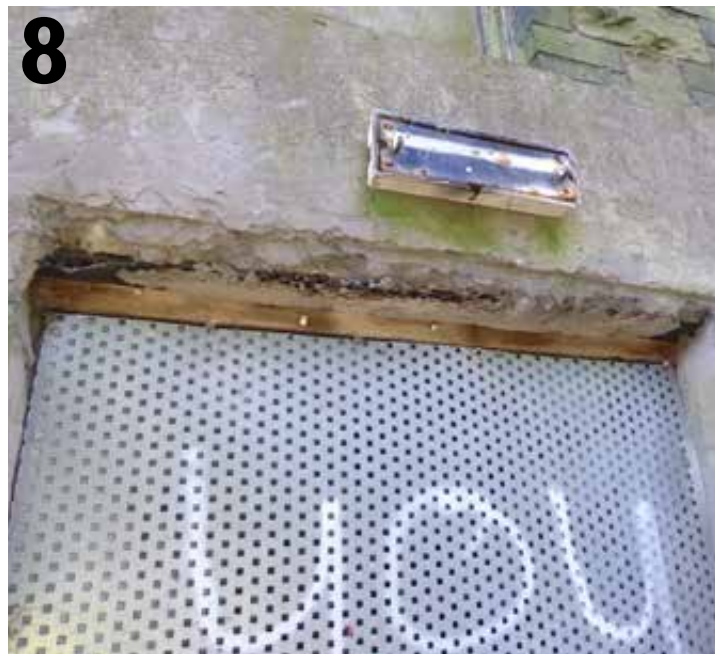
**6.4 REAR (EAST) ELEVATION**  
Examples of Condition Issues  
with the Stonework  
(with numbers referring  
to photographs)

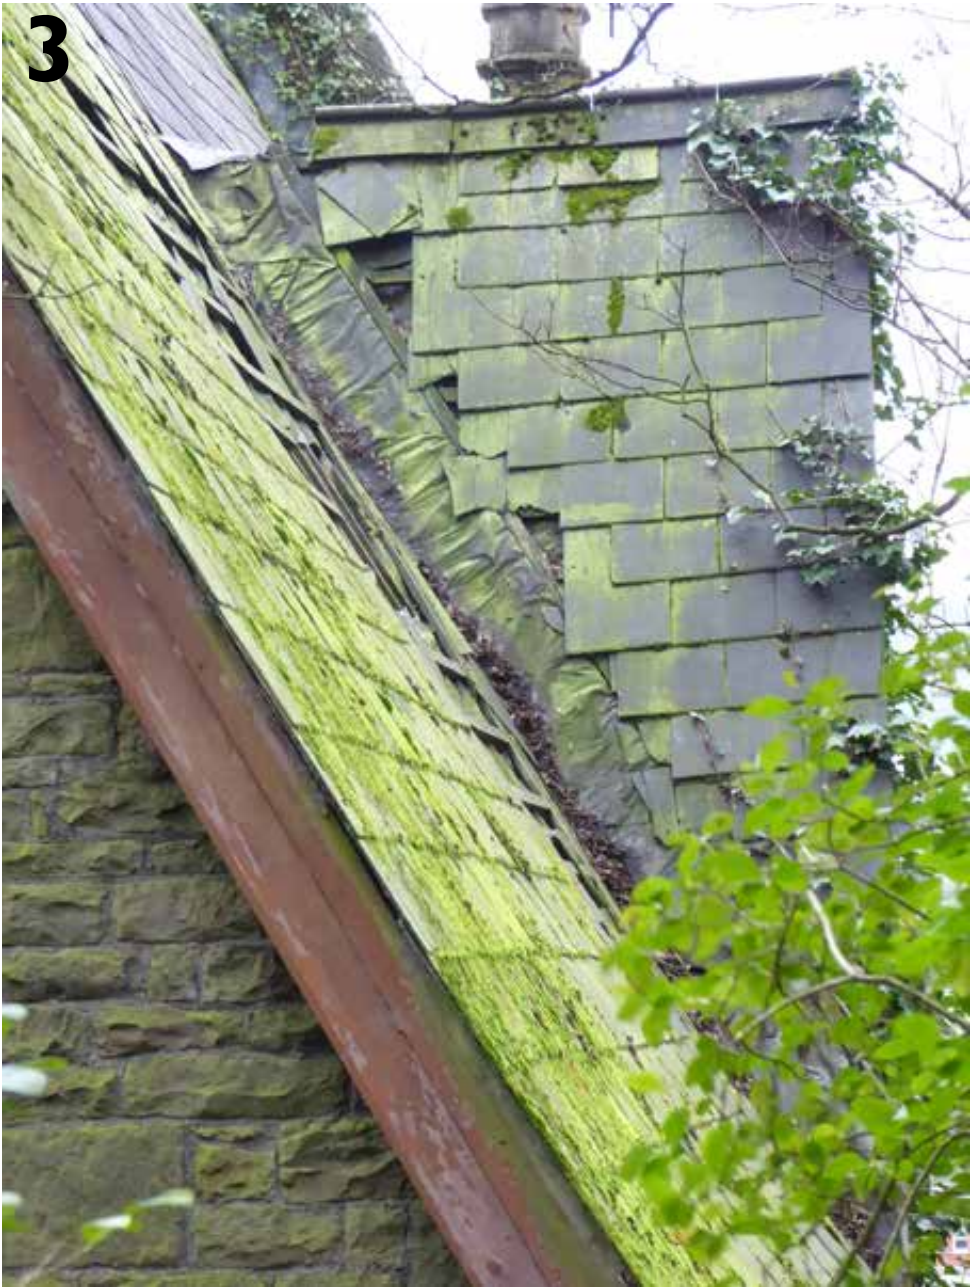
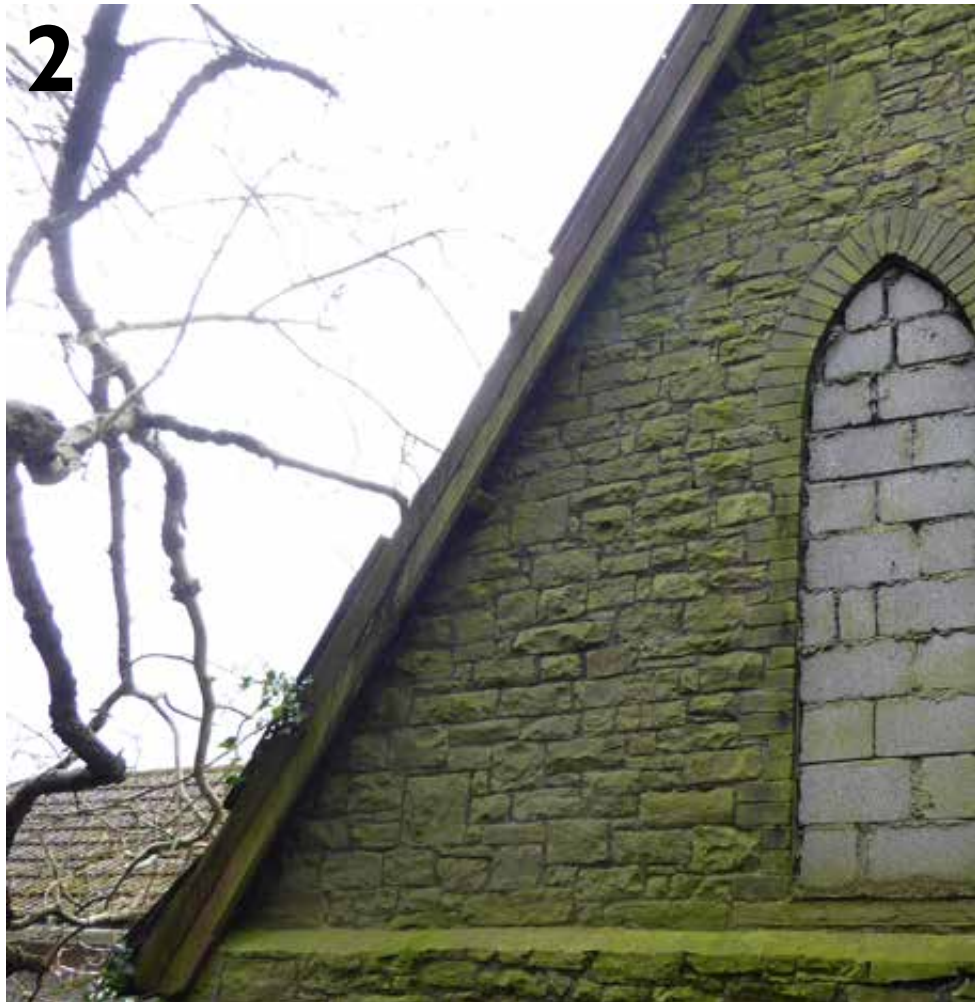
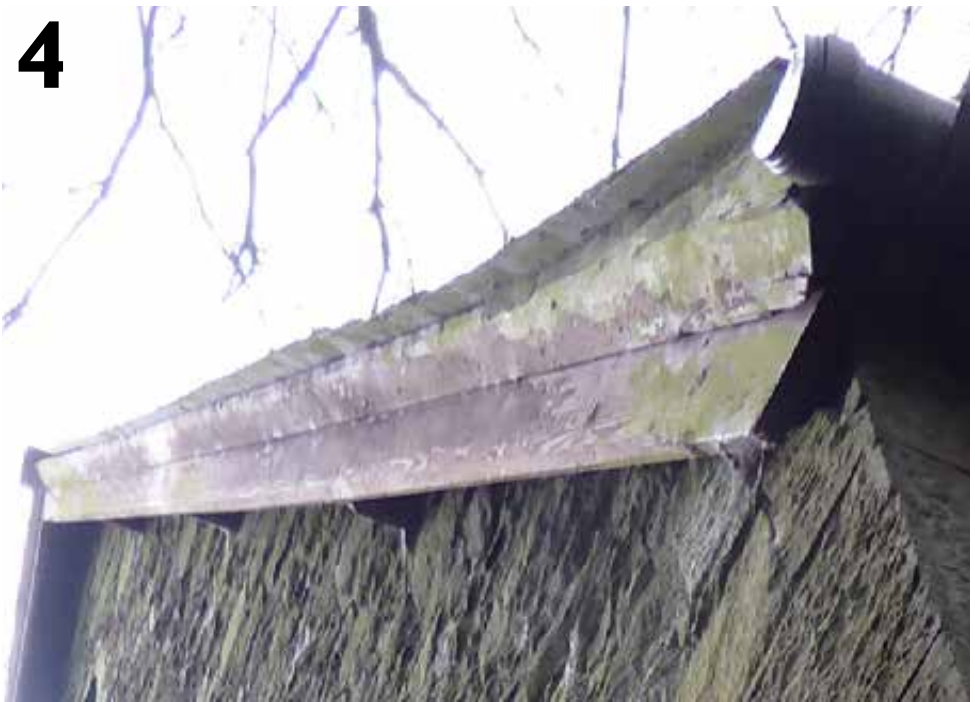
6.4 REAR (EAST) ELEVATION

Examples of Condition Issues  
with the Roof  
(with numbers  
referring to  
photographs)
