# Synagogue, Merthyr Tydfil

## RECORD OF BUILDING AND CONDITION ASSESSMENT REPORT

.....  
(449)2503-GWP-A-HIS-P00

Date: 17.03.25

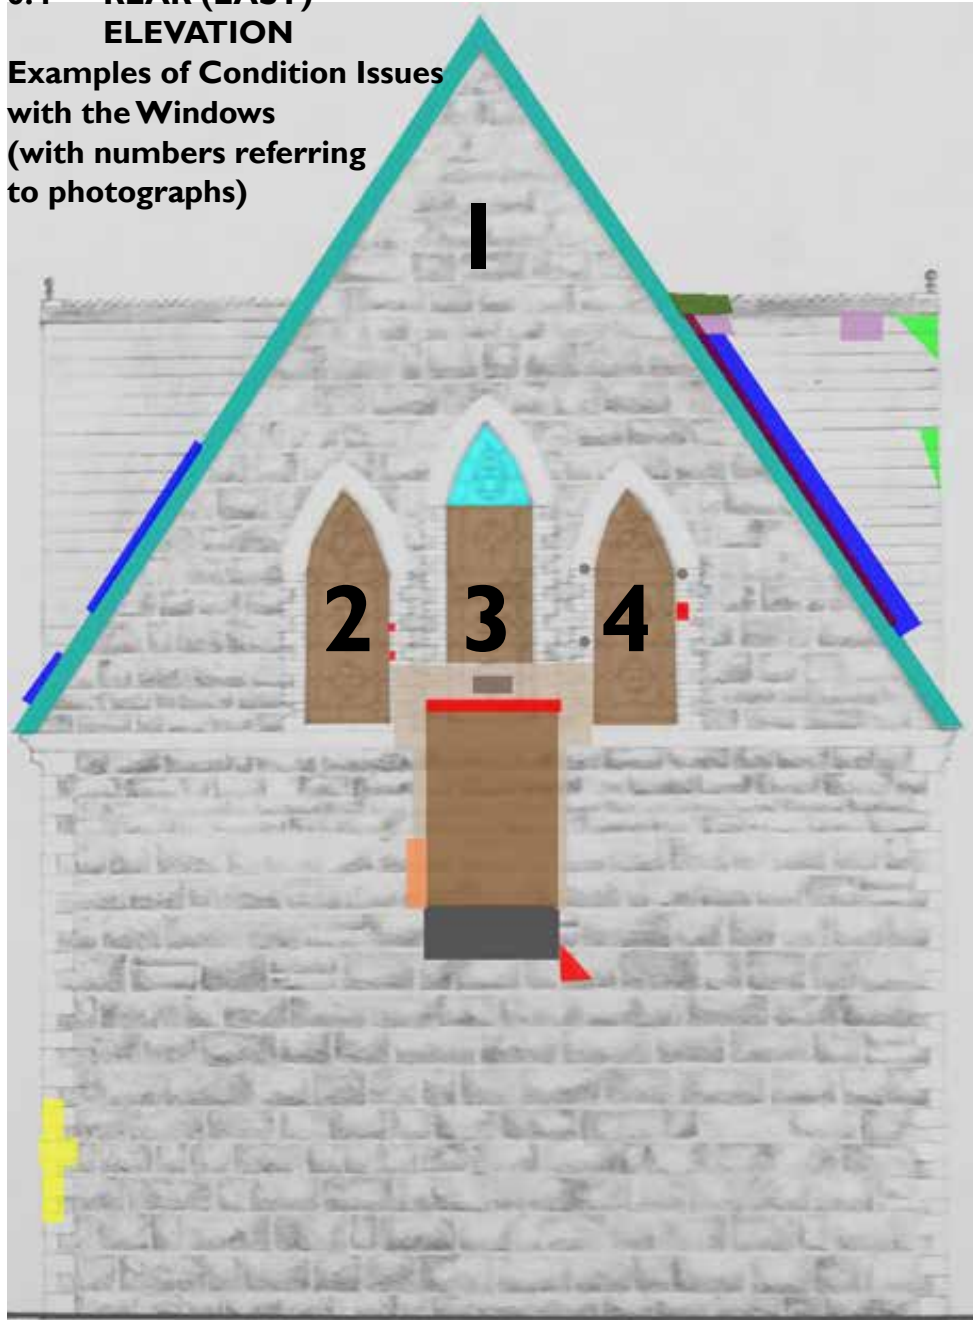
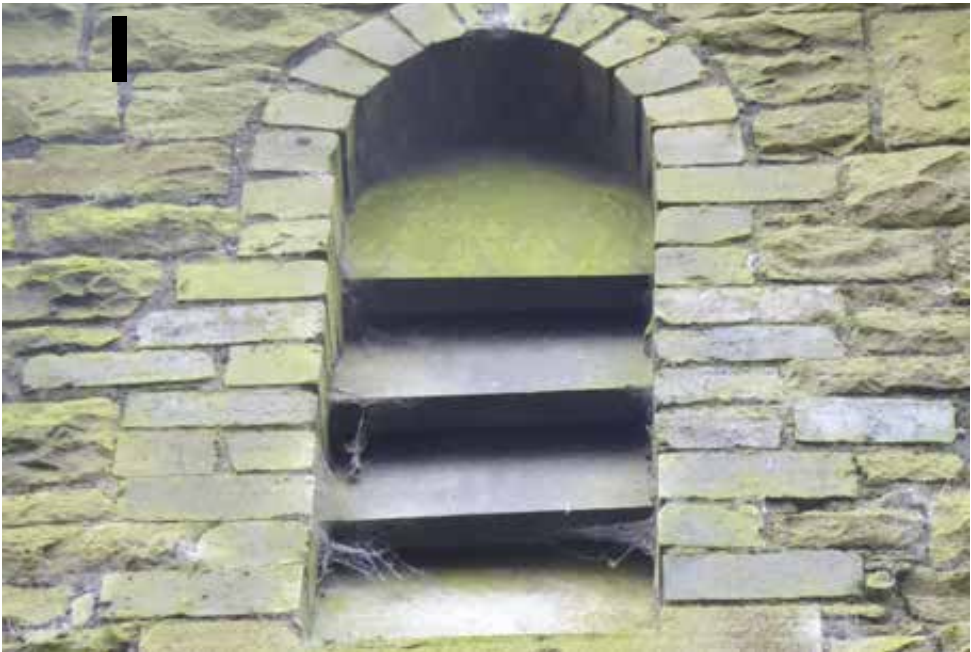
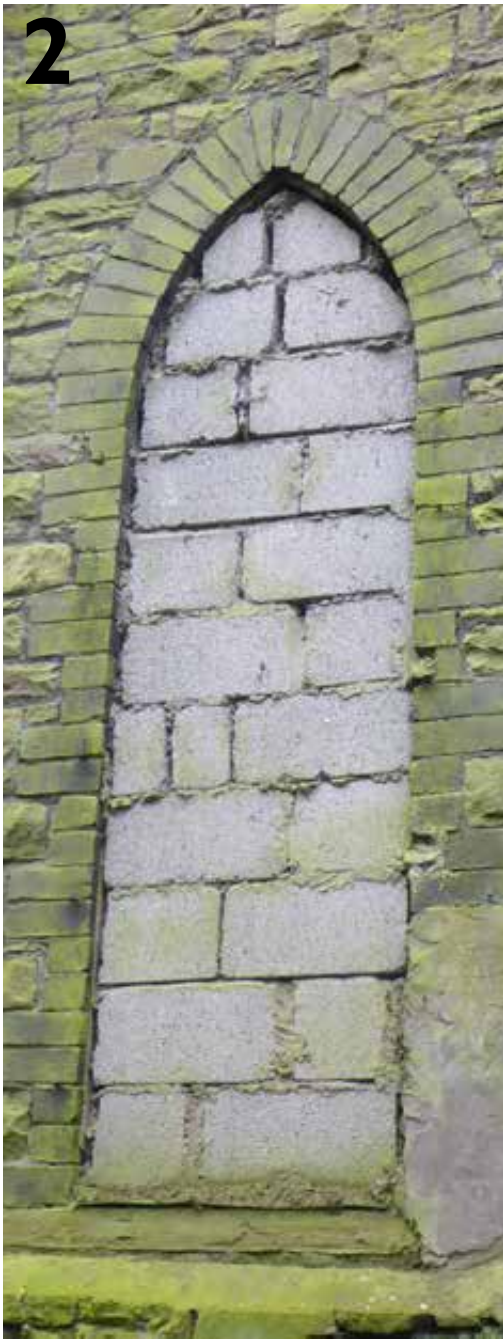
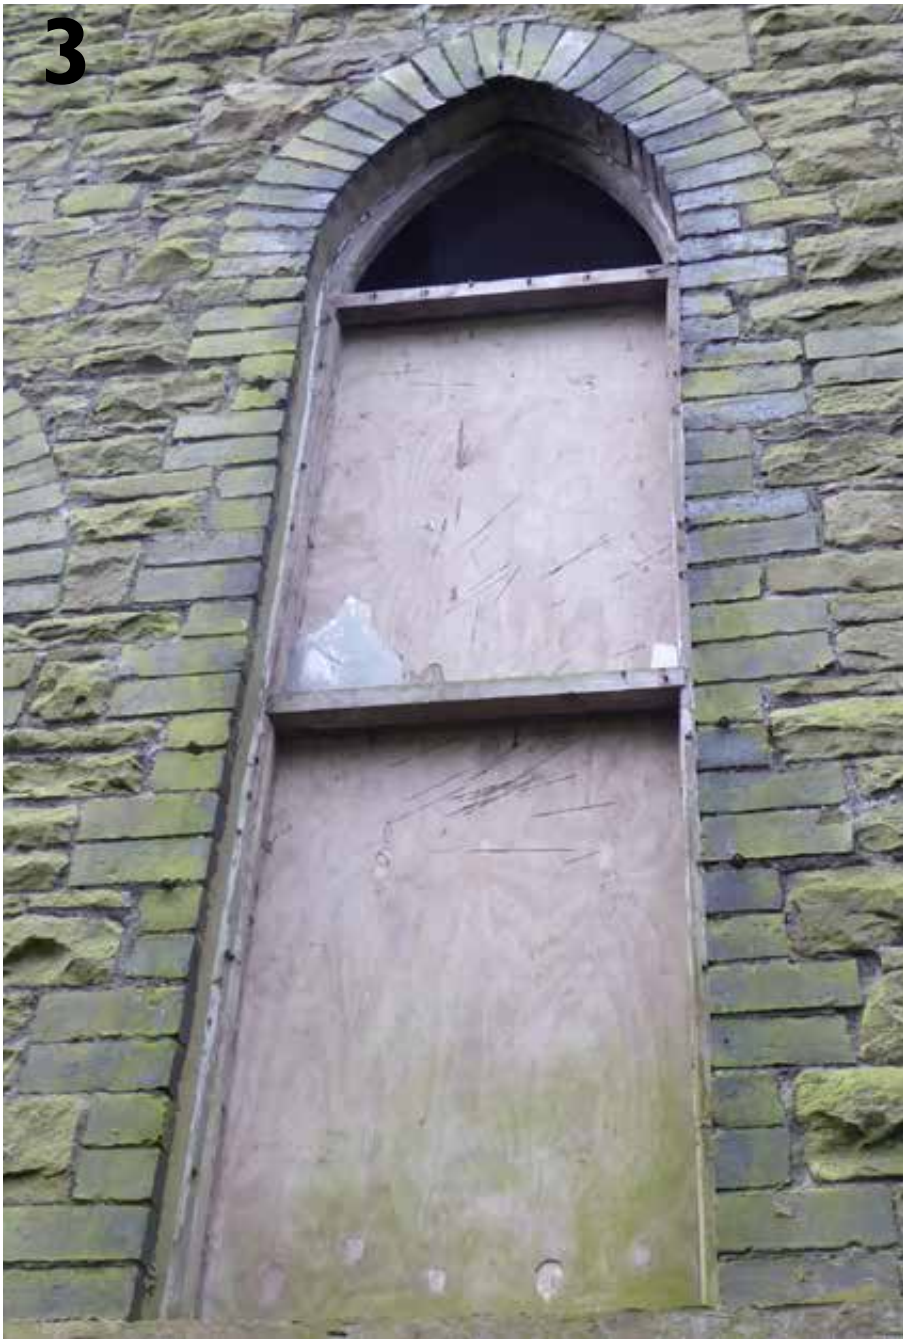
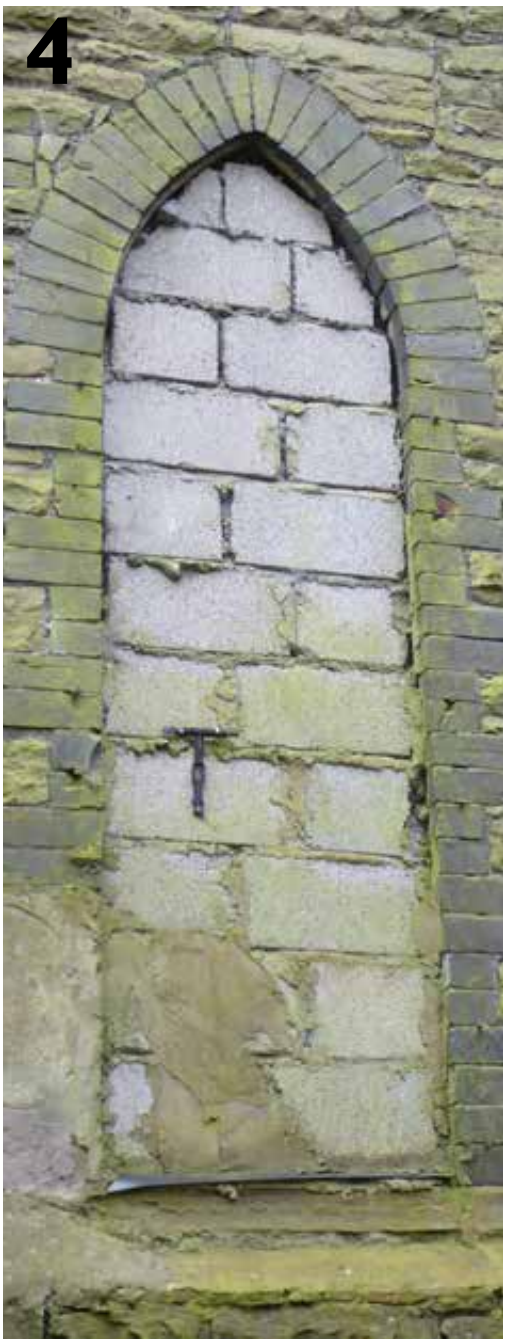
6.4 REAR (EAST)  
ELEVATION

Examples of Condition Issues  
with the Windows  
(with numbers referring  
to photographs)
