# Synagogue, Merthyr Tydfil

## RECORD OF BUILDING AND CONDITION ASSESSMENT REPORT

.....  
(449)2503-GVVP-A-HIS-P00

Date: 17.03.25

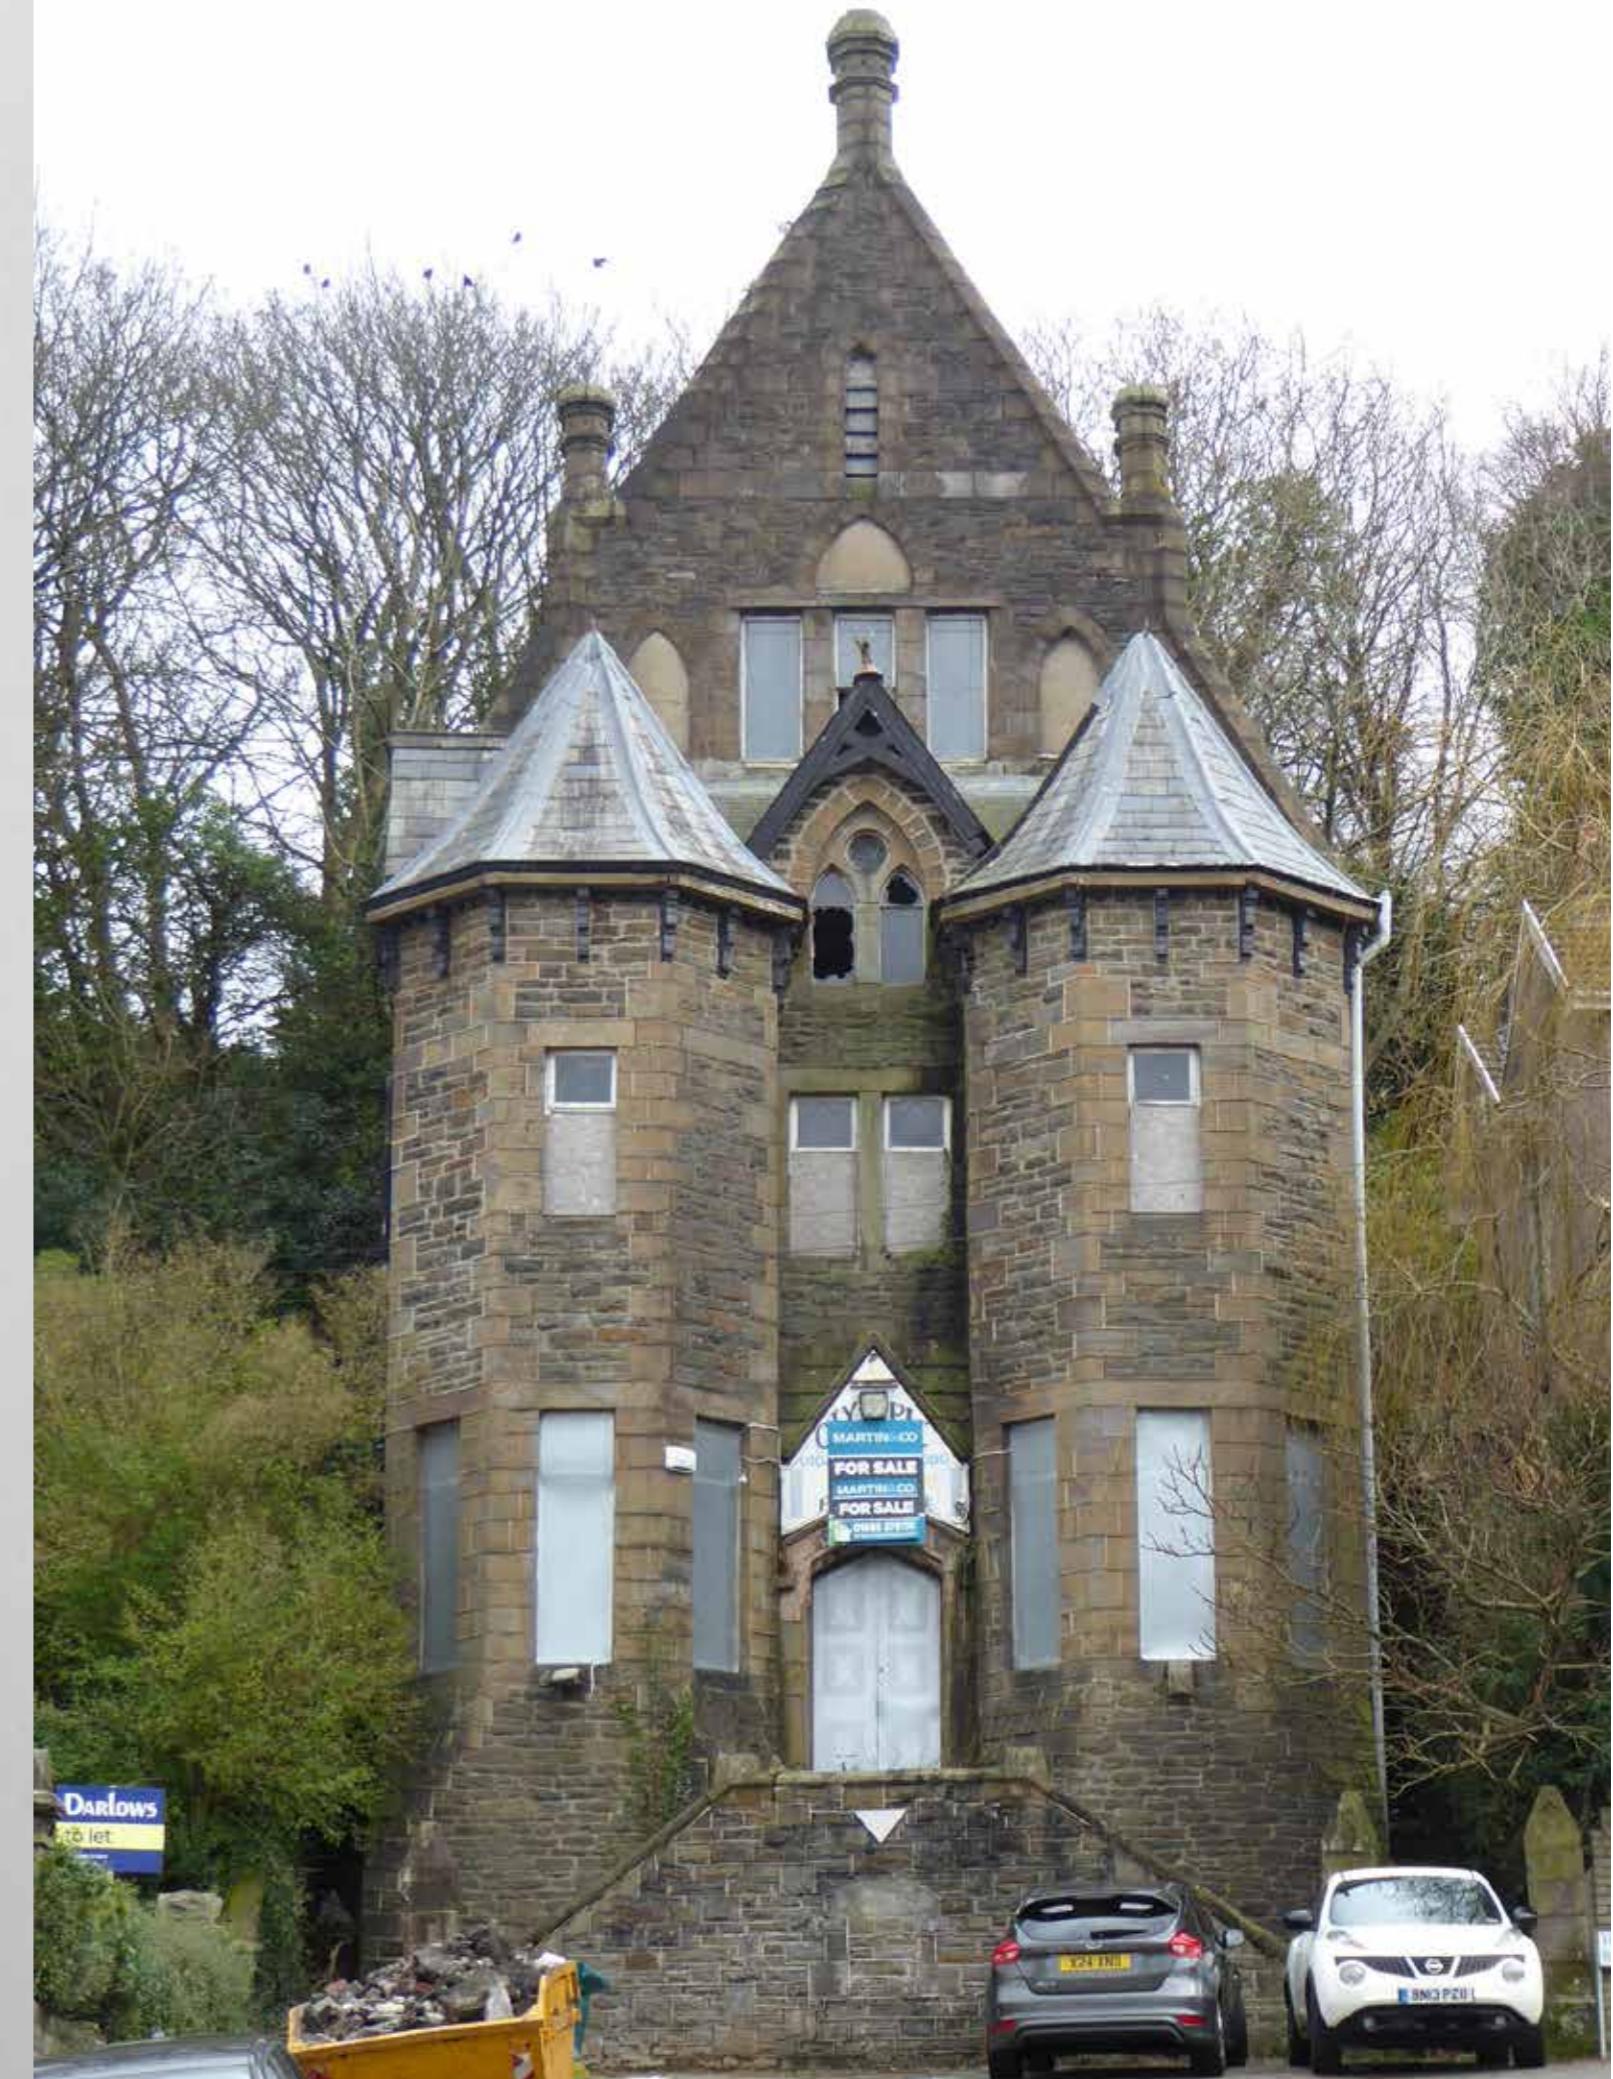
**5.1 FRONT (WEST) ELEVATION**

It is, however, apparent that the top section of the stone gable wall to the front elevation, within the upper half of the roof and above into the finial, is leaning quite considerably into the building. Some of the mortar joints at the top of the wall and to the finial have opened up a fair bit as a result. An inspection was made in the roof space, in 2020, to see if purlin ends had failed and encouraged the wall to lean into the pockets left by the failed purlin ends. There was no suggestion that this was the case.

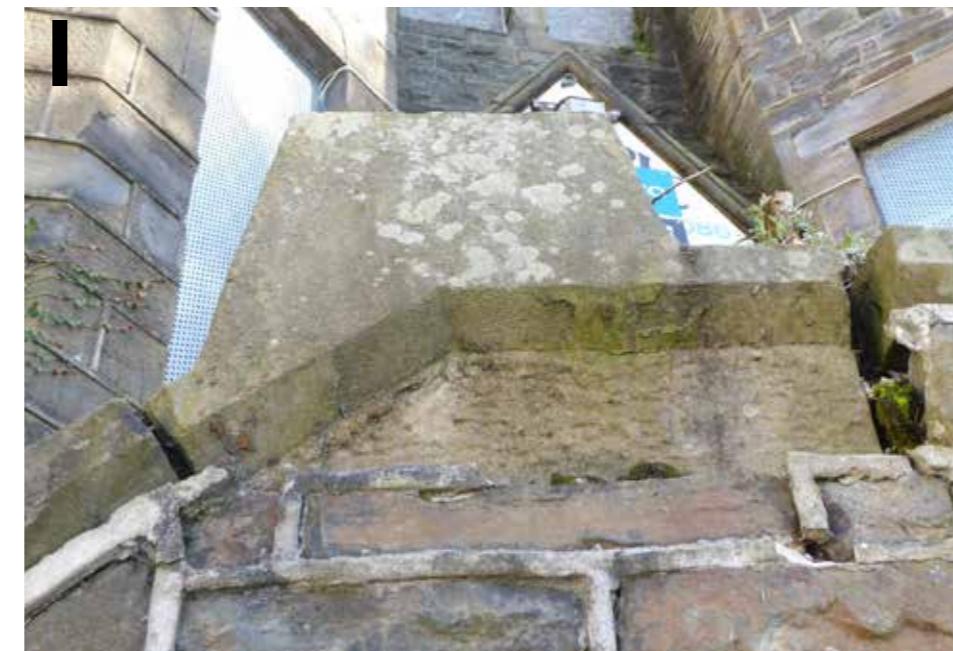
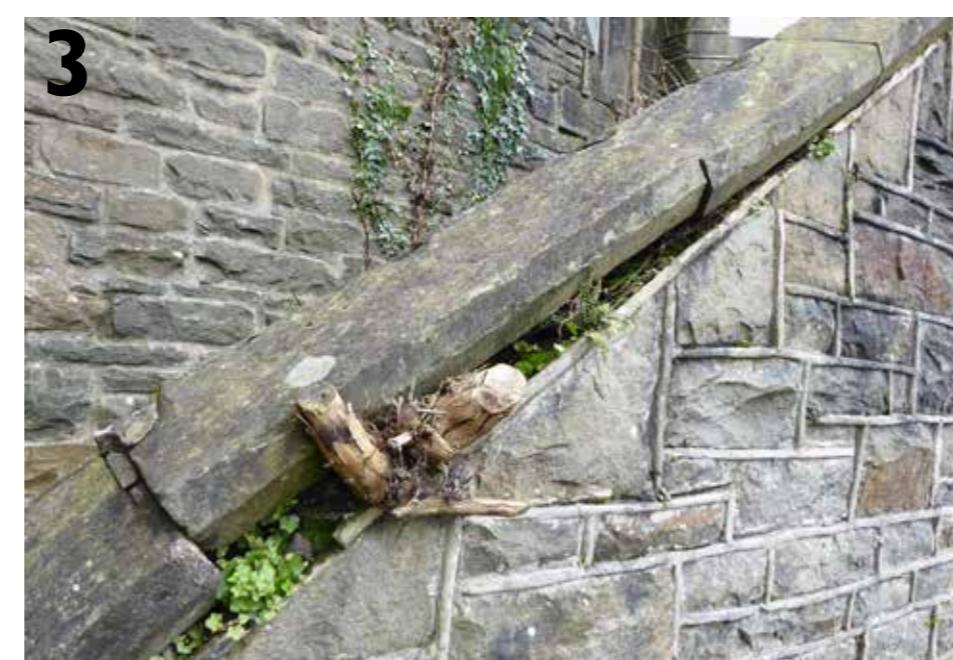
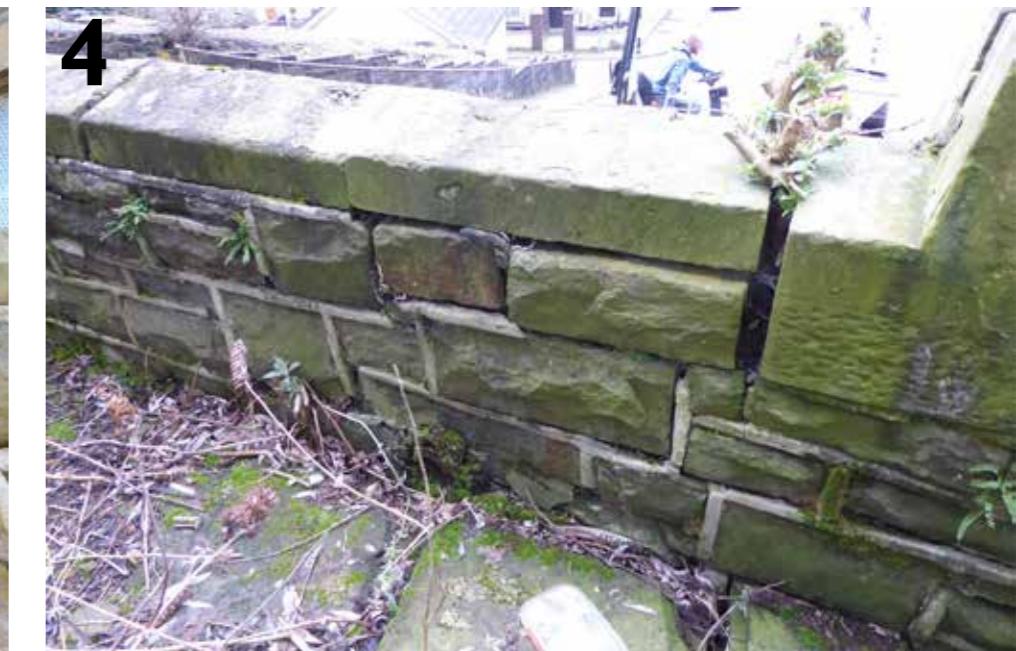
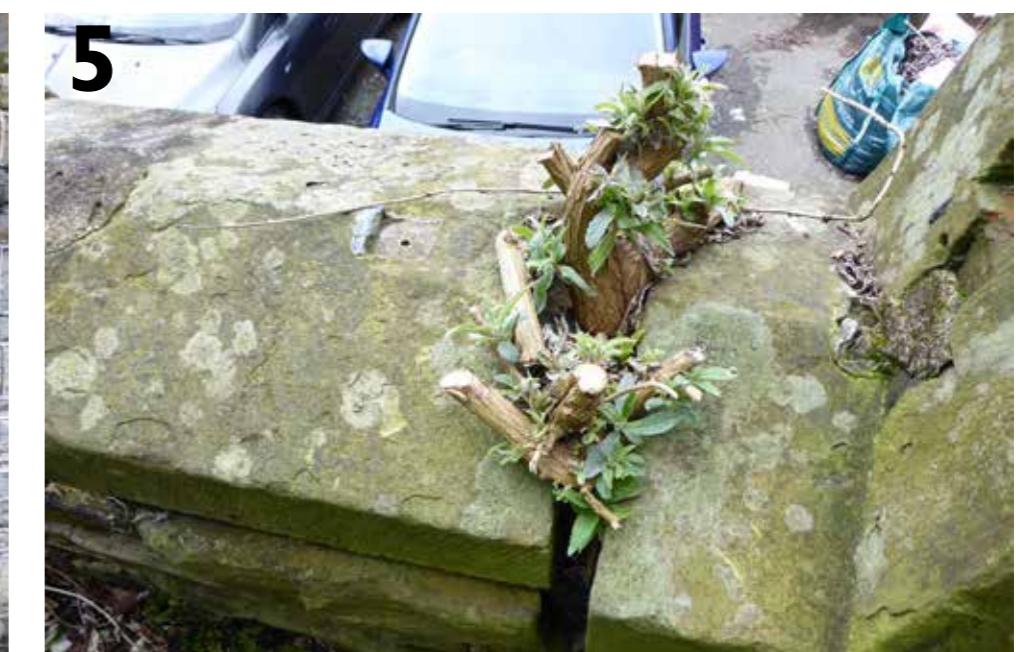
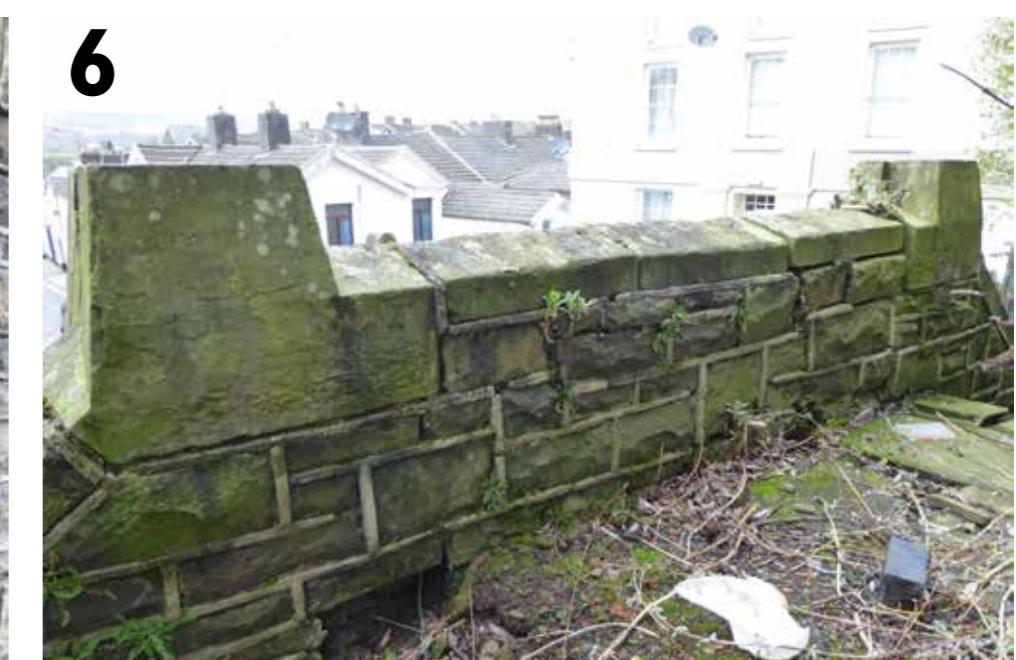
## Examples of Condition Issues

## with the Stonework

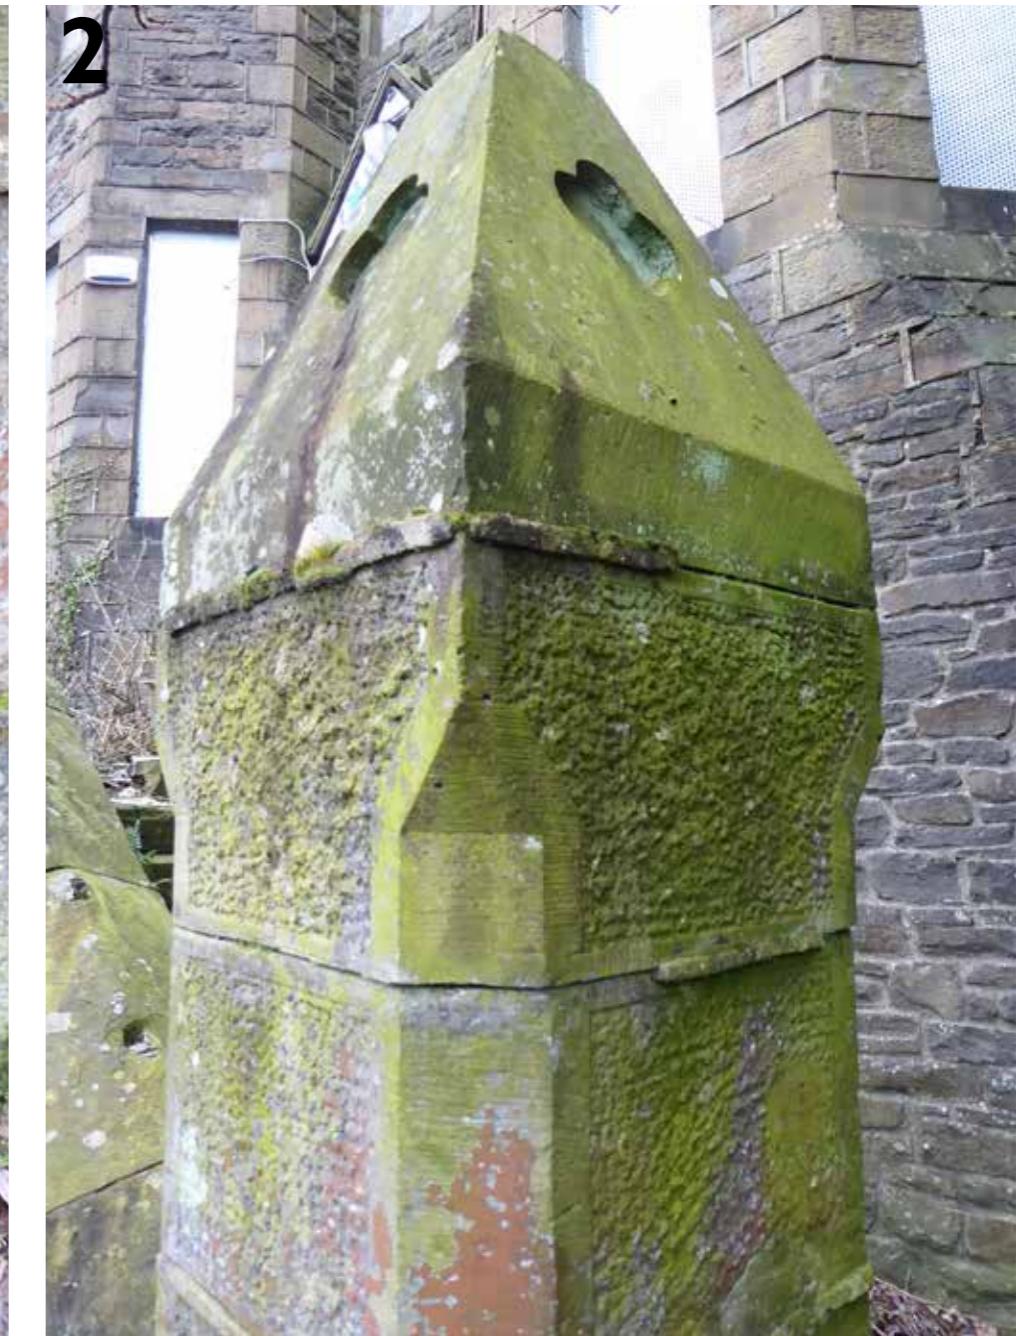
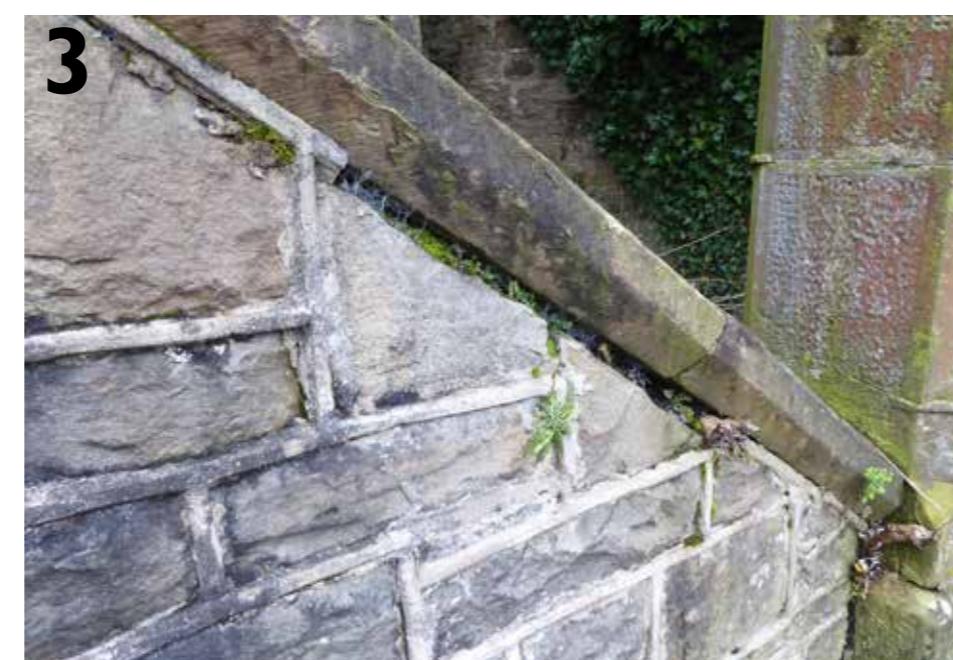
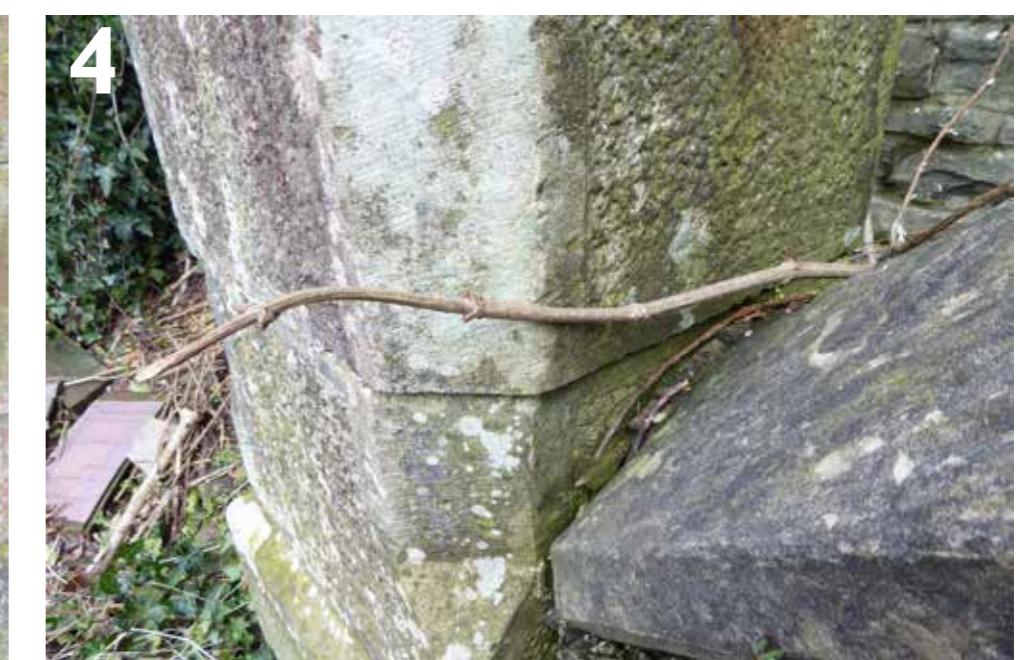
**6.1 FRONT (WEST) ELEVATION****Examples of Condition Issues  
with the Stonework****(with numbers referring to photographs)**

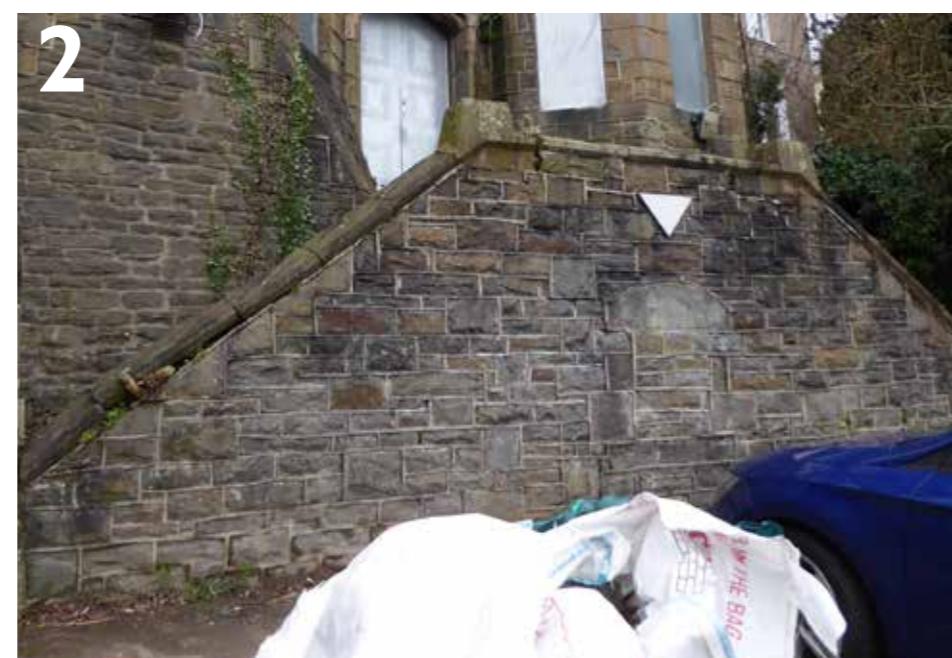
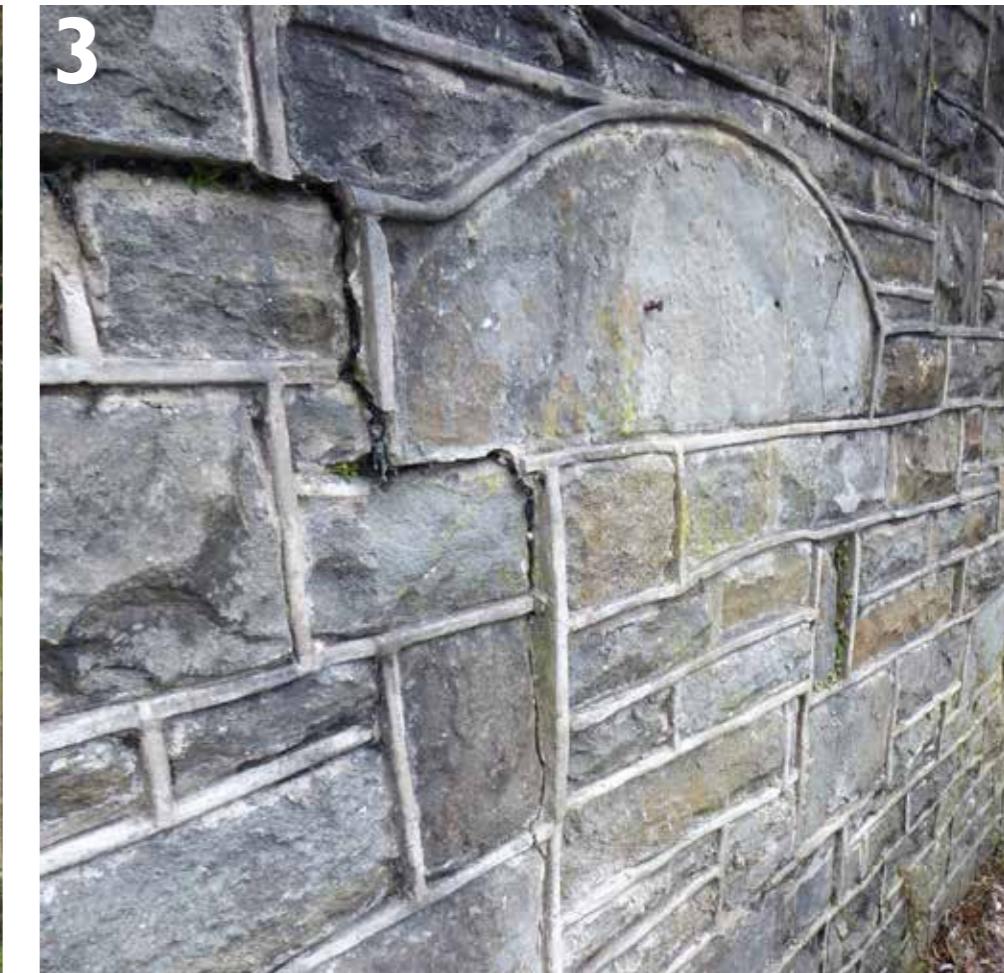
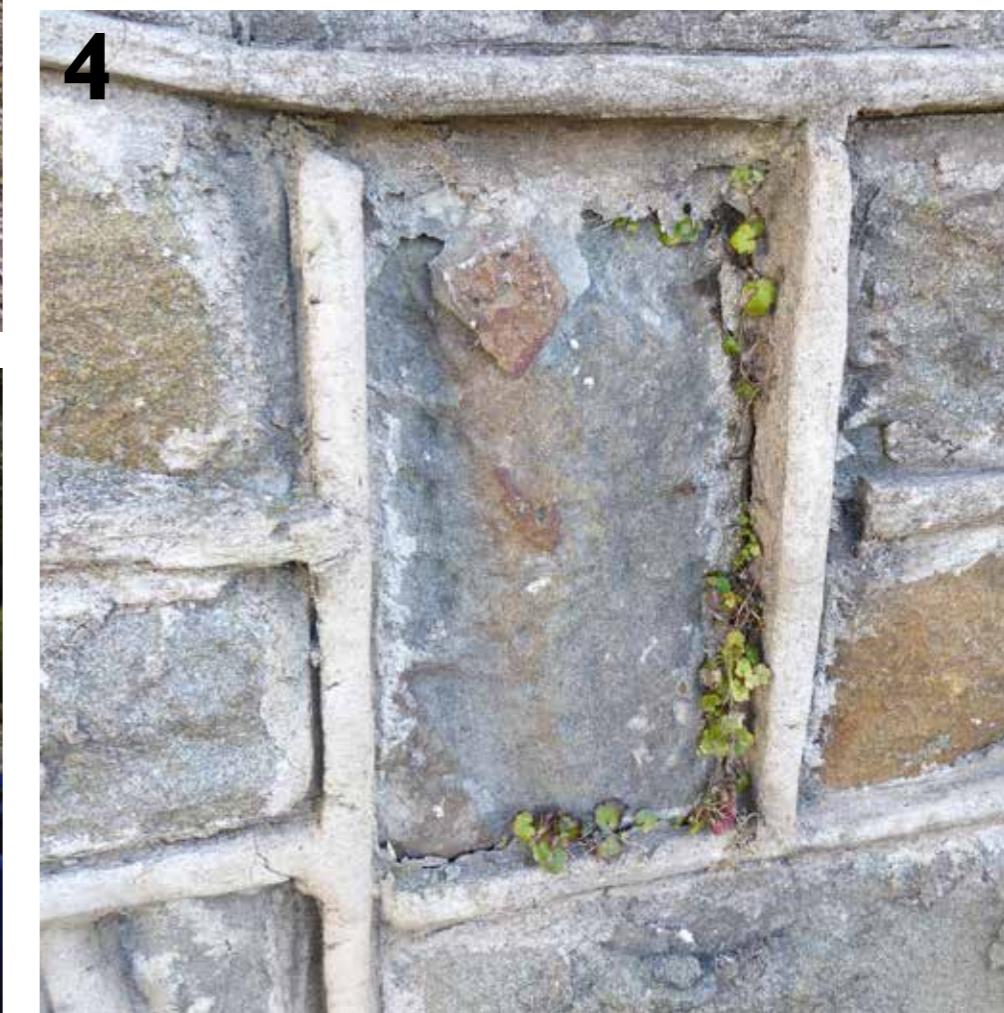
## 6.1 FRONT (WEST) ELEVATION

## Examples of Condition Issues

## with the Stonework

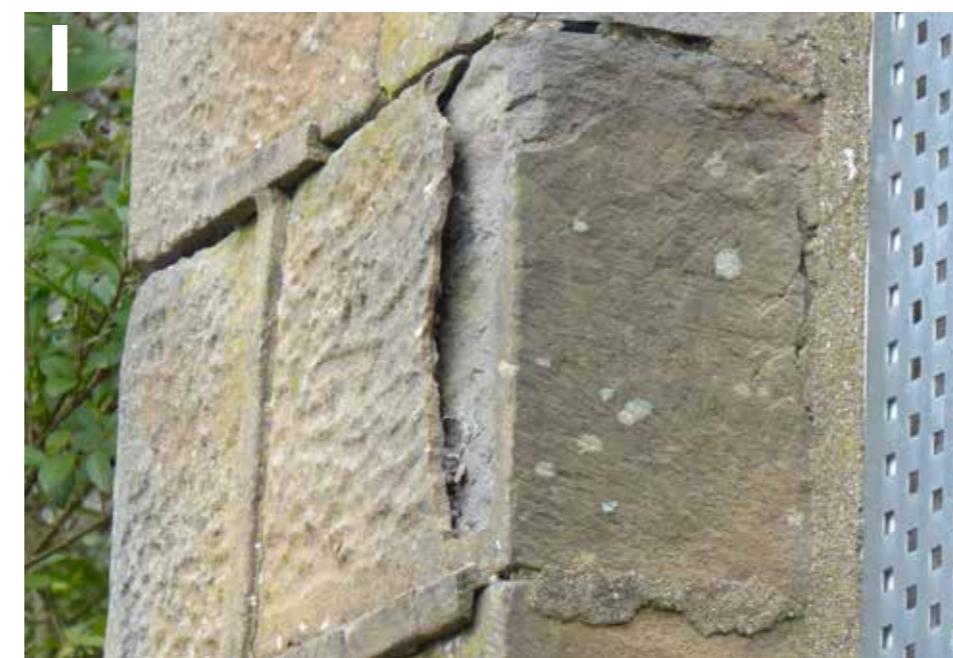
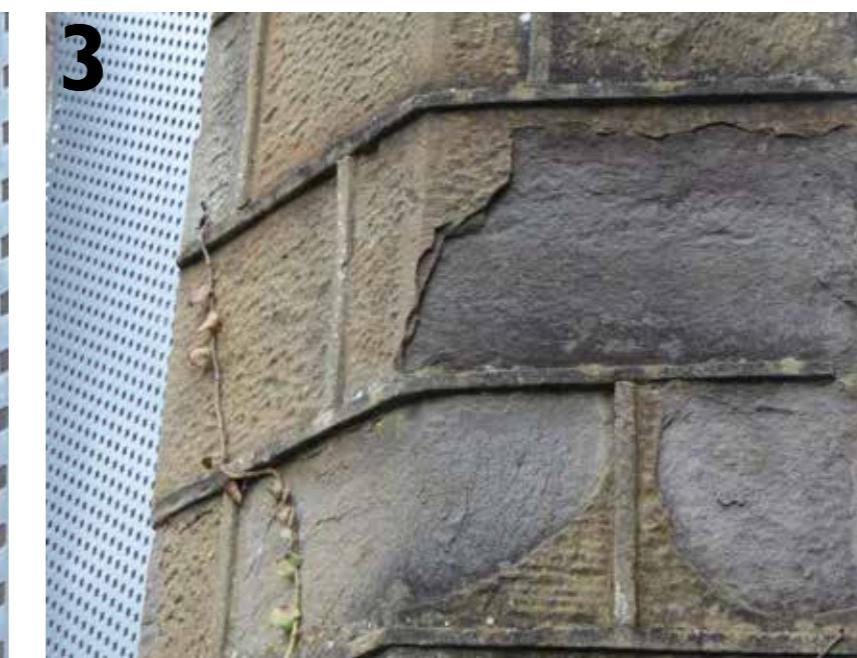
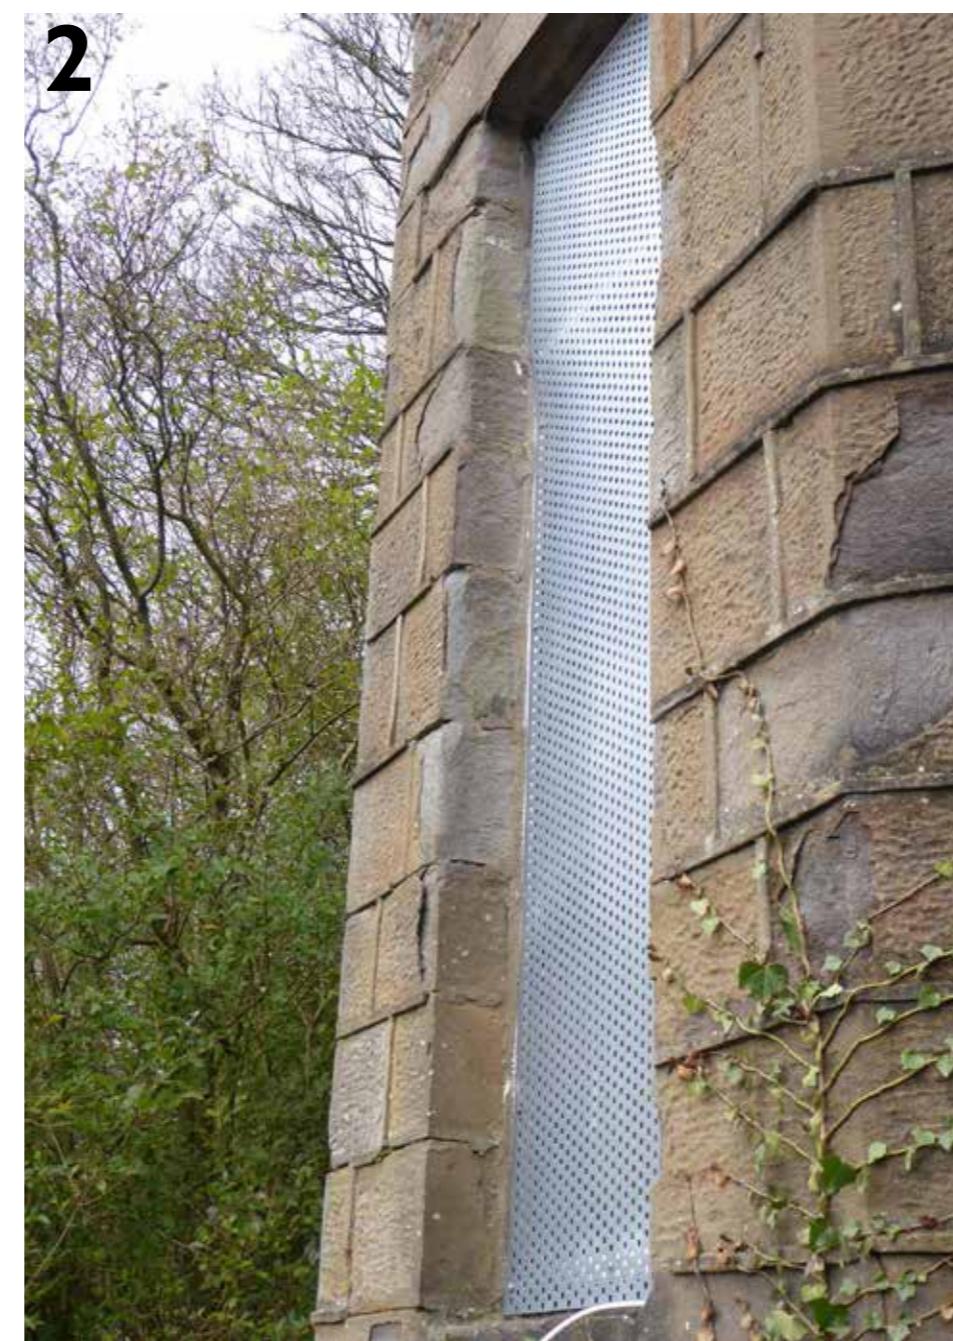
## 6.1 FRONT (WEST) ELEVATION

## Examples of Condition Issues

## with the Stonework

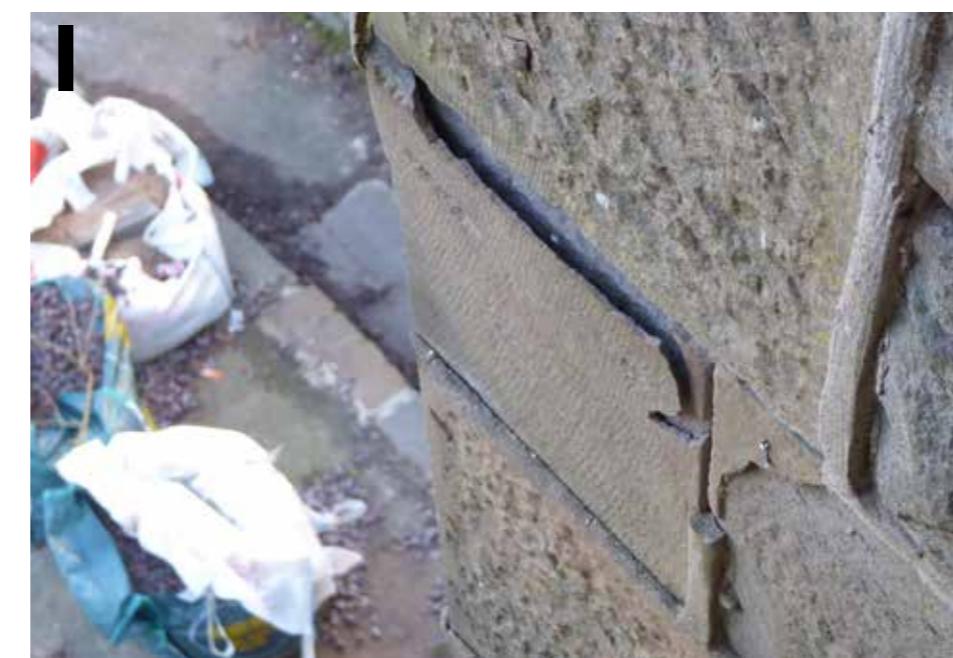
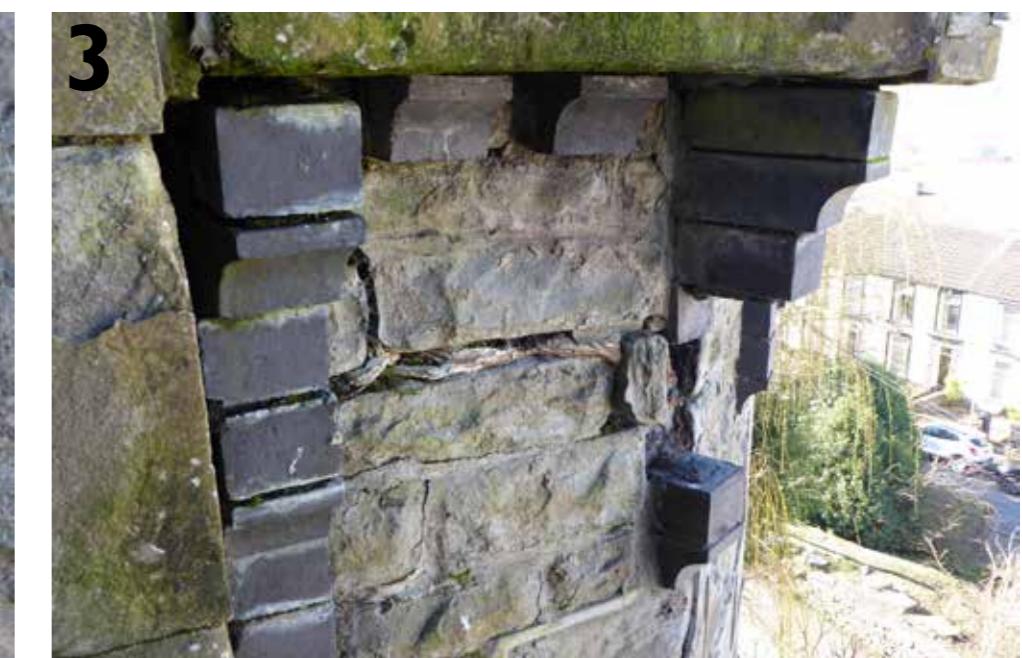
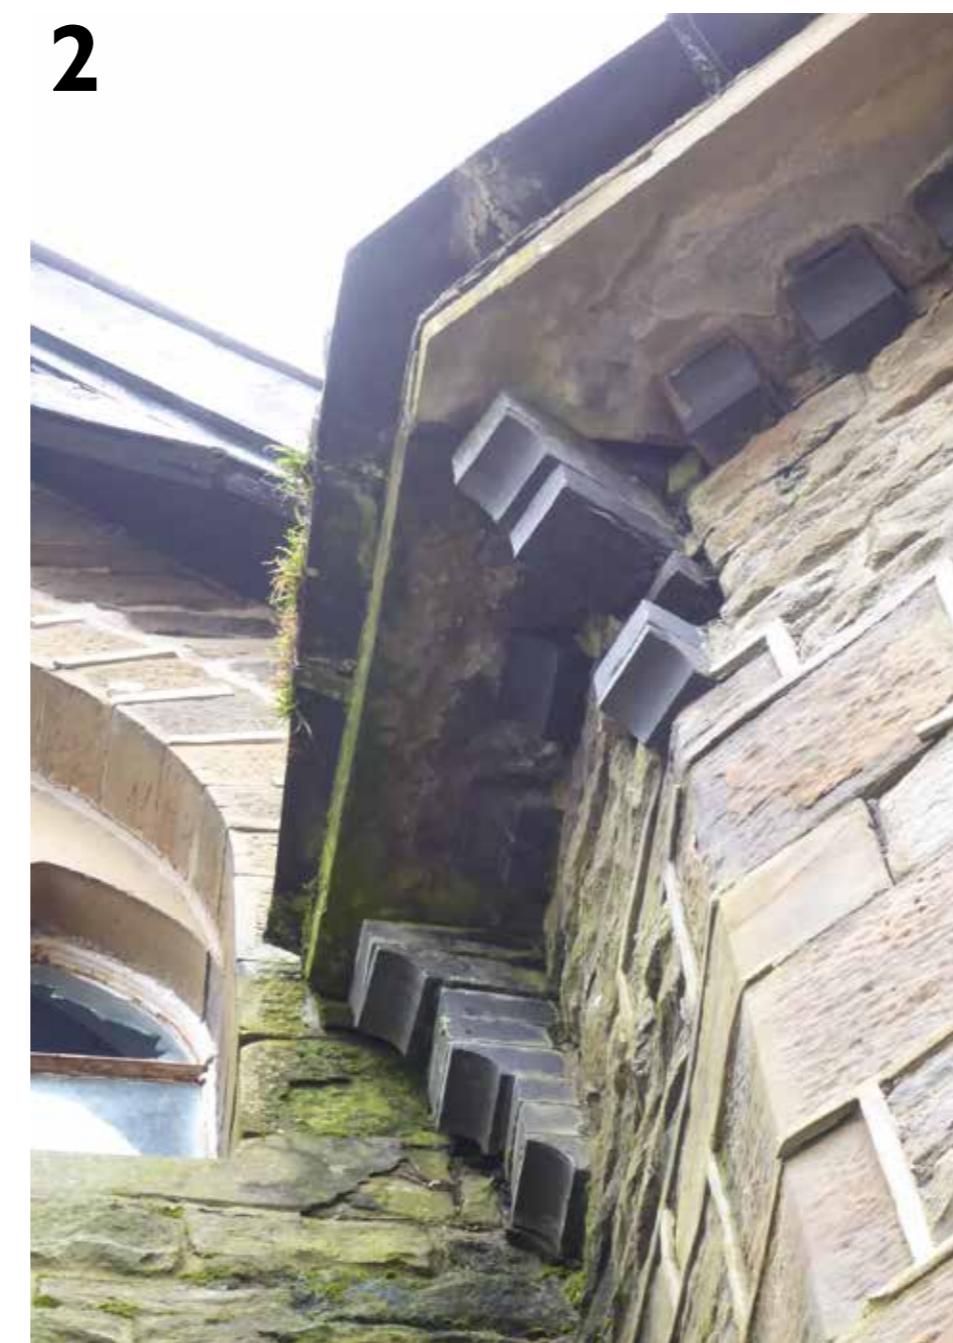
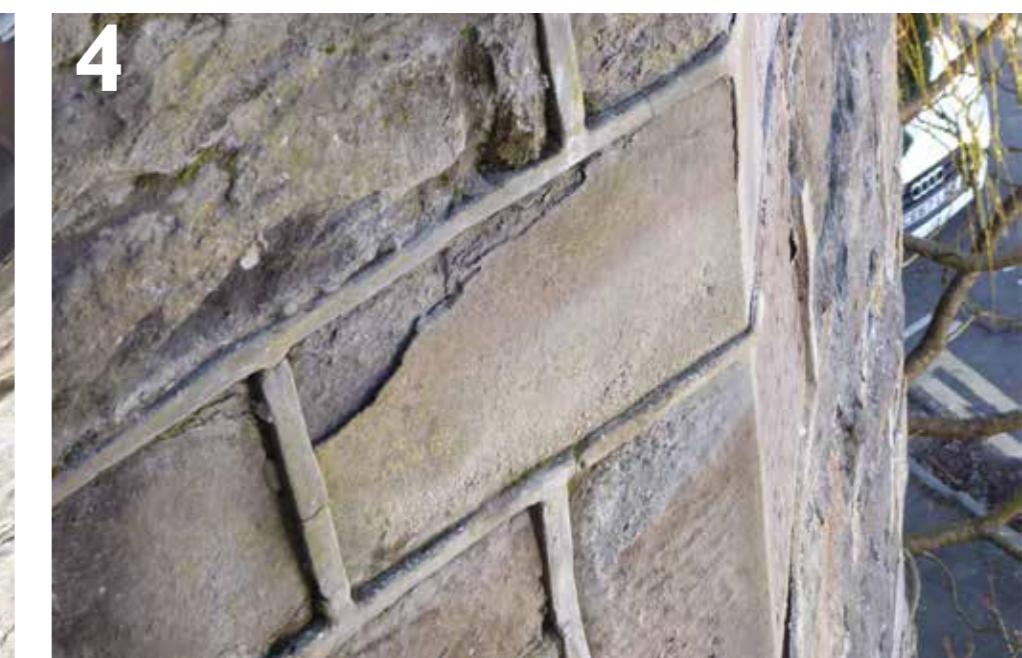
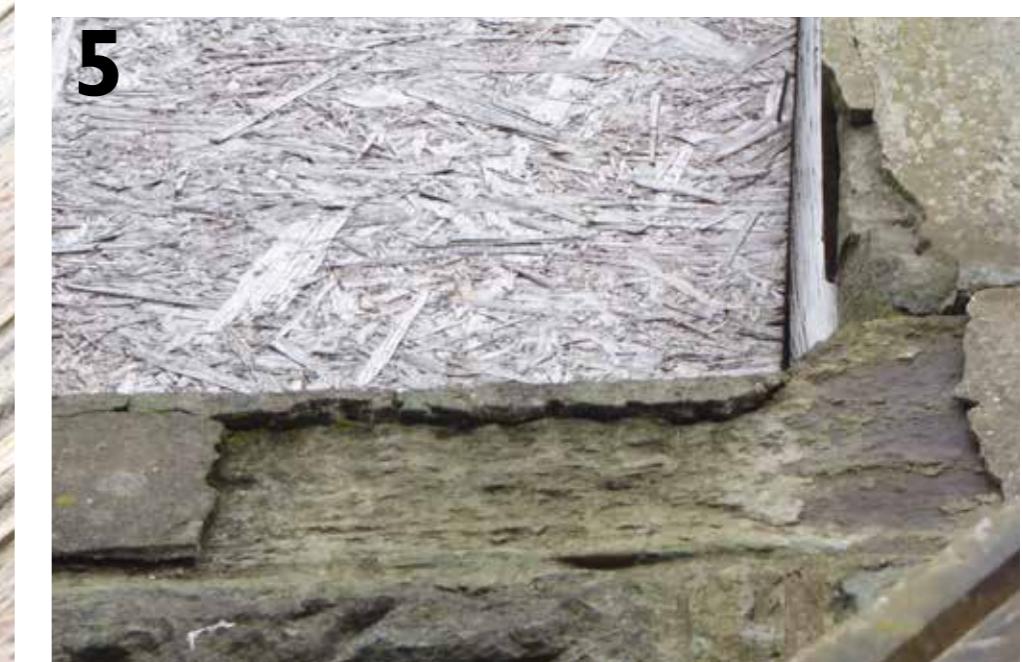
**6.1 FRONT (WEST) ELEVATION****Examples of Condition Issues  
with the Stonework****(with numbers referring to photographs)**

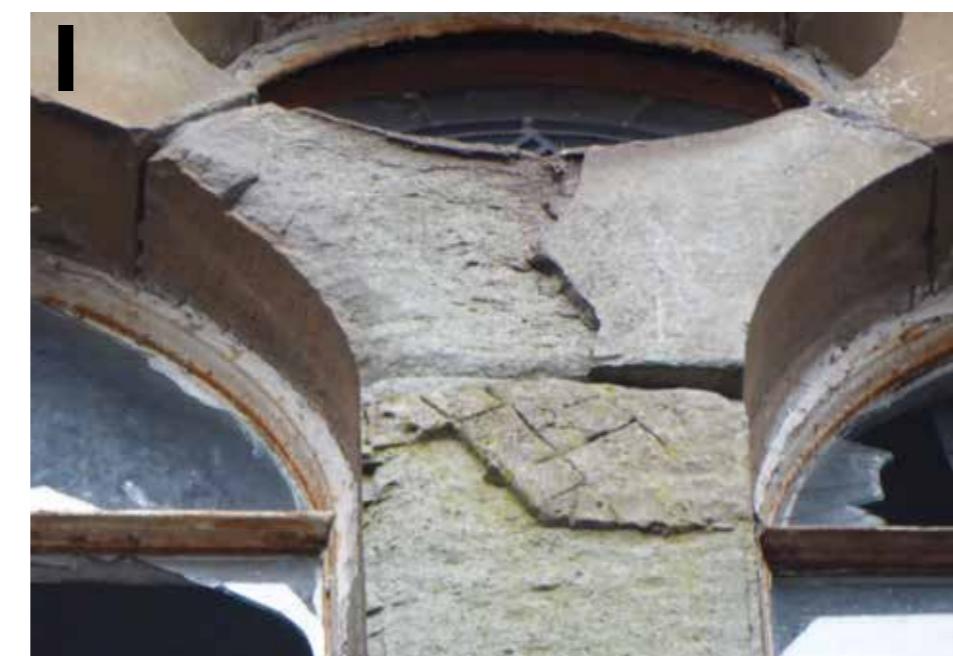
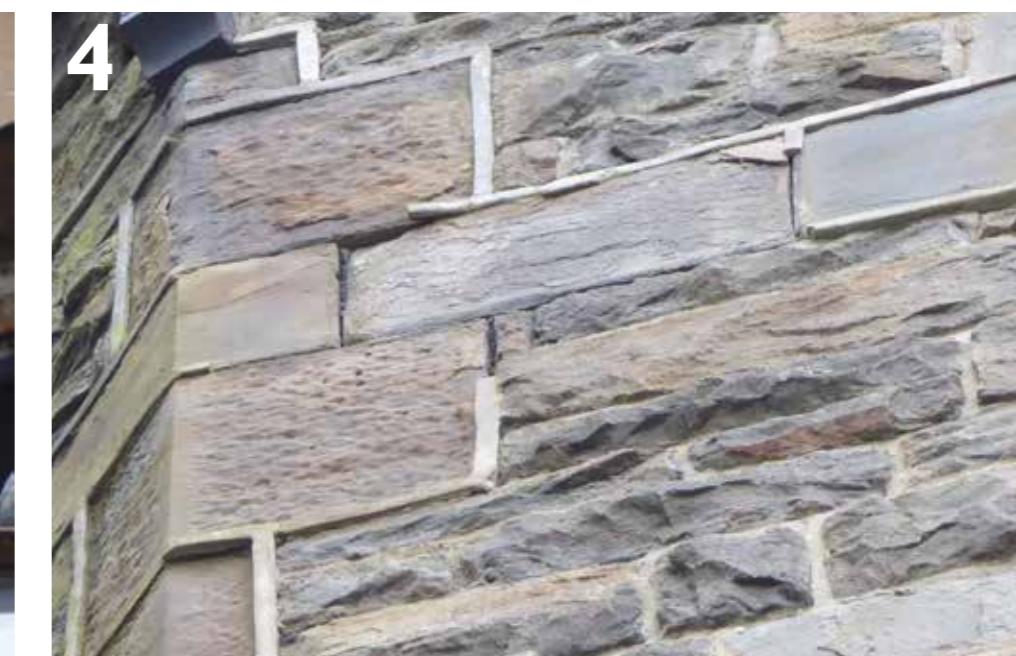
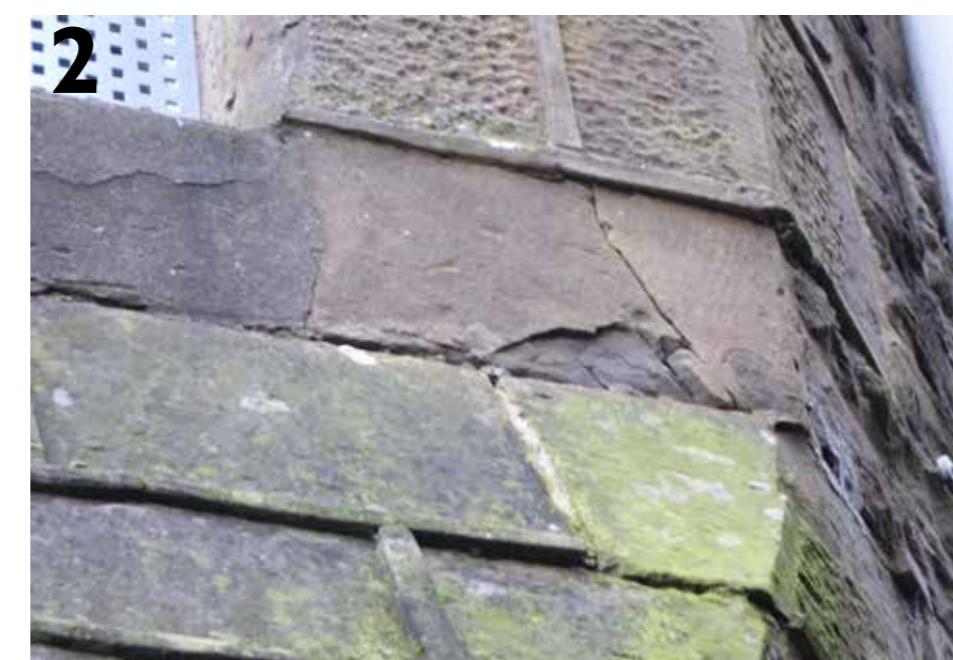
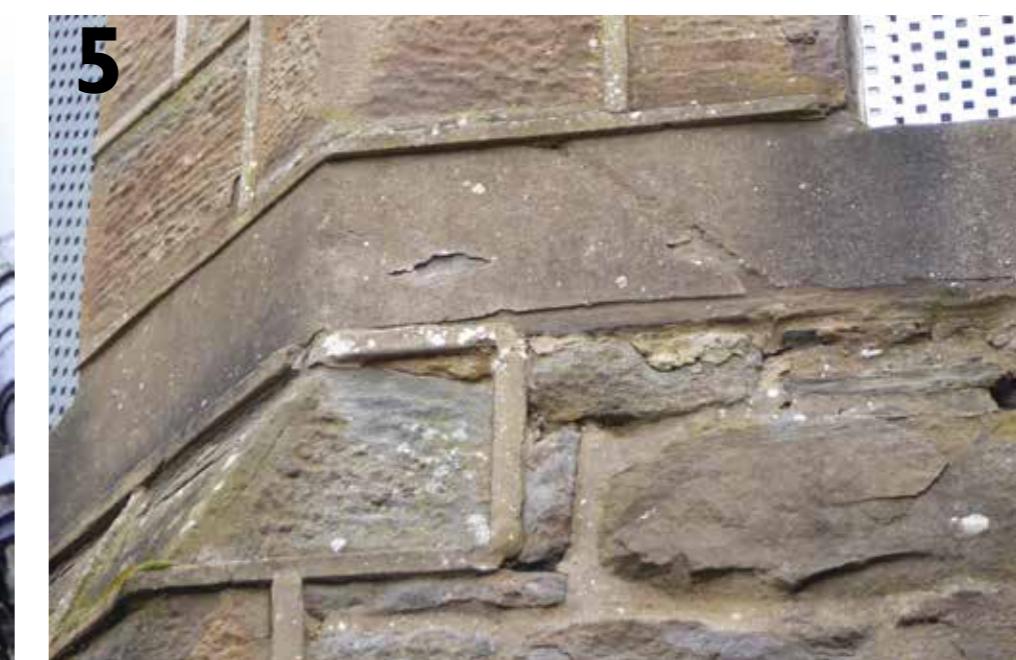
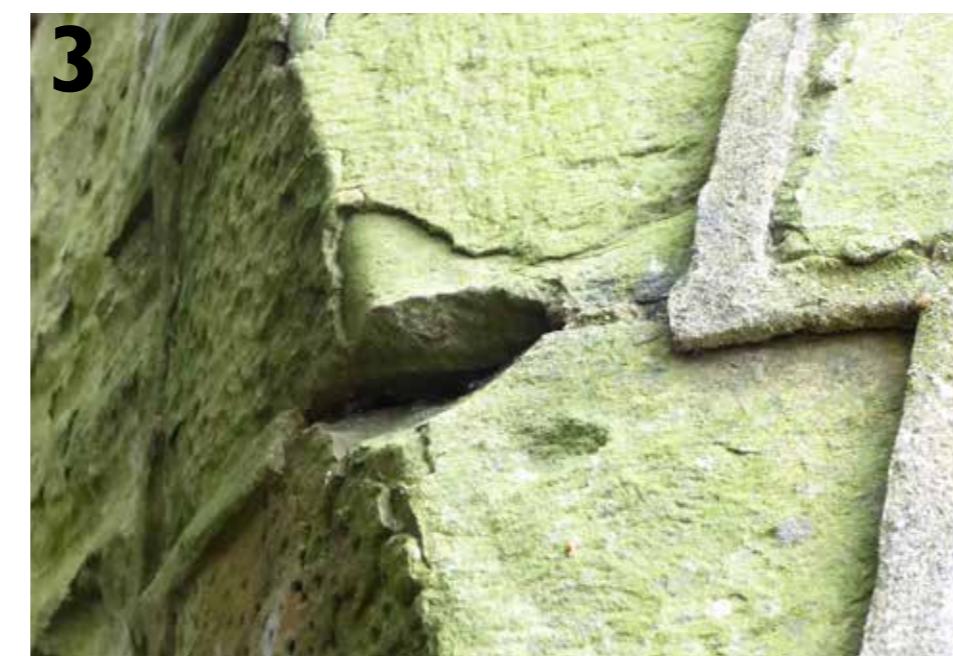
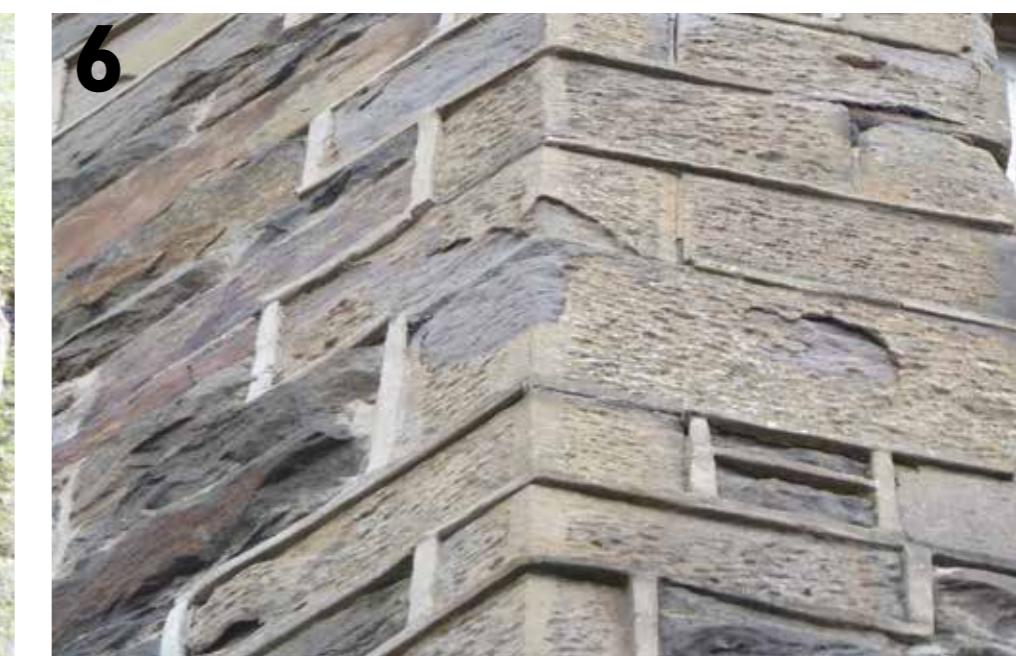
**6.1 FRONT (WEST) ELEVATION****Examples of Condition Issues  
with the Stonework****(with numbers referring to photographs)**
