# Synagogue, Merthyr Tydfil

## RECORD OF BUILDING AND CONDITION ASSESSMENT REPORT

.....  
(449)2503-GVVP-A-HIS-P00

Date: 17.03.25

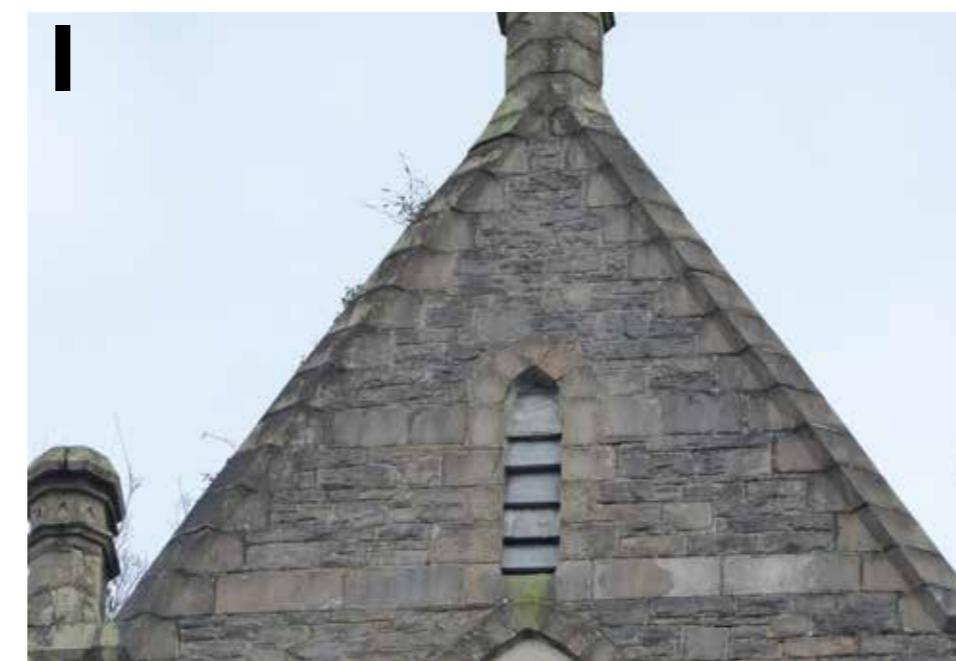
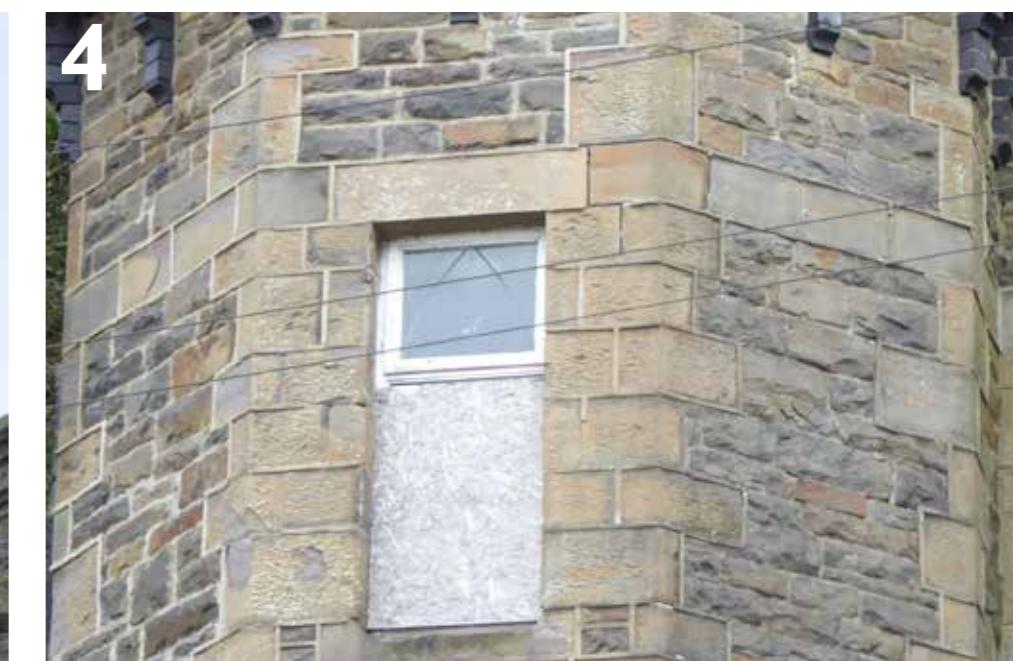
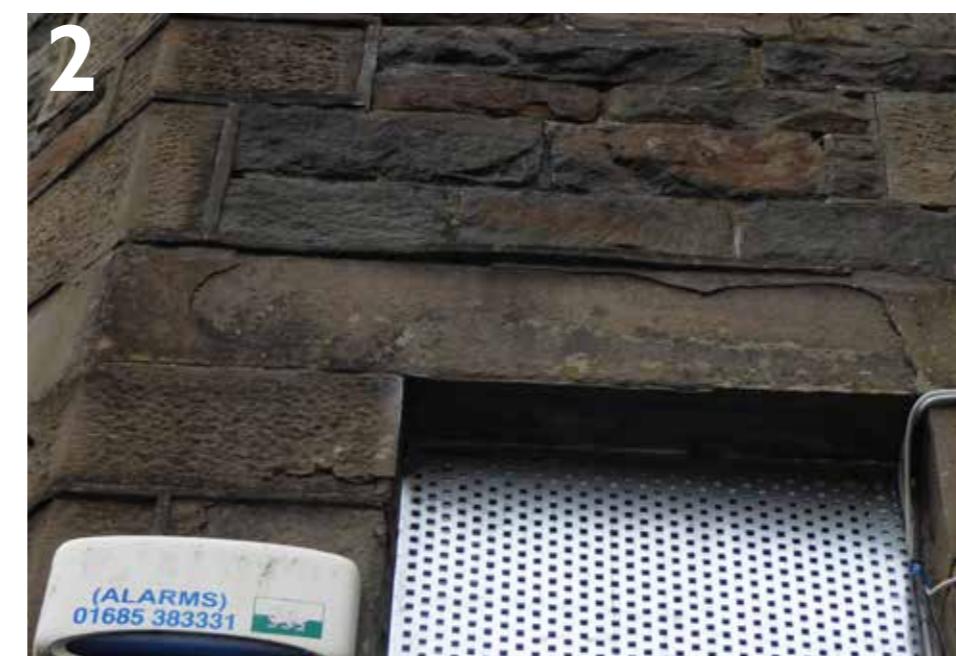
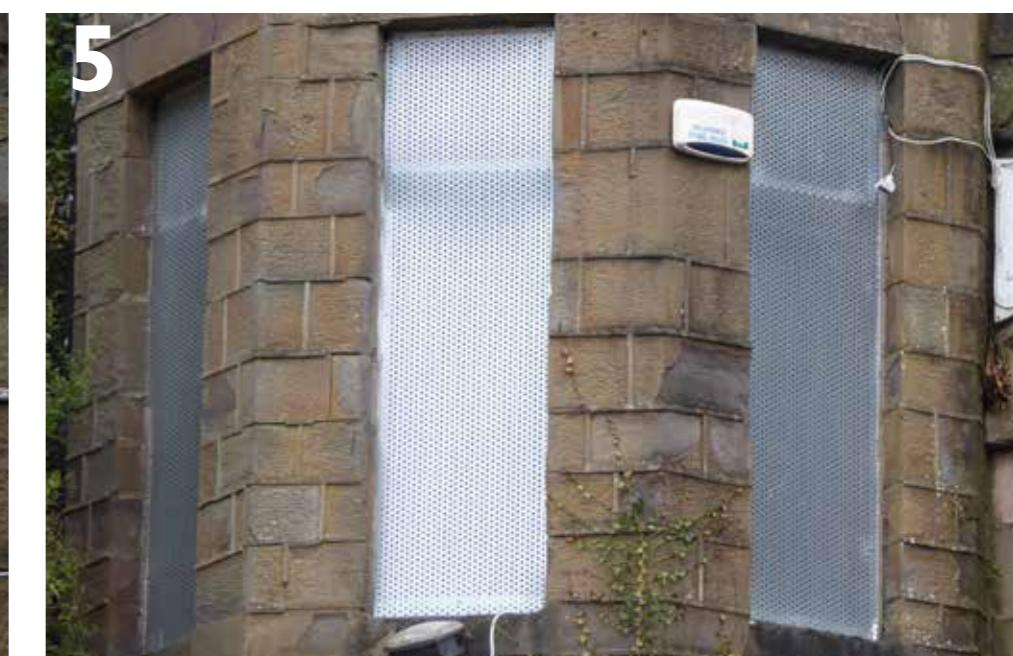
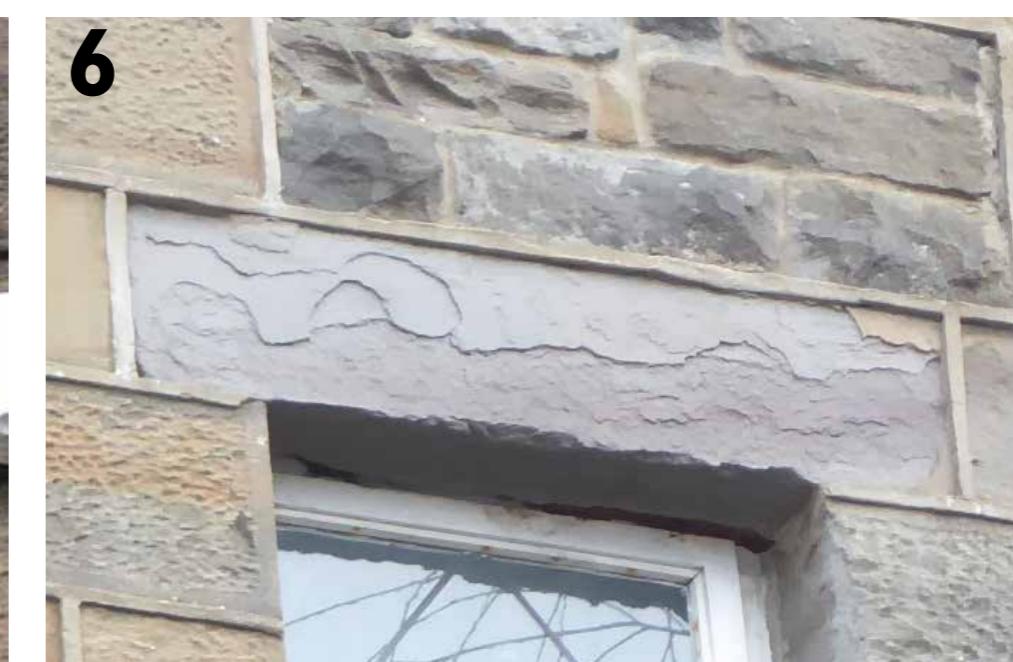
**6.1 FRONT (WEST) ELEVATION****Examples of Condition Issues  
with the Stonework****(with numbers referring to photographs)**

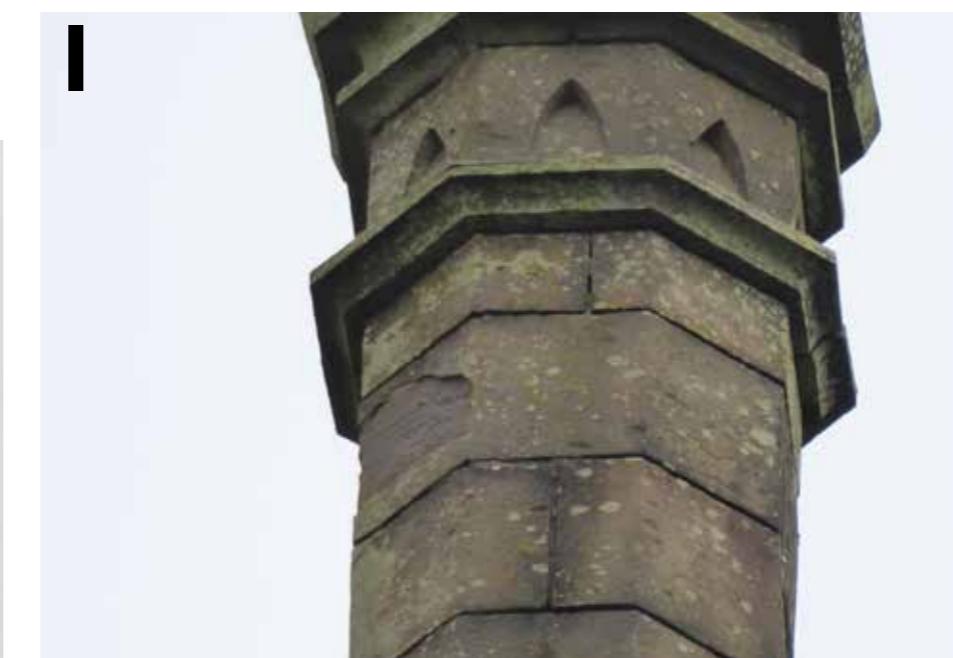
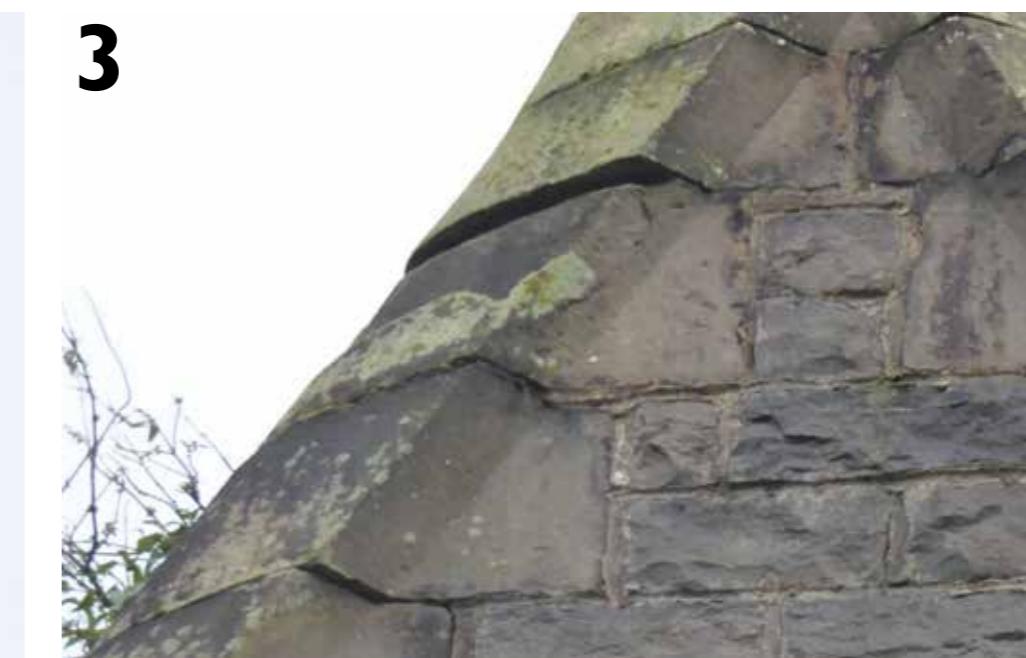
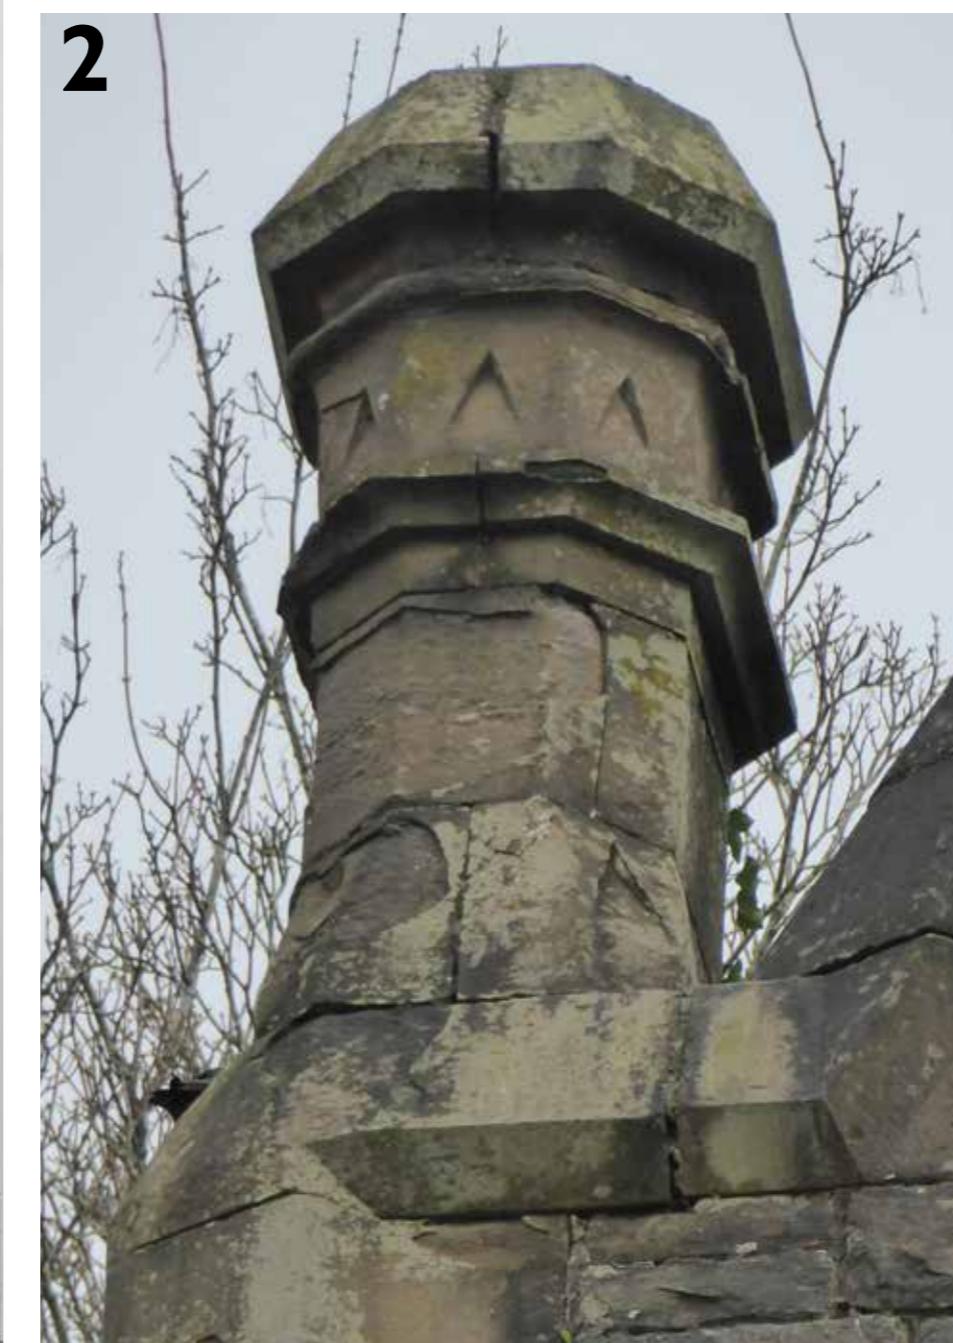
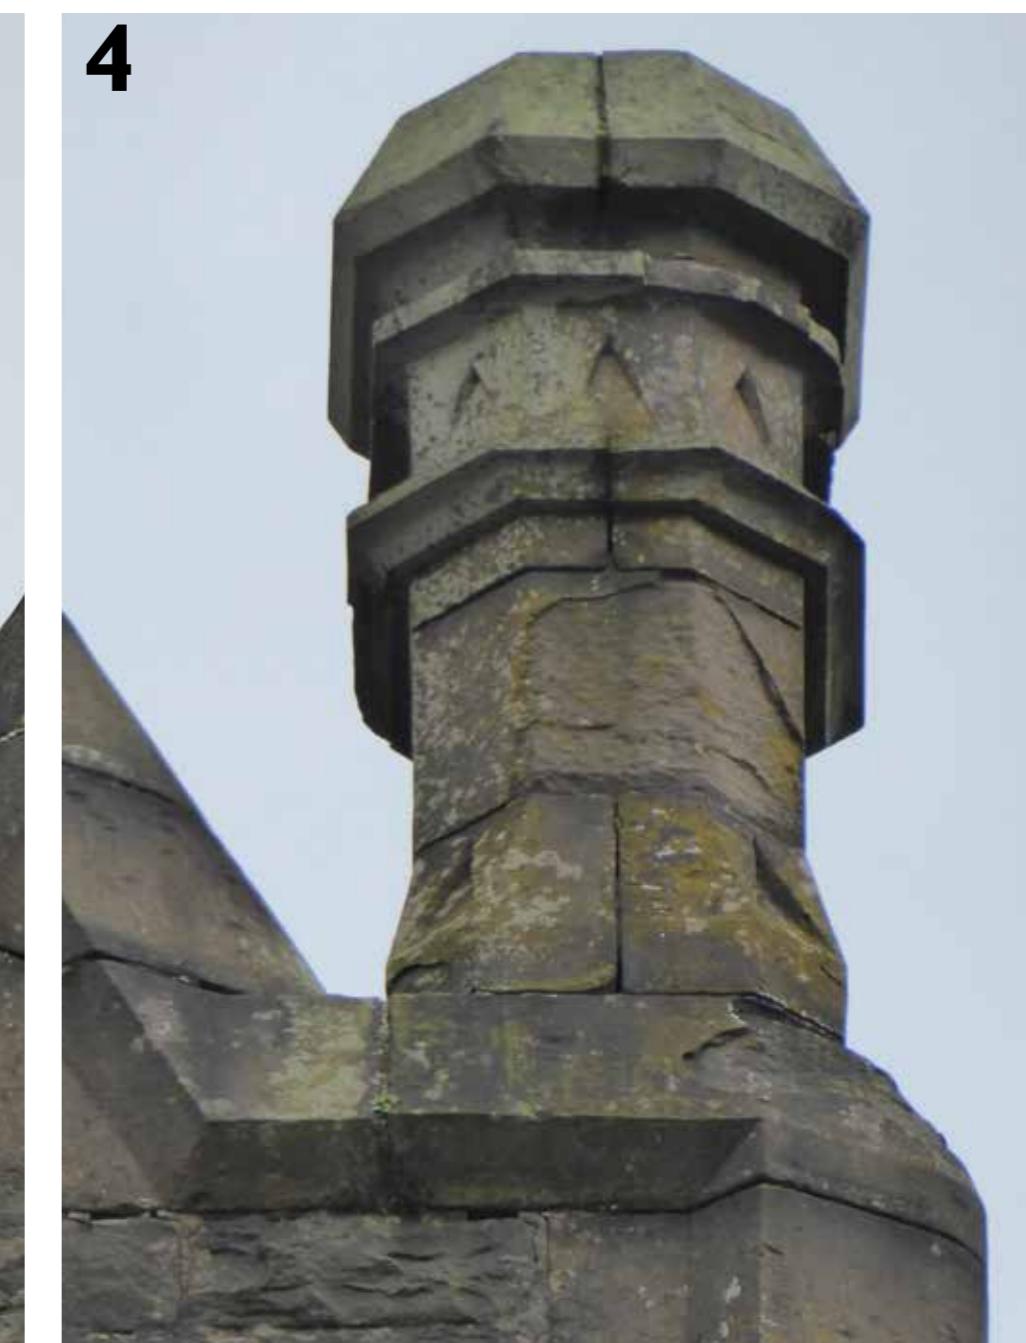
**6.1 FRONT (WEST) ELEVATION****Examples of Condition Issues  
with the Stonework****(with numbers referring to photographs)**

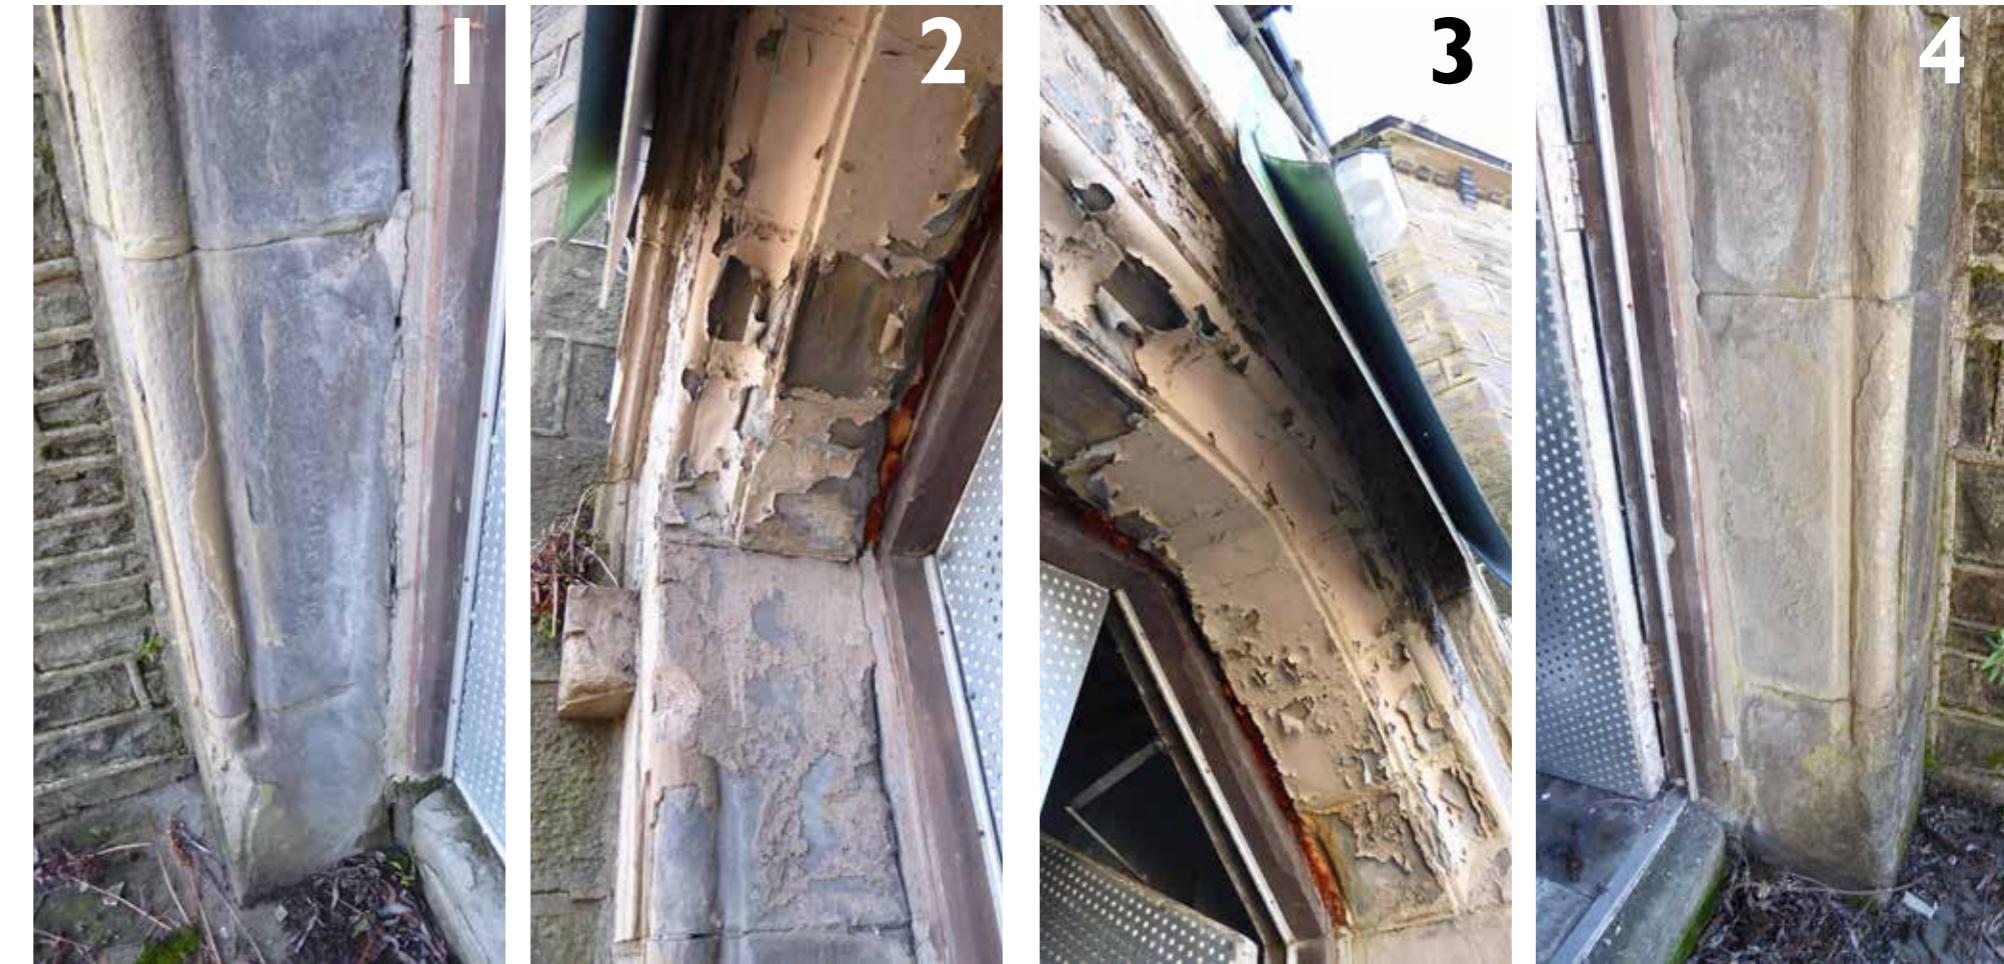
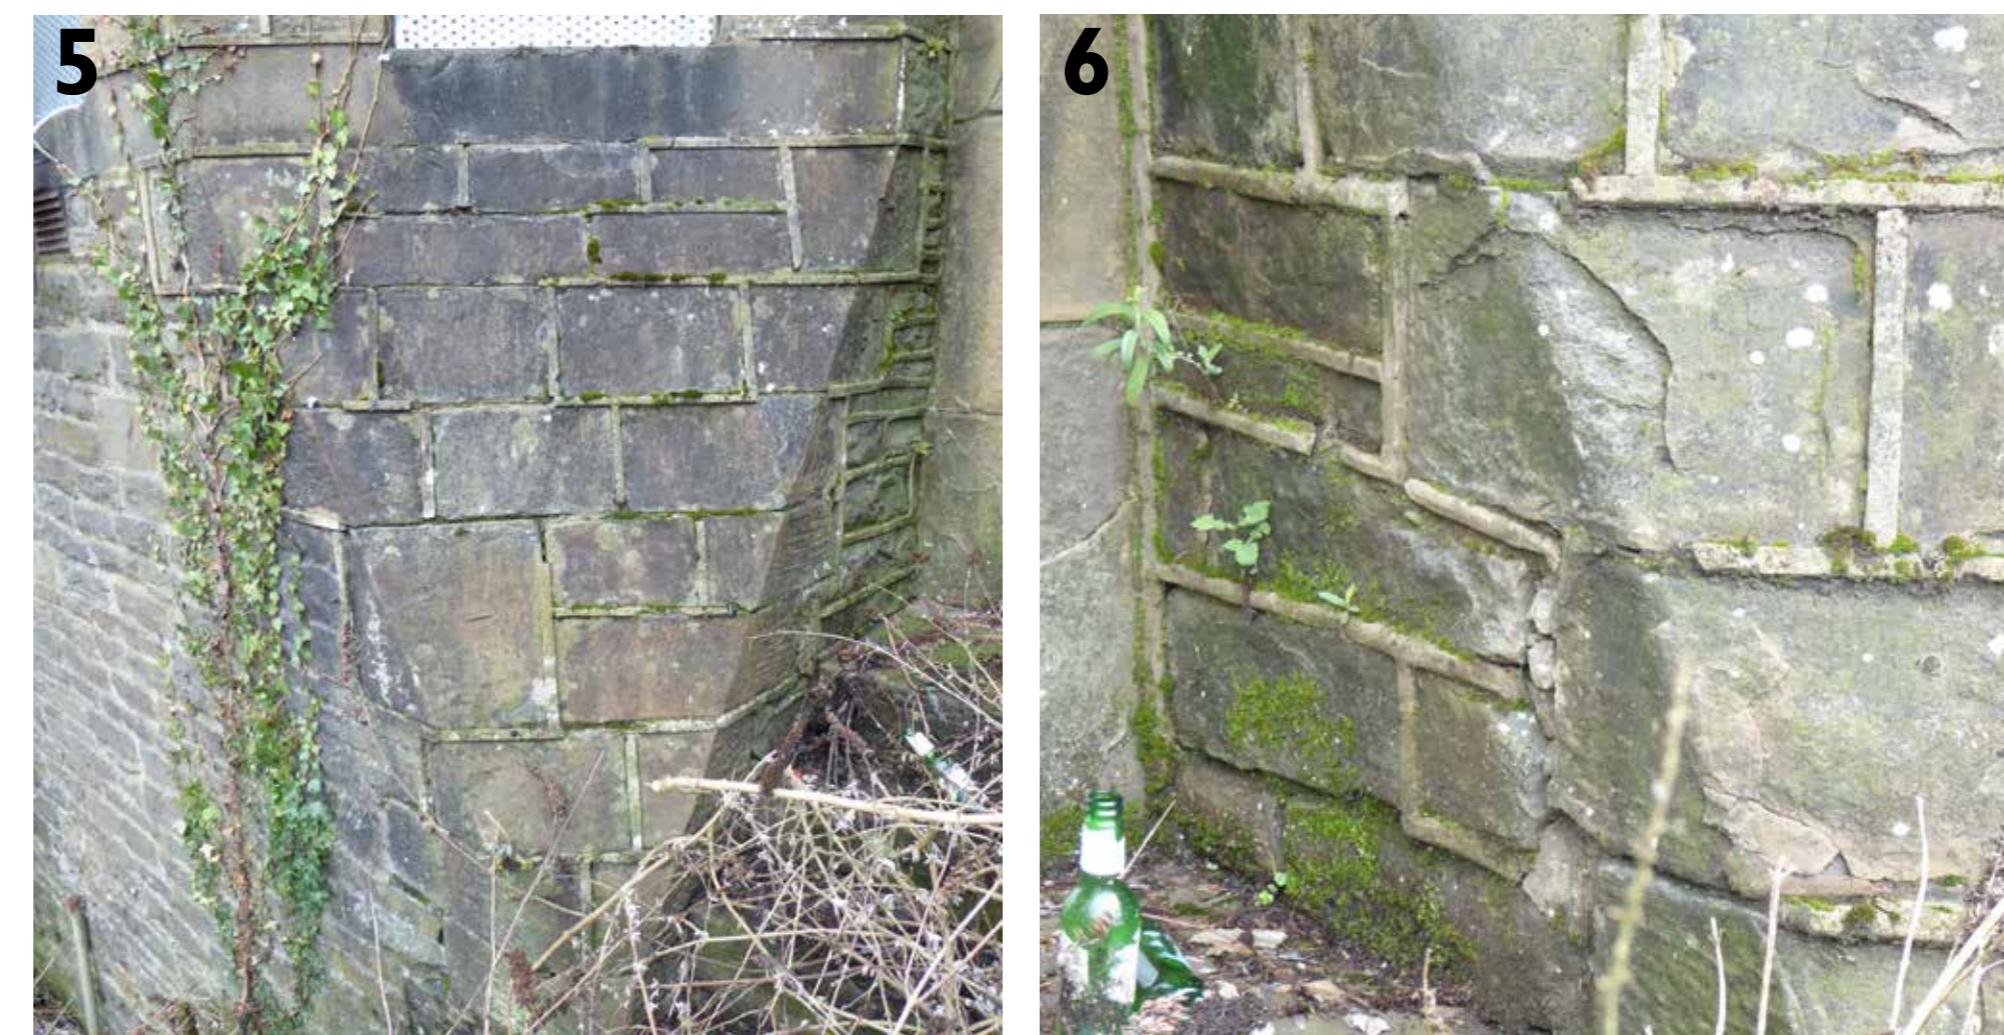
**6.1 FRONT (WEST) ELEVATION****Examples of Condition Issues****with the Stonework****(with numbers referring to photographs)**

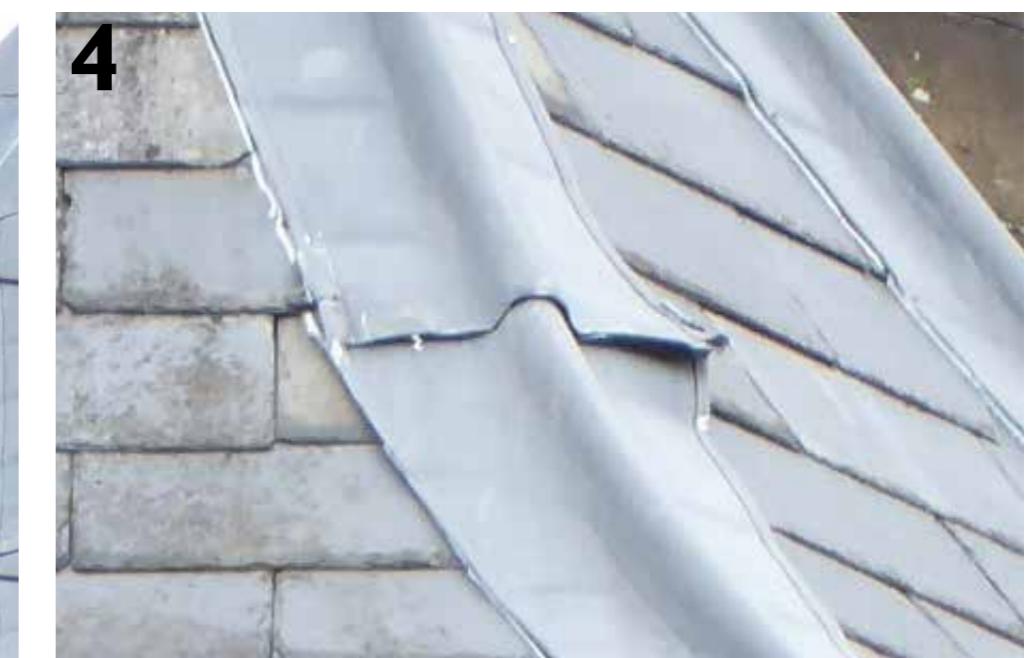
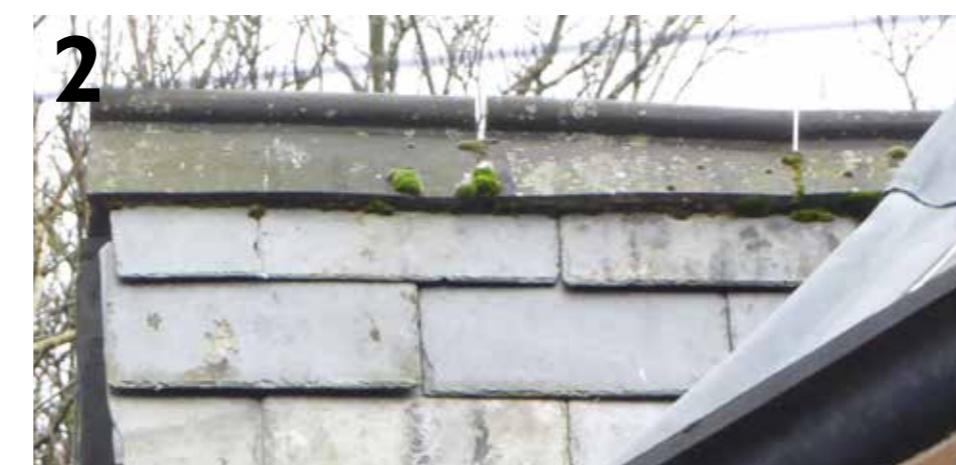
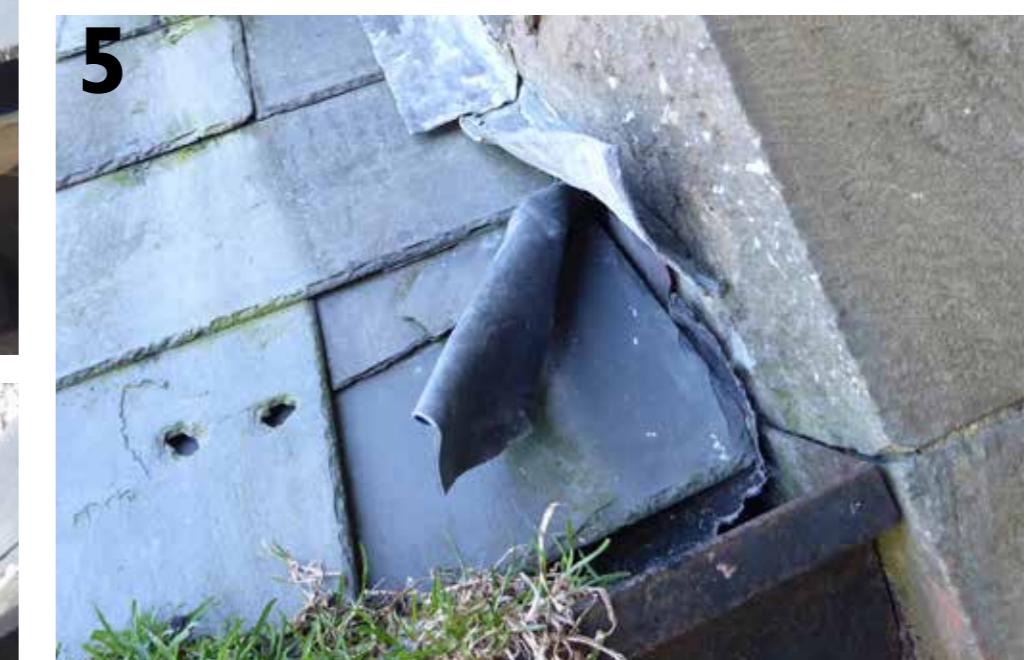
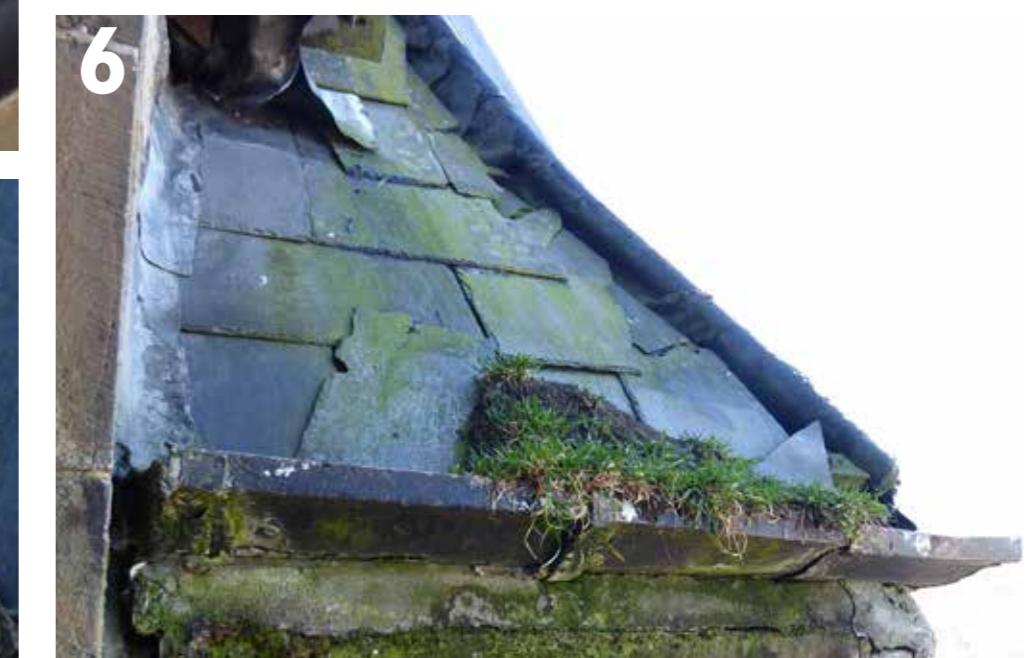
Examples of Condition Issues with the Roof  
(with numbers referring to photographs)

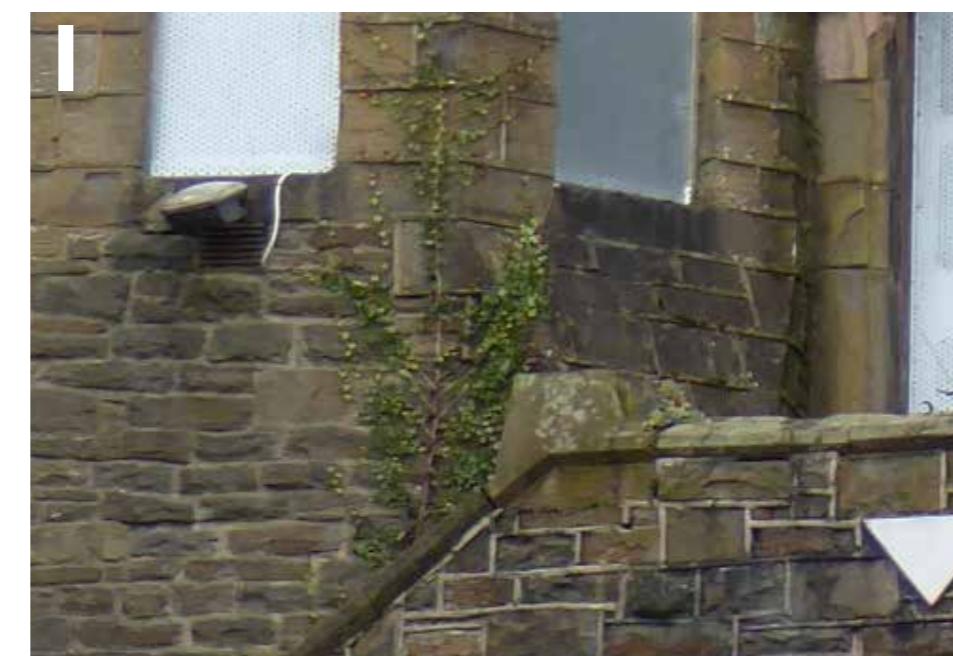
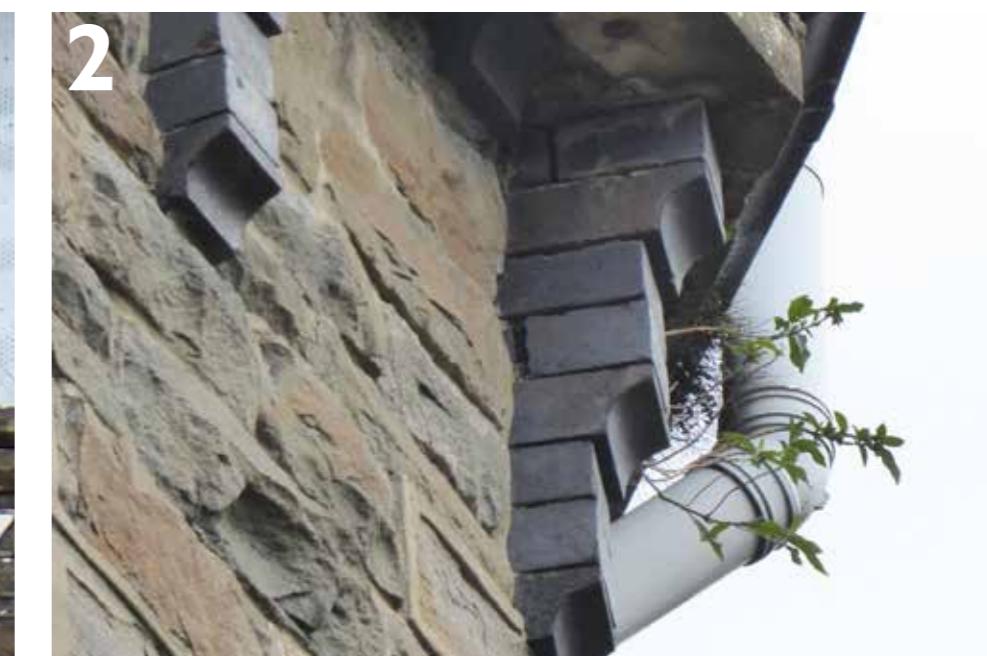
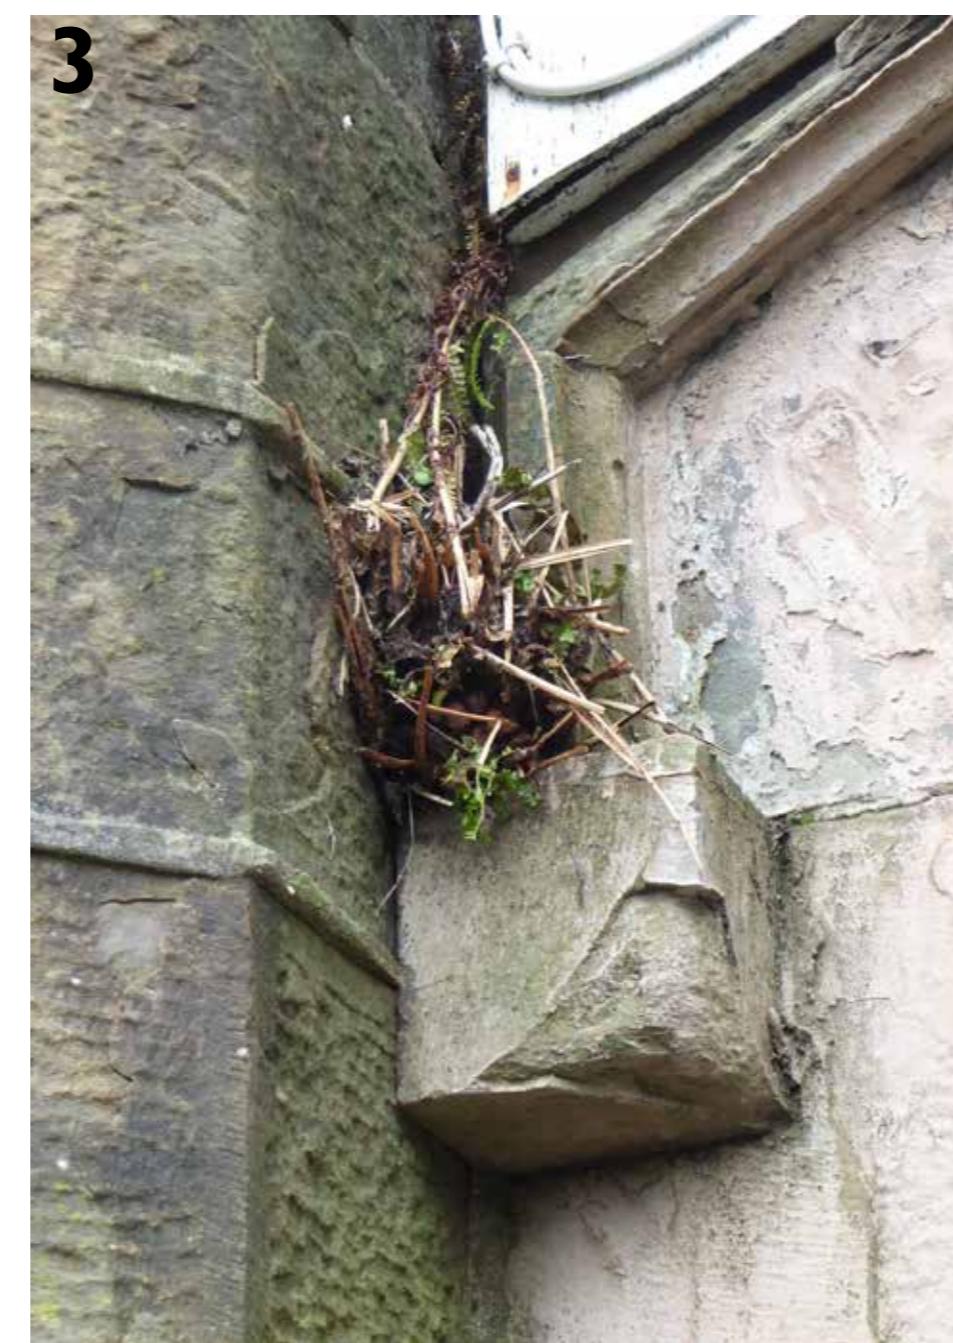
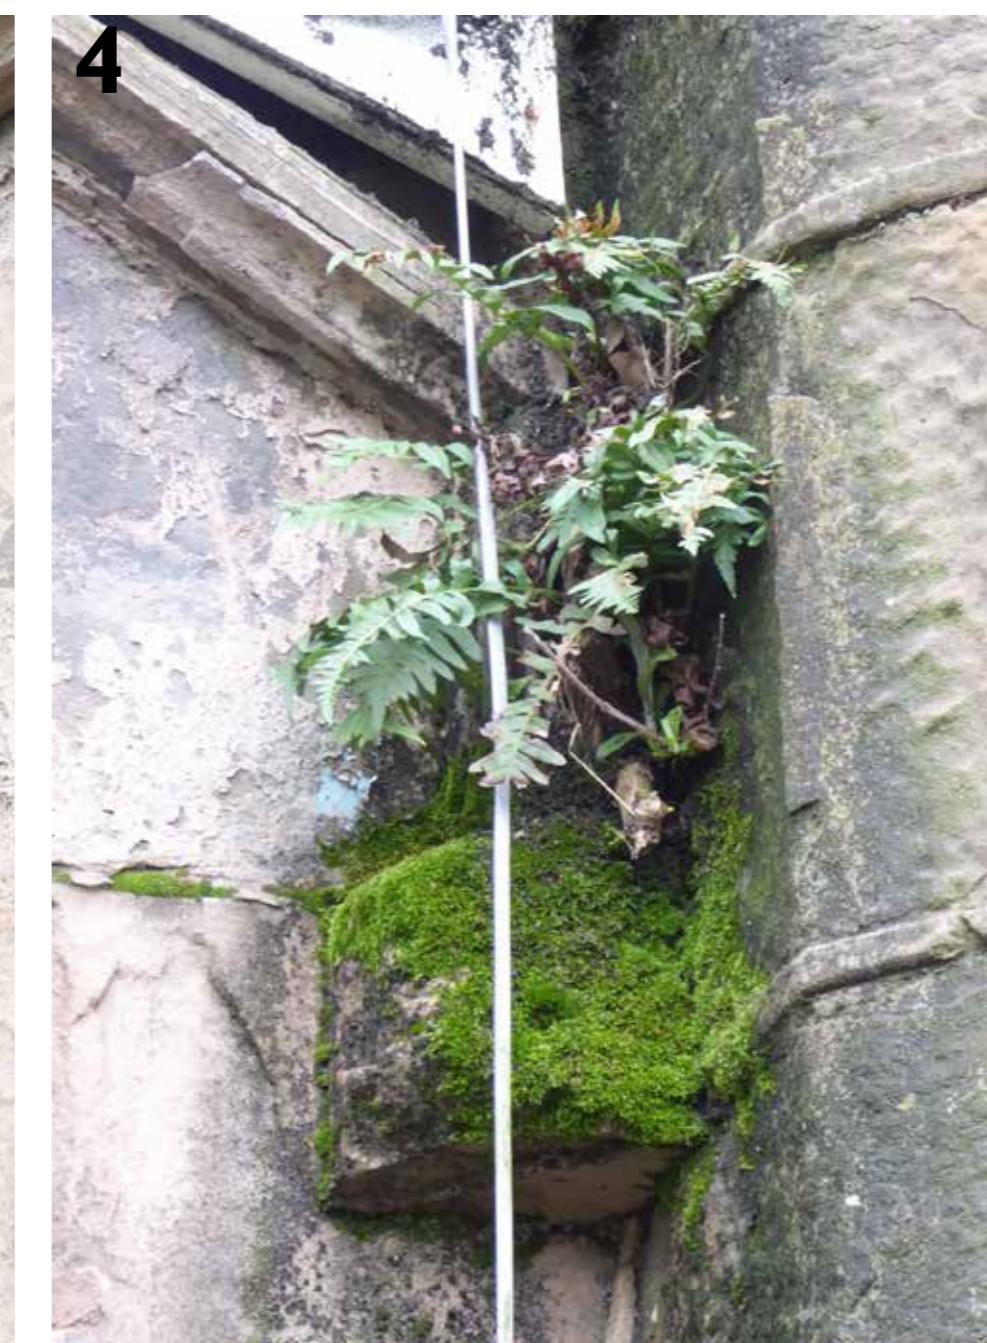
Examples of Condition Issues with Vegetation  
(with numbers referring to photographs)

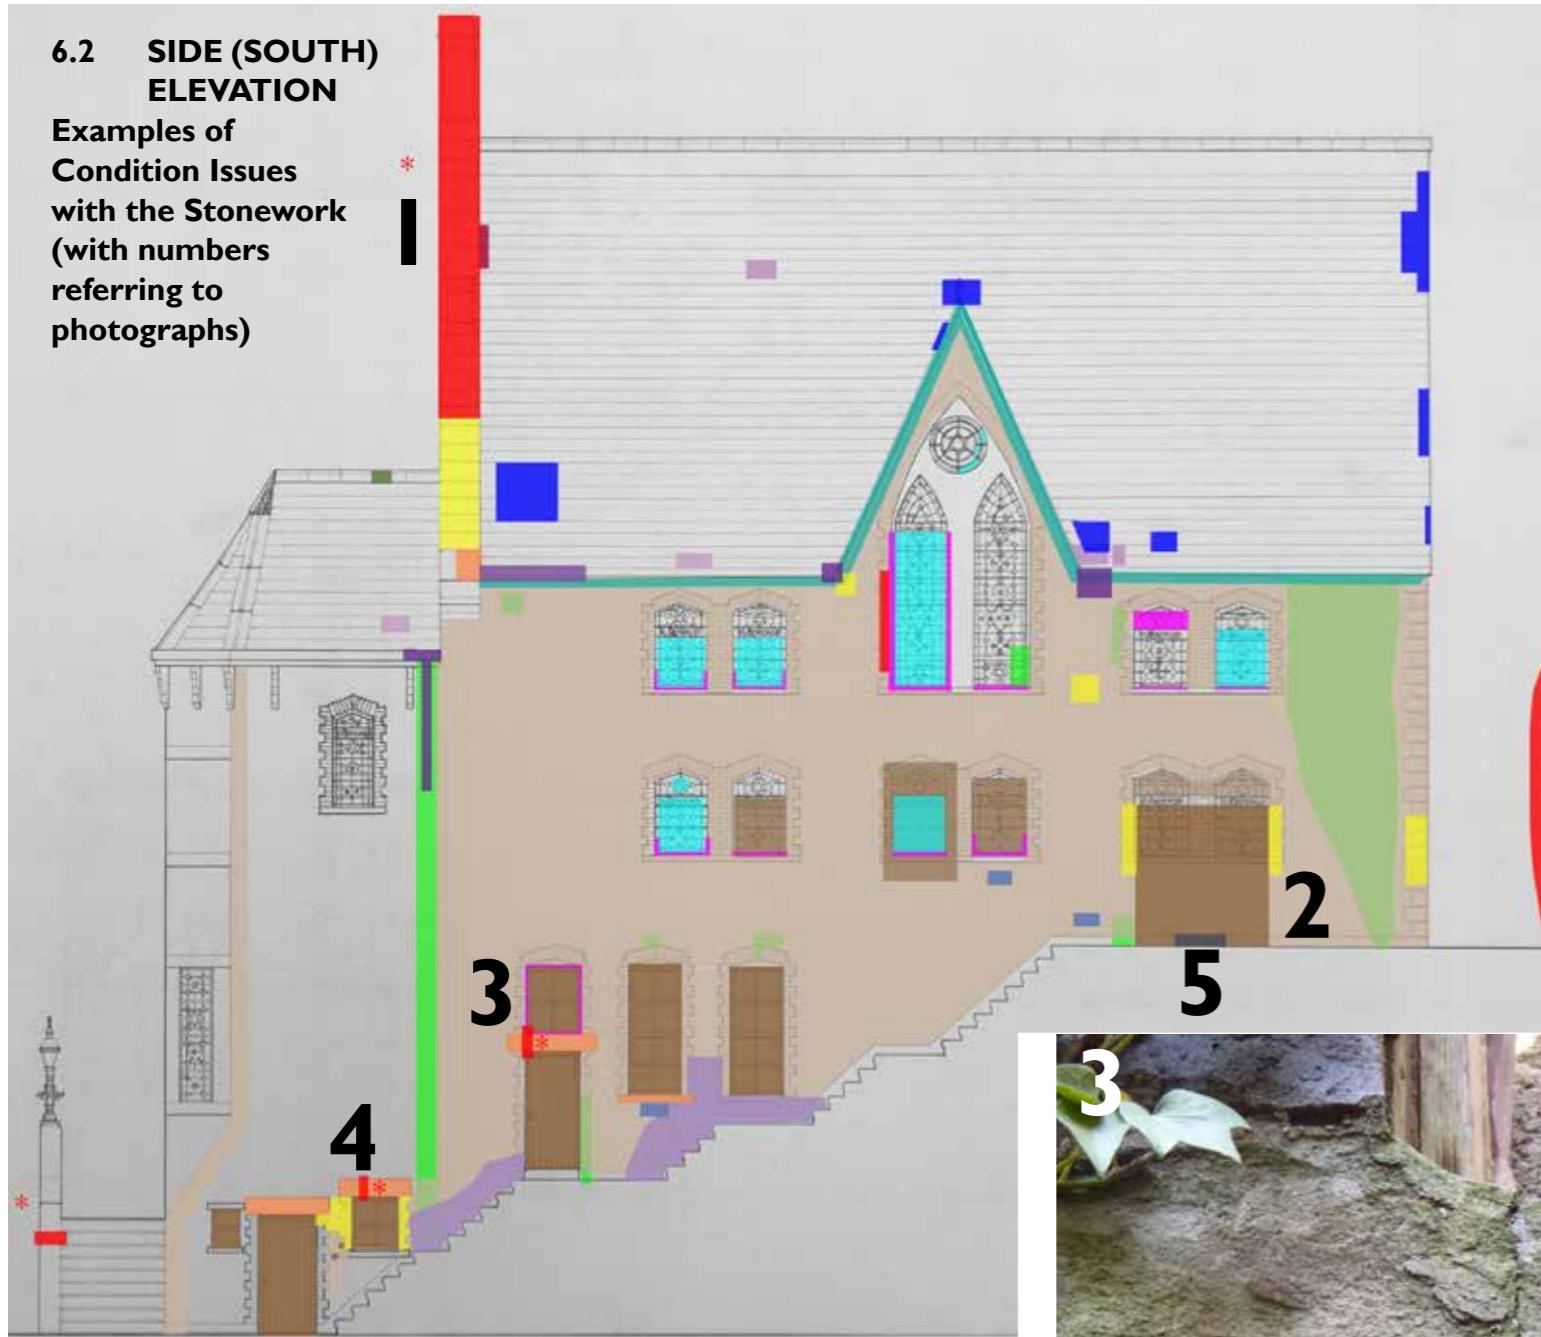
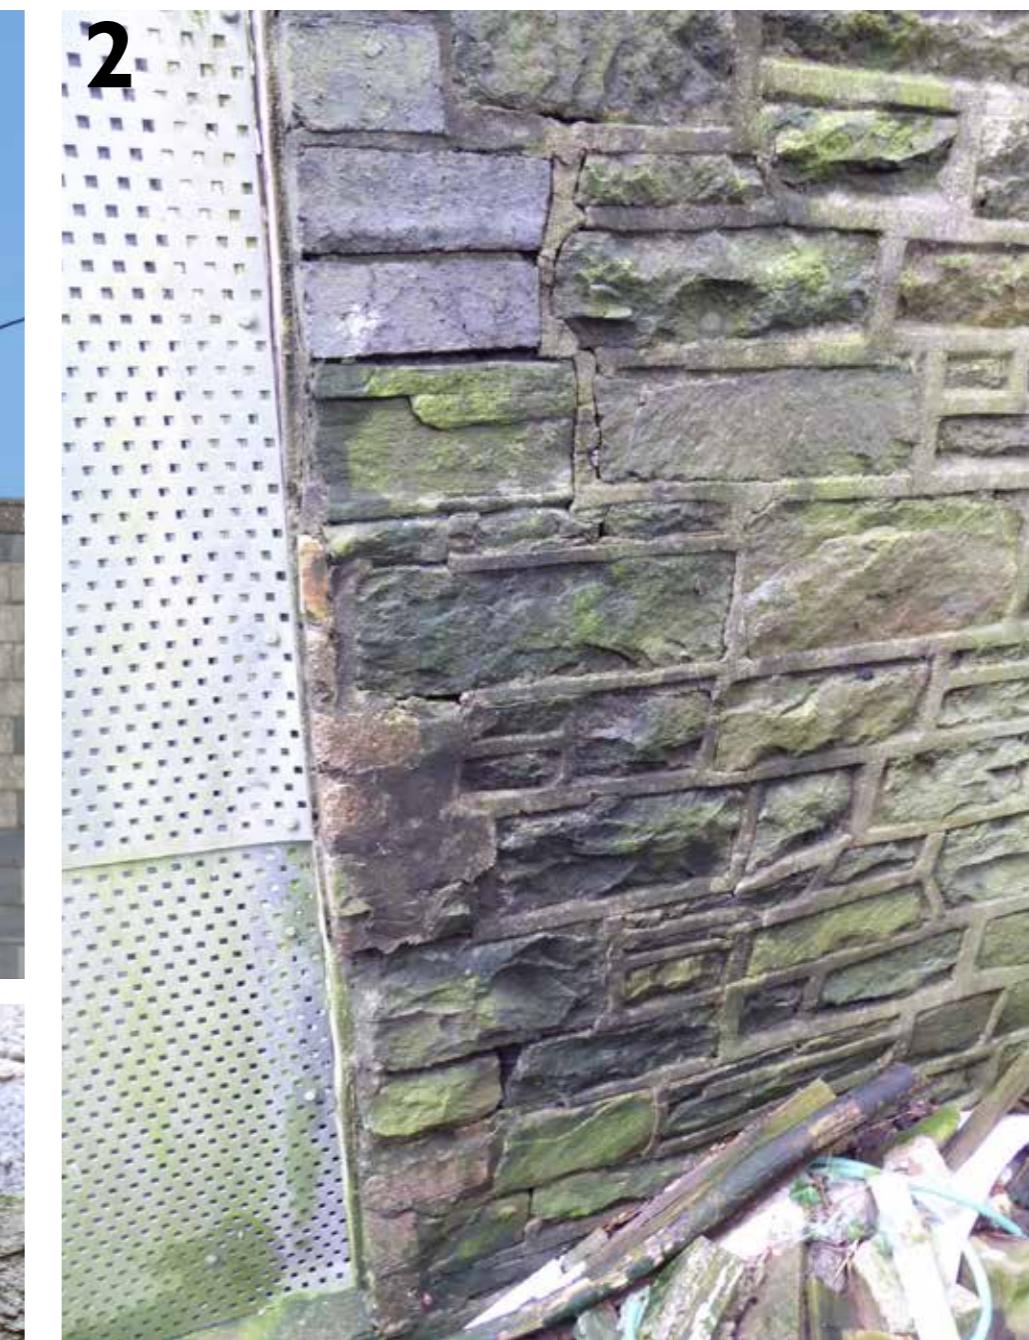
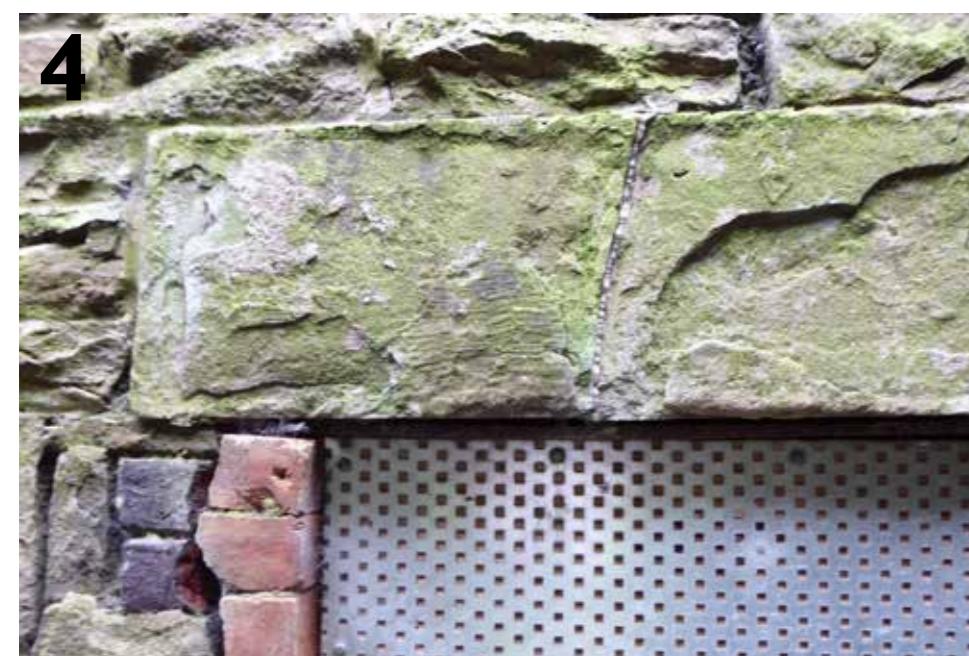
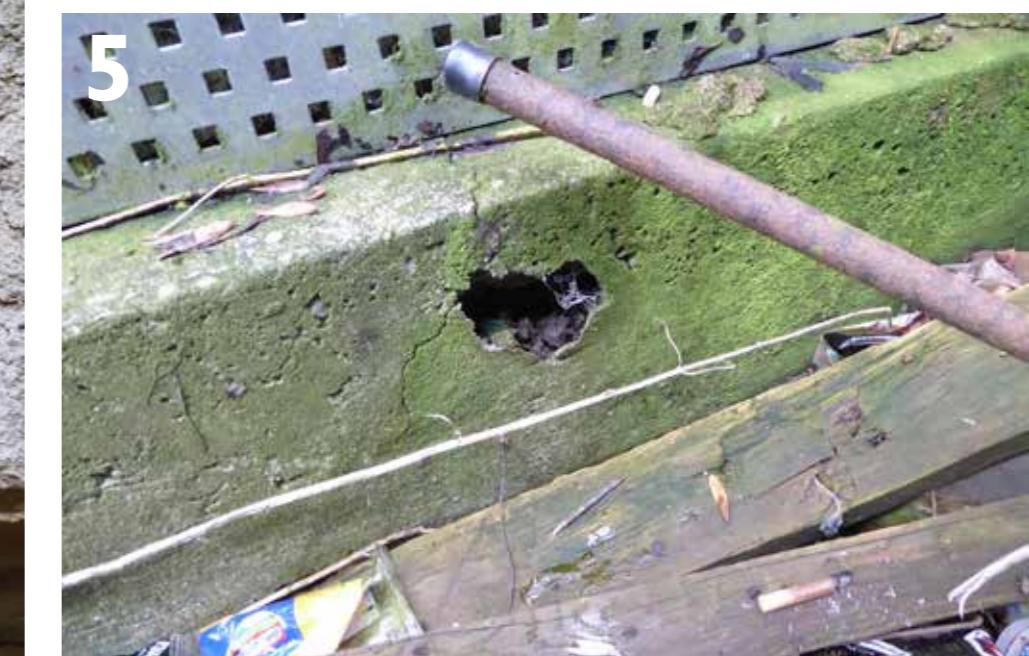
Examples of Condition Issues with the Stonework (with numbers referring to photographs)
