# Synagogue, Merthyr Tydfil

## RECORD OF BUILDING AND CONDITION ASSESSMENT REPORT

.....  
(449)2503-GVVP-A-HIS-P00

Date: 17.03.25

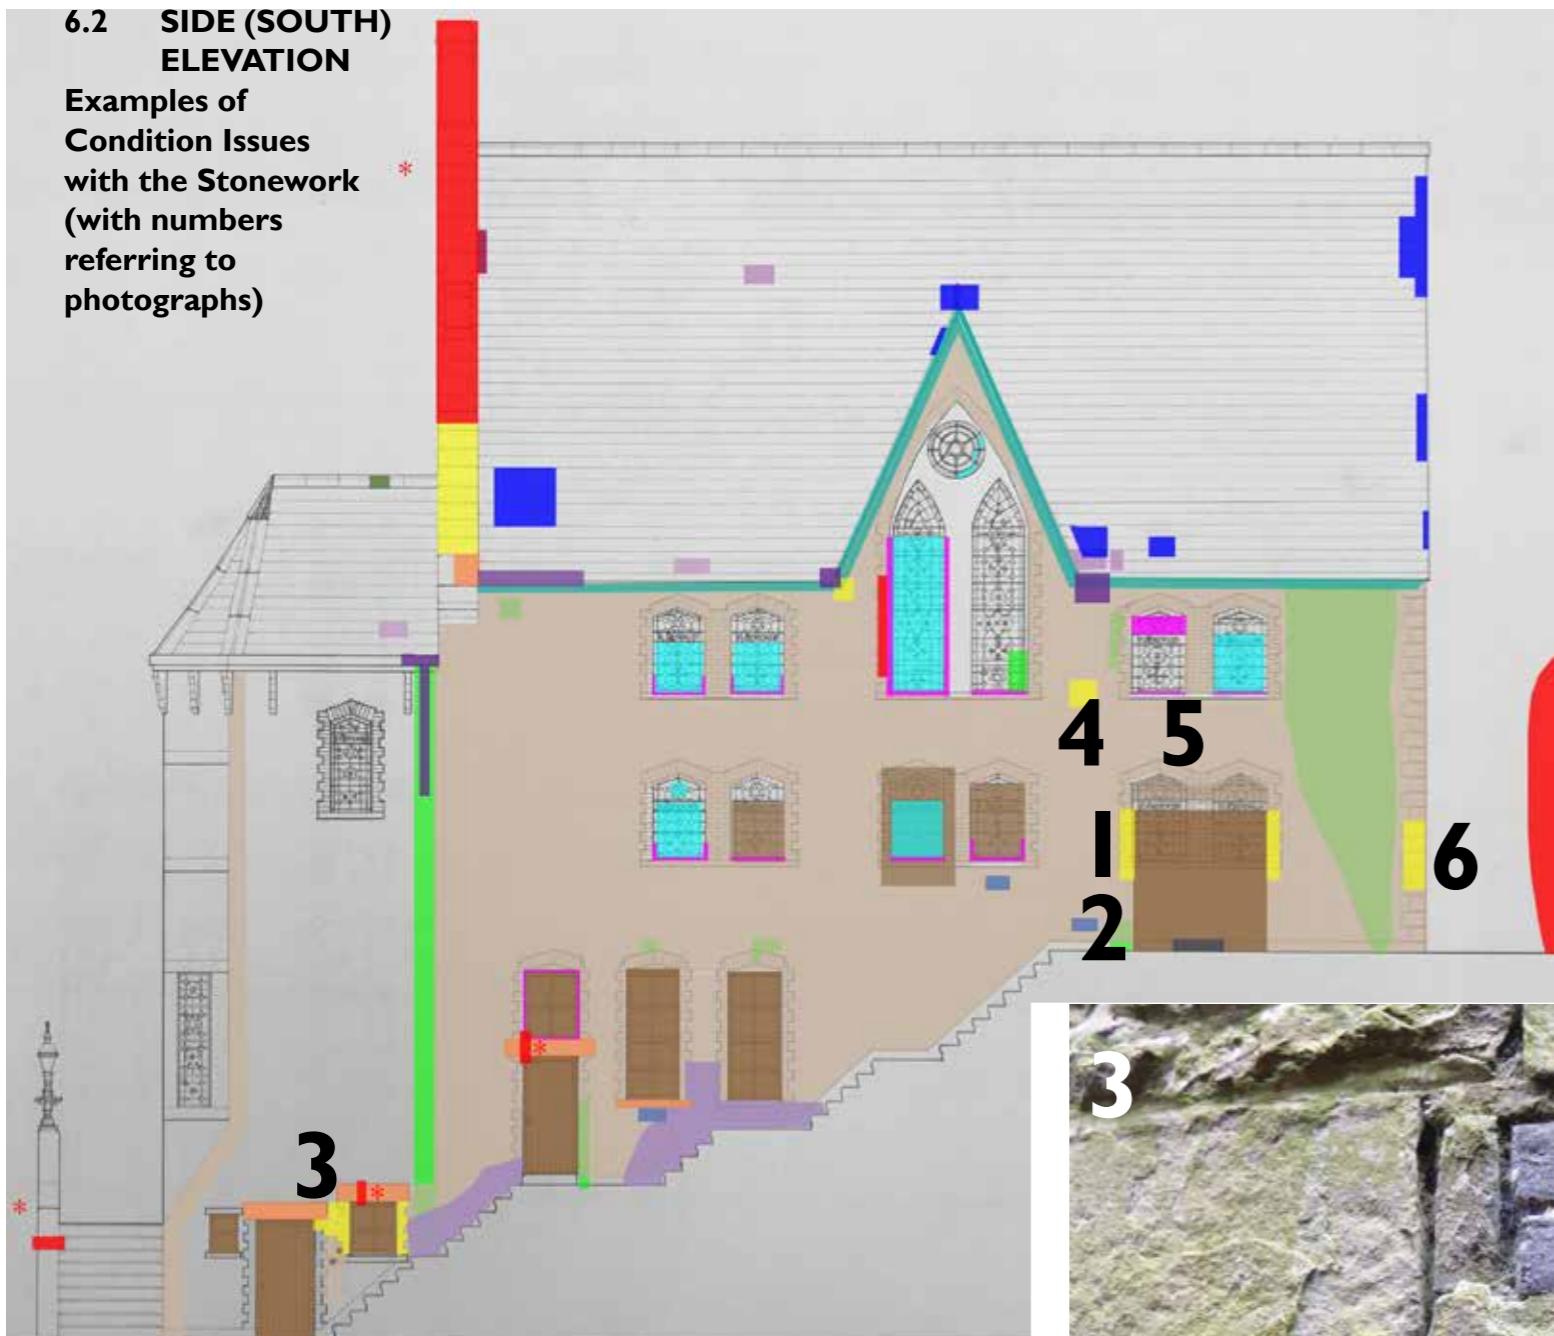
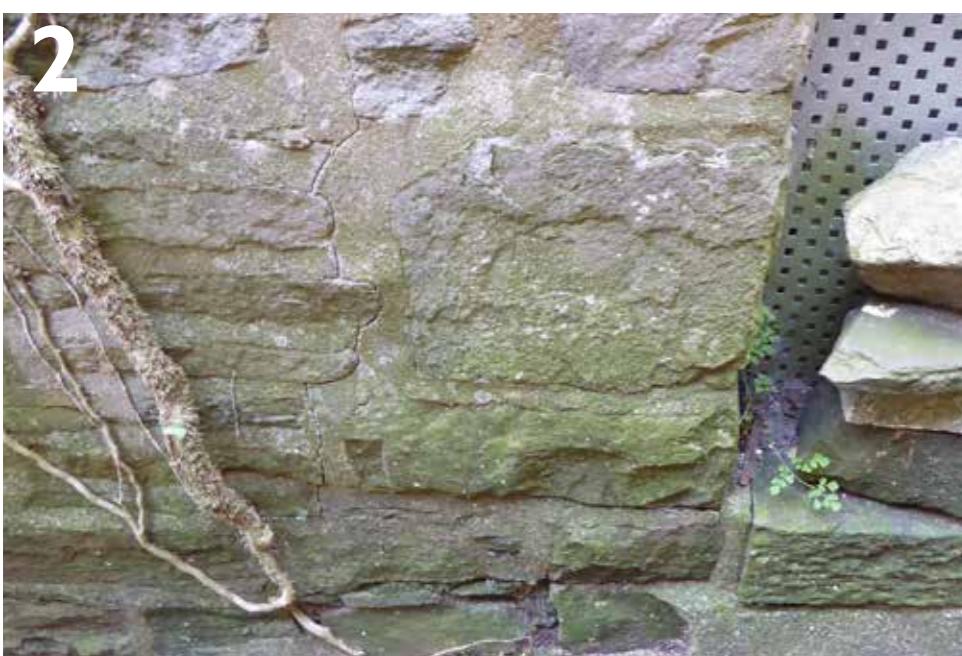
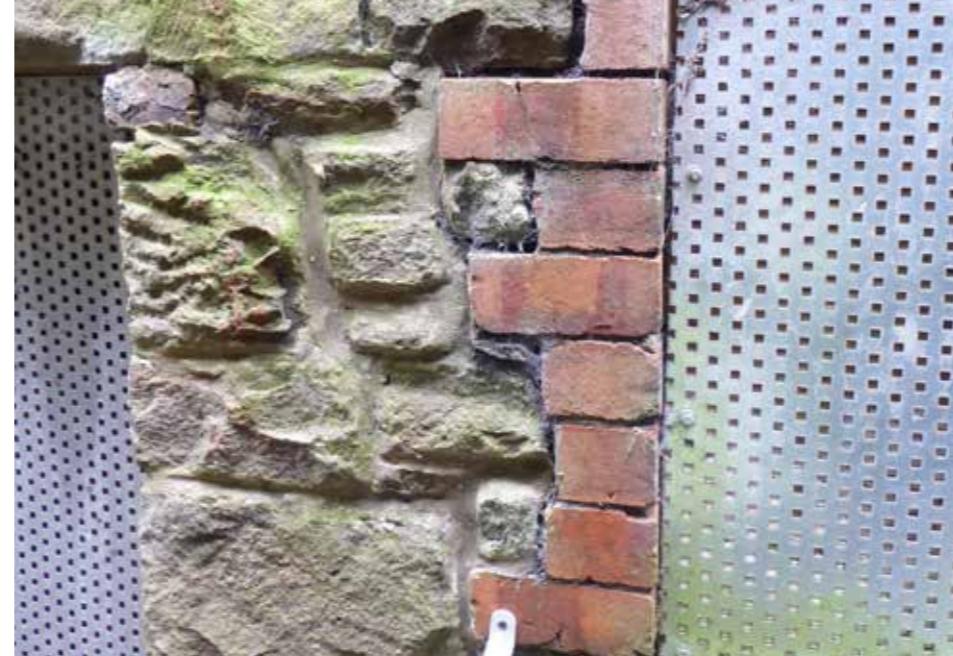
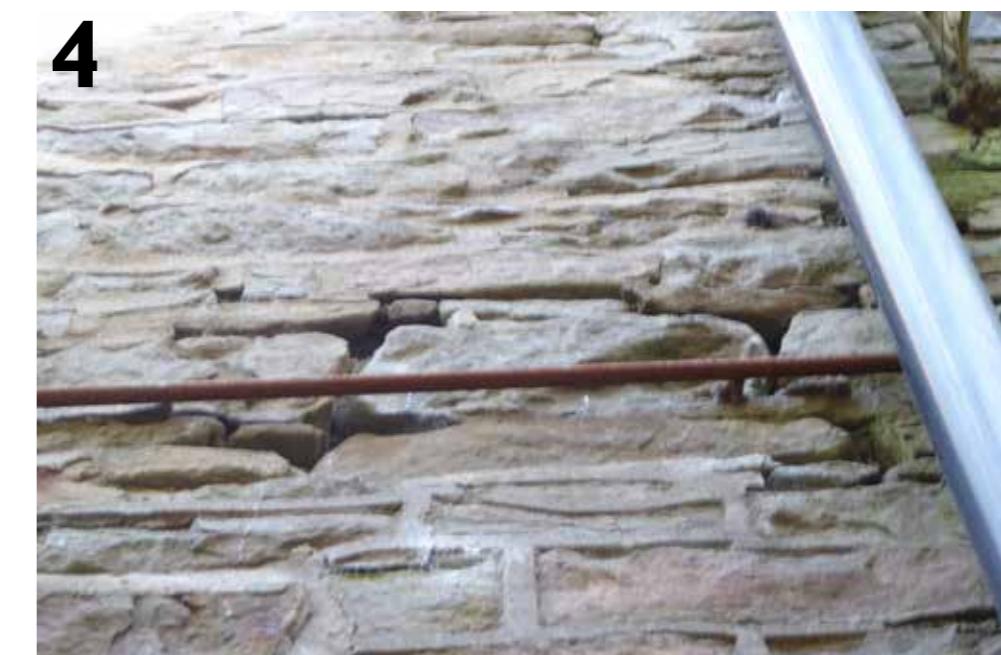
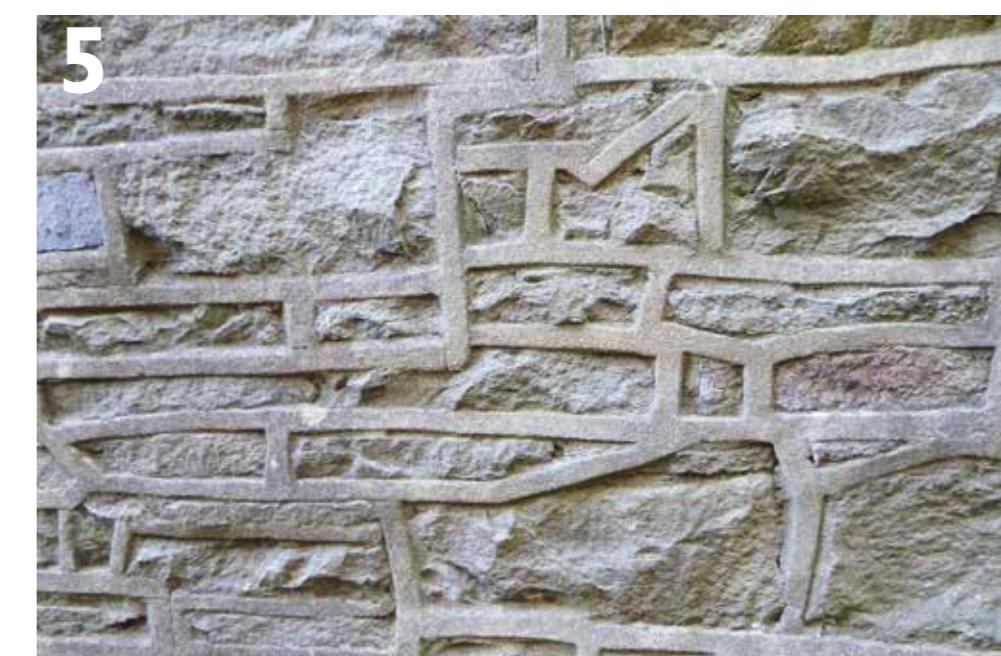
Examples of Condition Issues with the Stonework (with numbers referring to photographs)

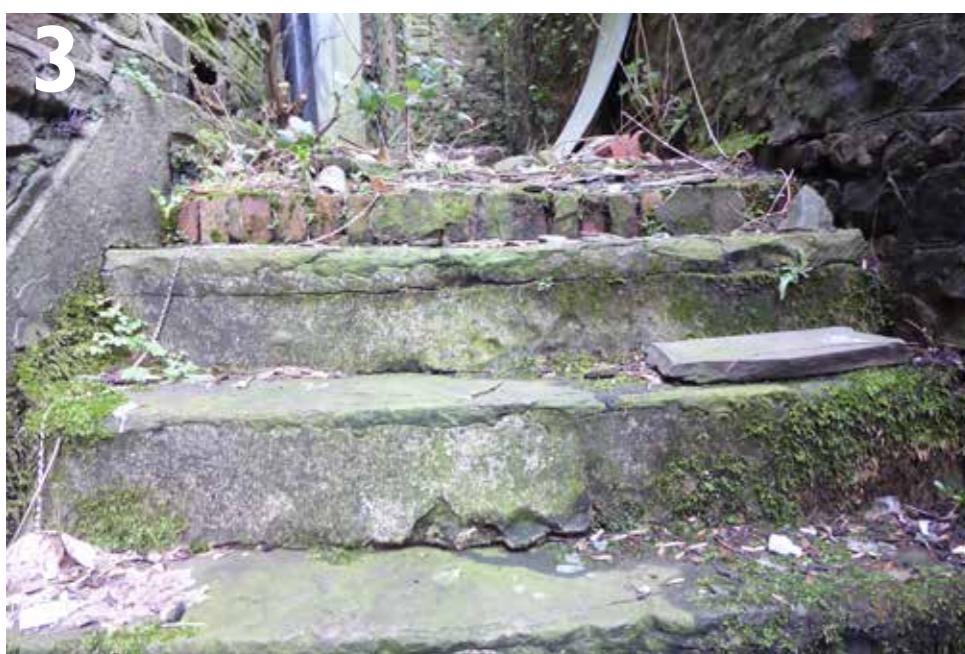
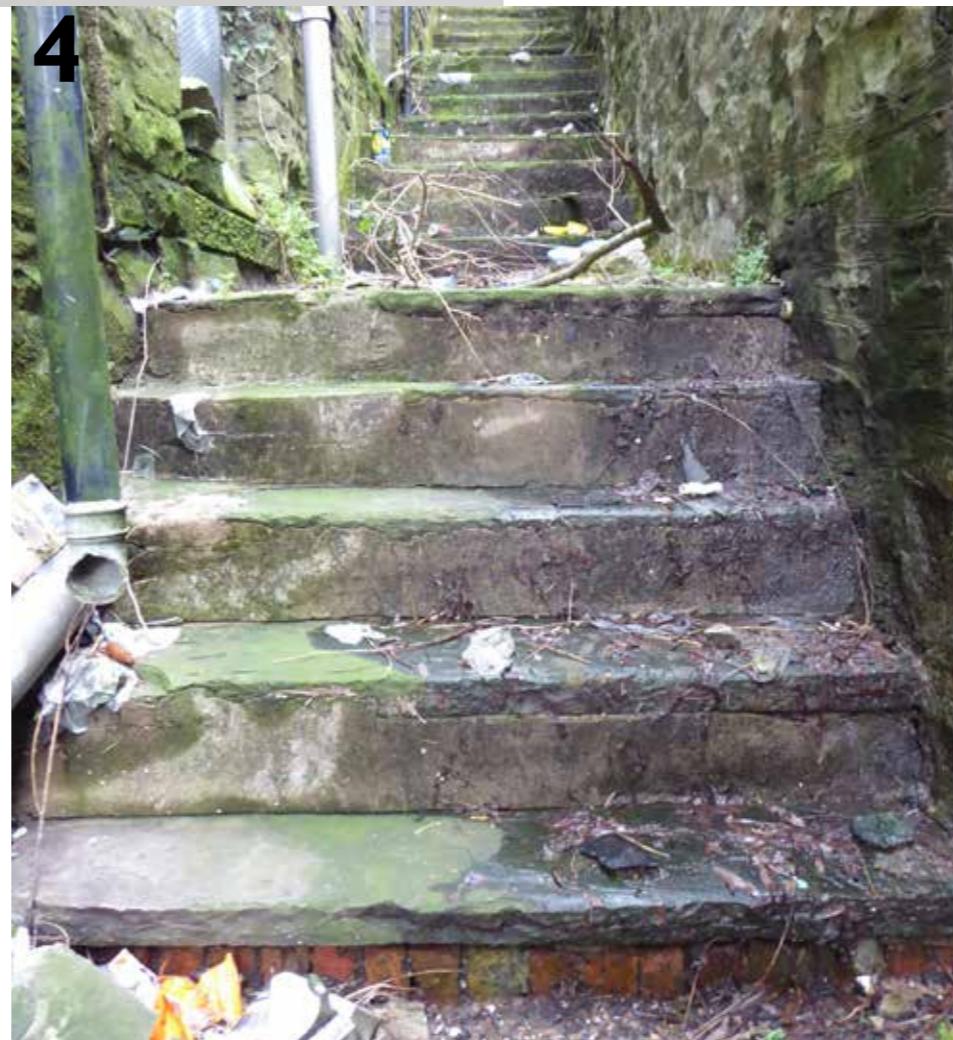
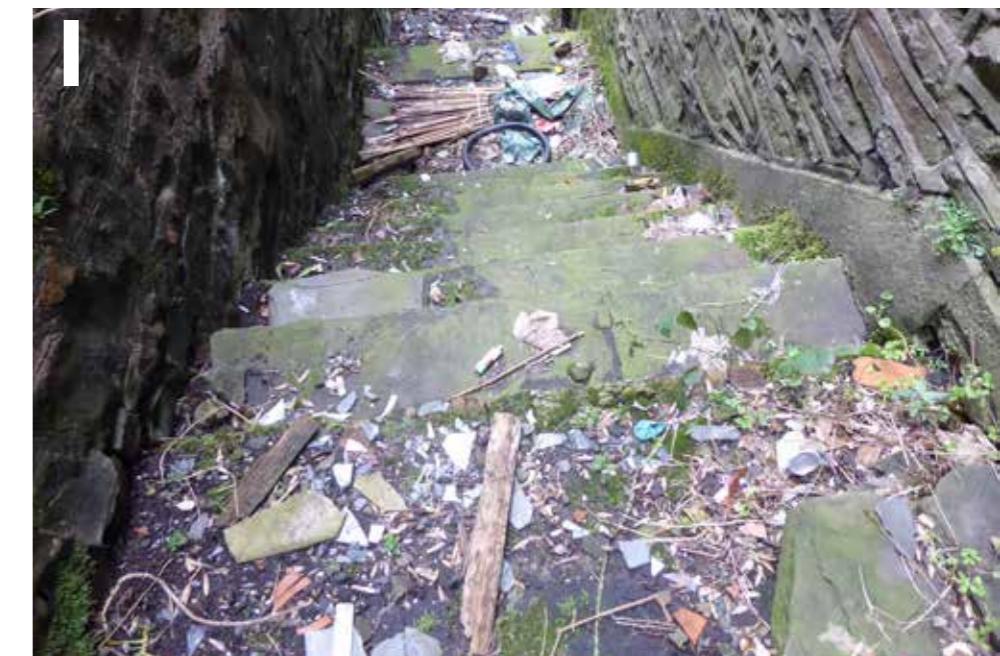
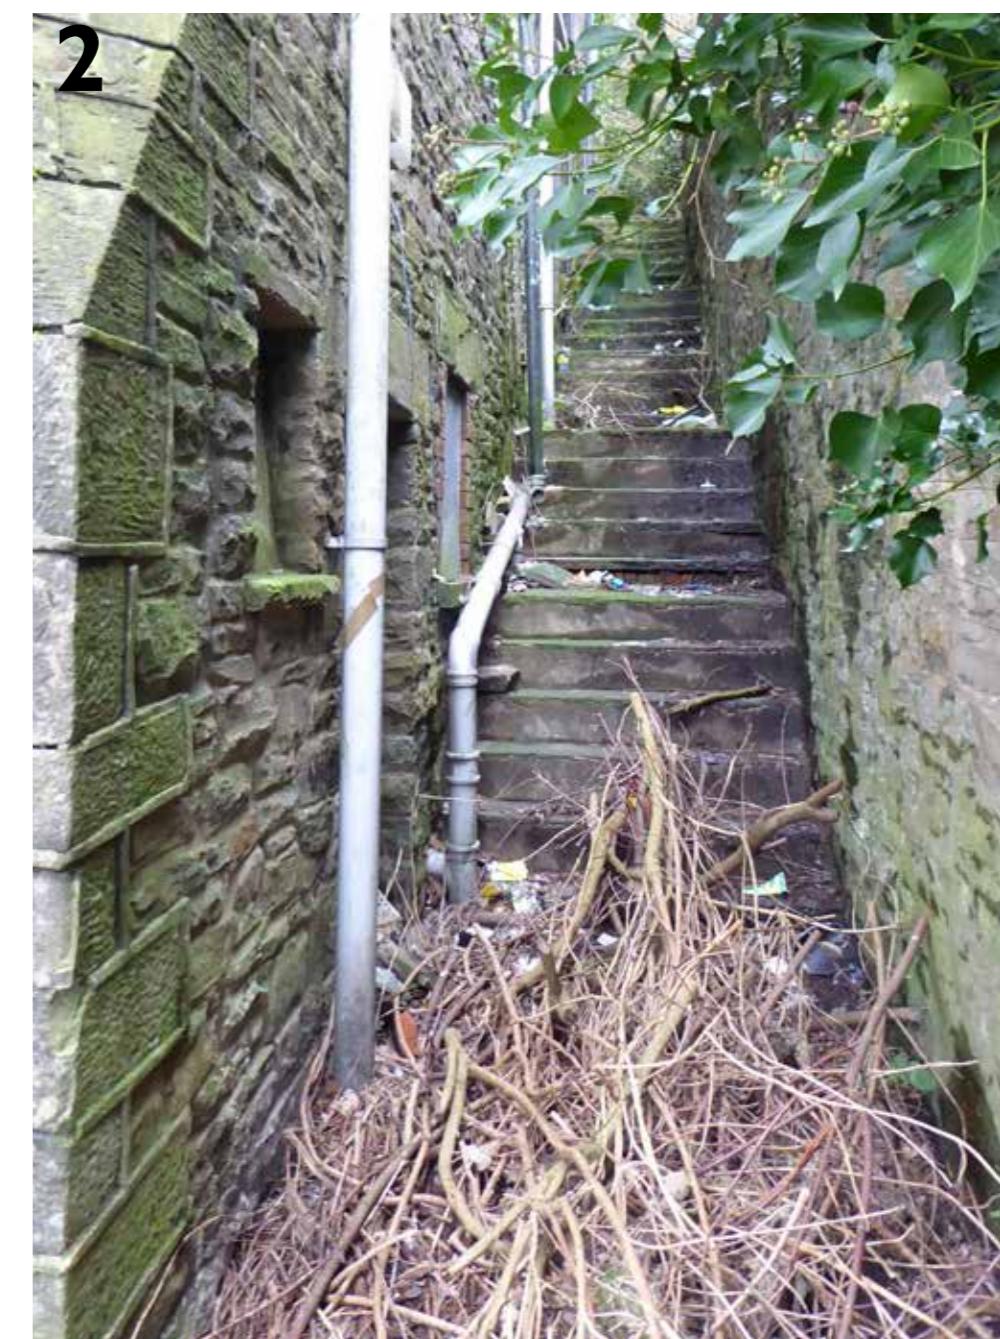
Examples of Condition Issues with the Stonework (with numbers referring to photographs)

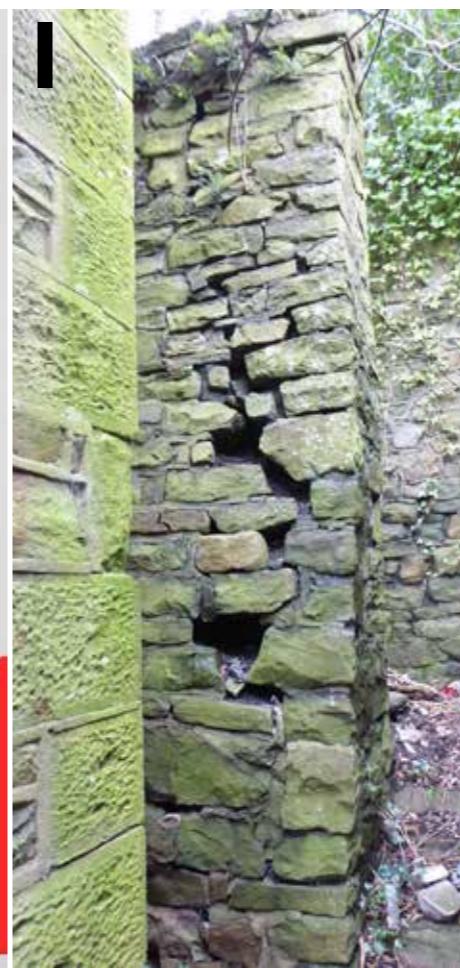
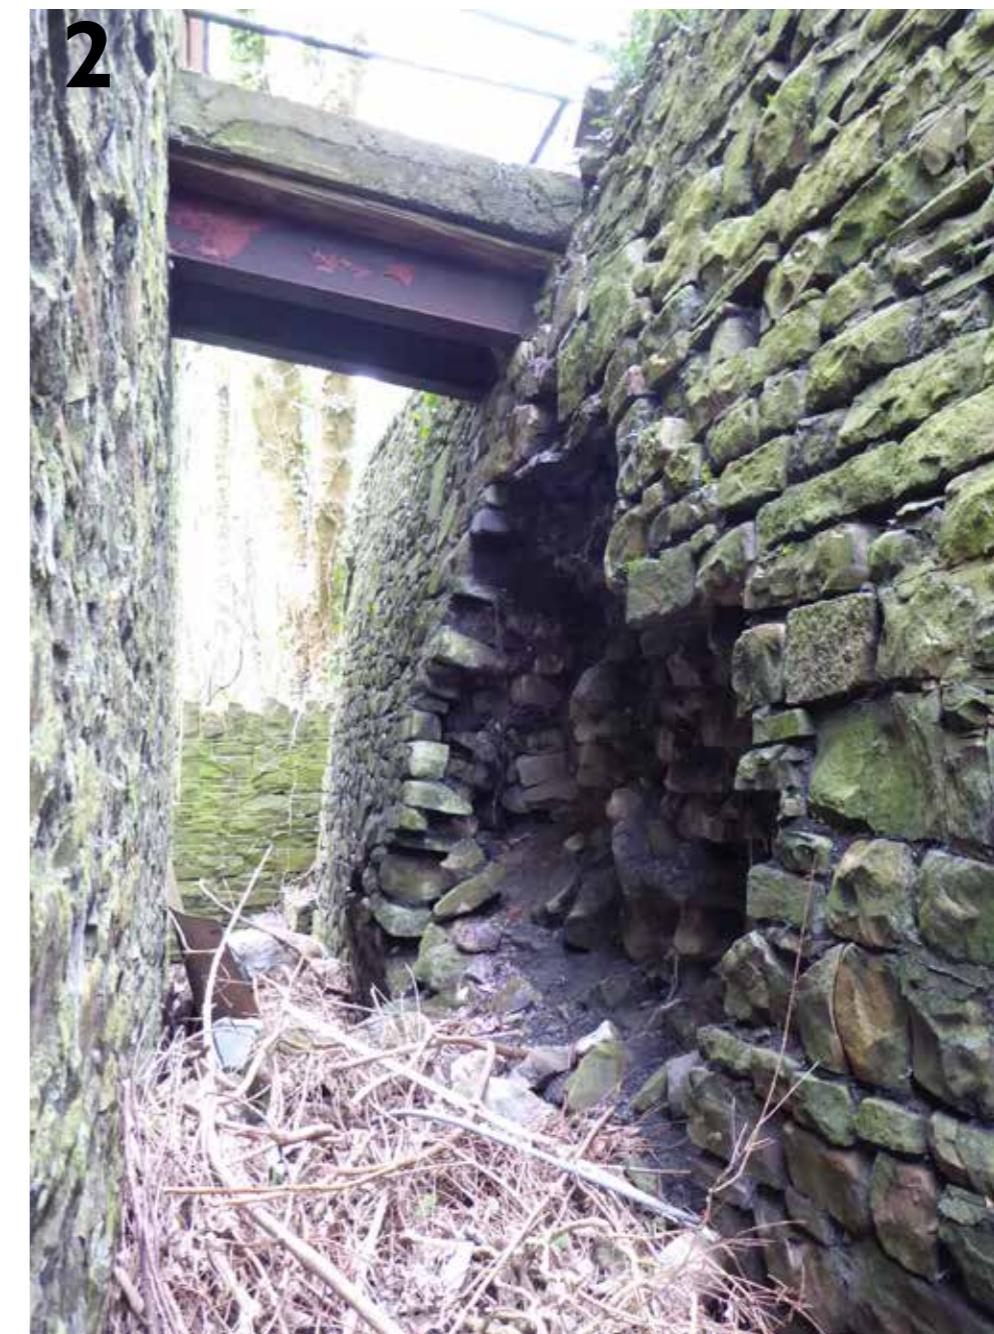
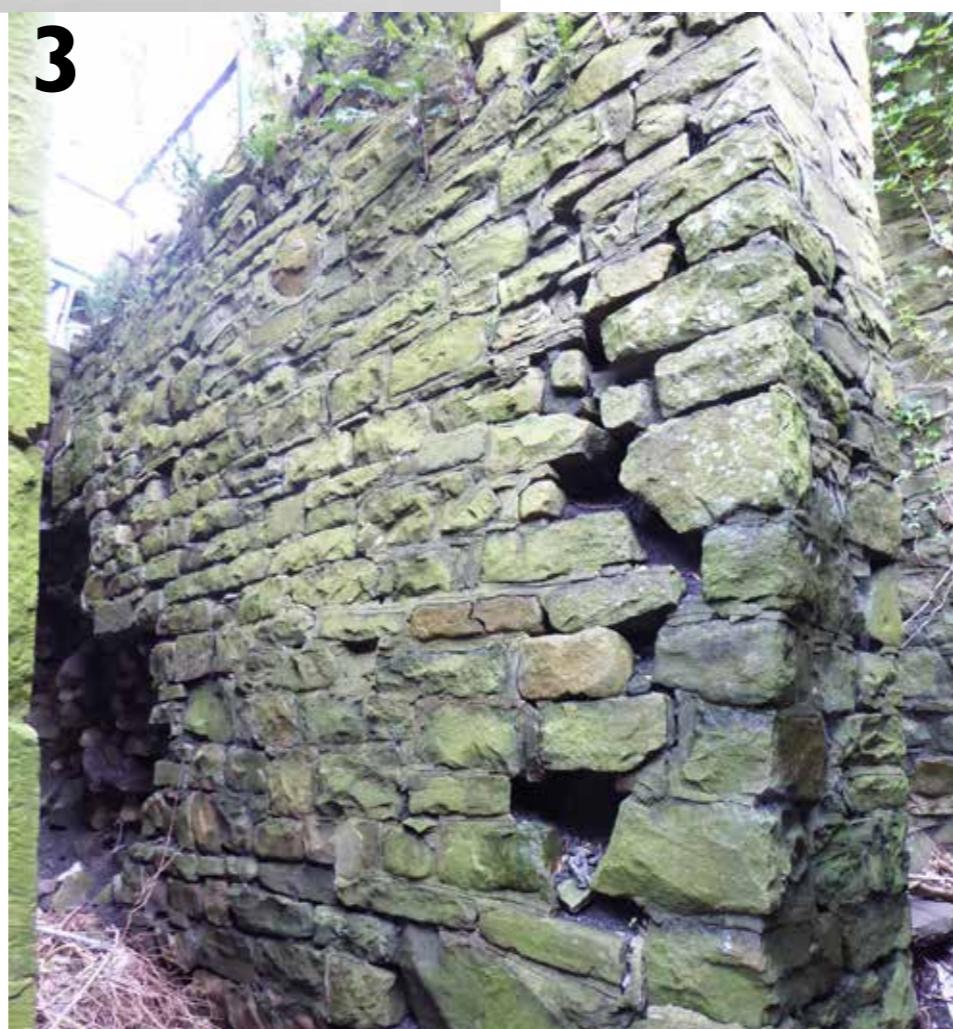
Examples of Condition  
Issues  
with the Stonework  
(with numbers referring  
to photographs)

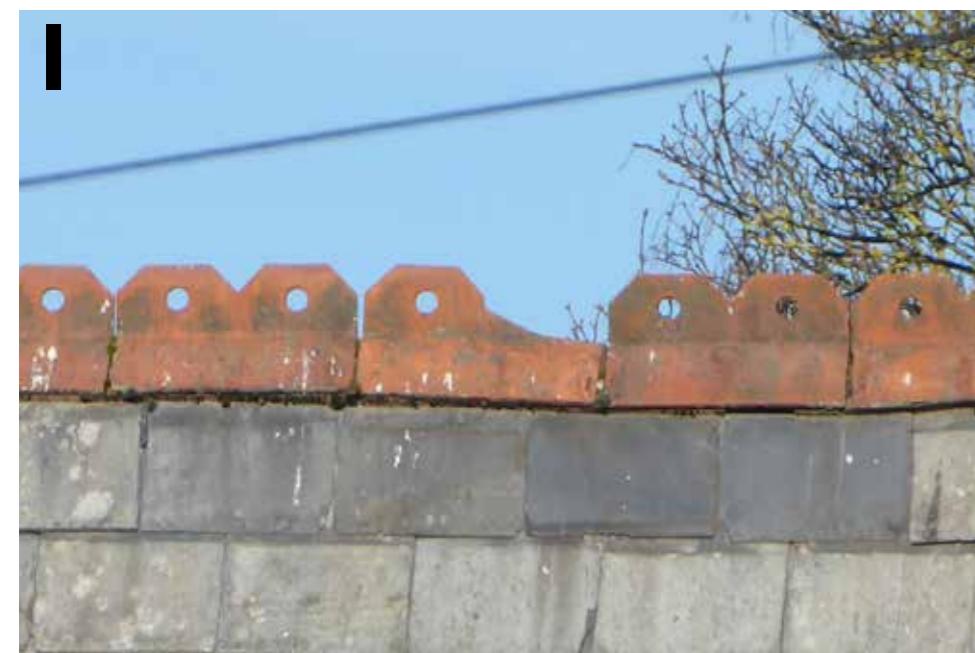
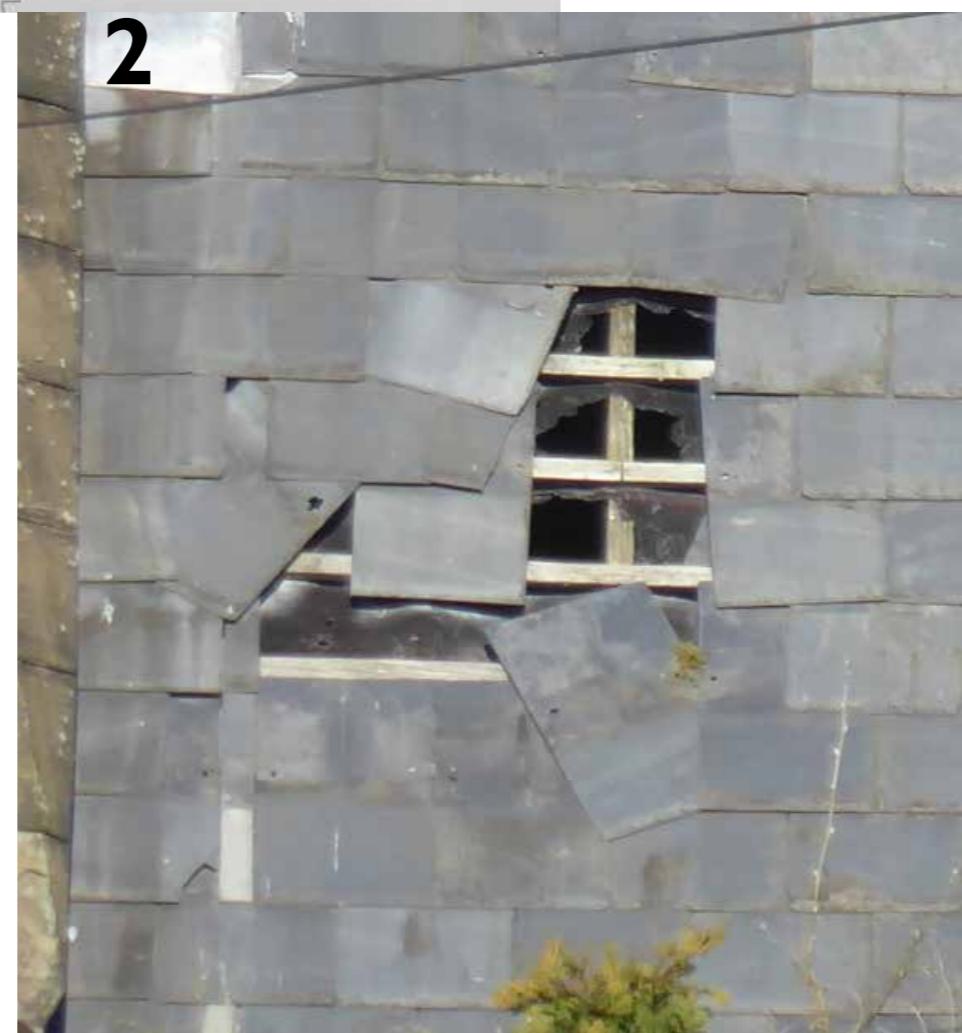
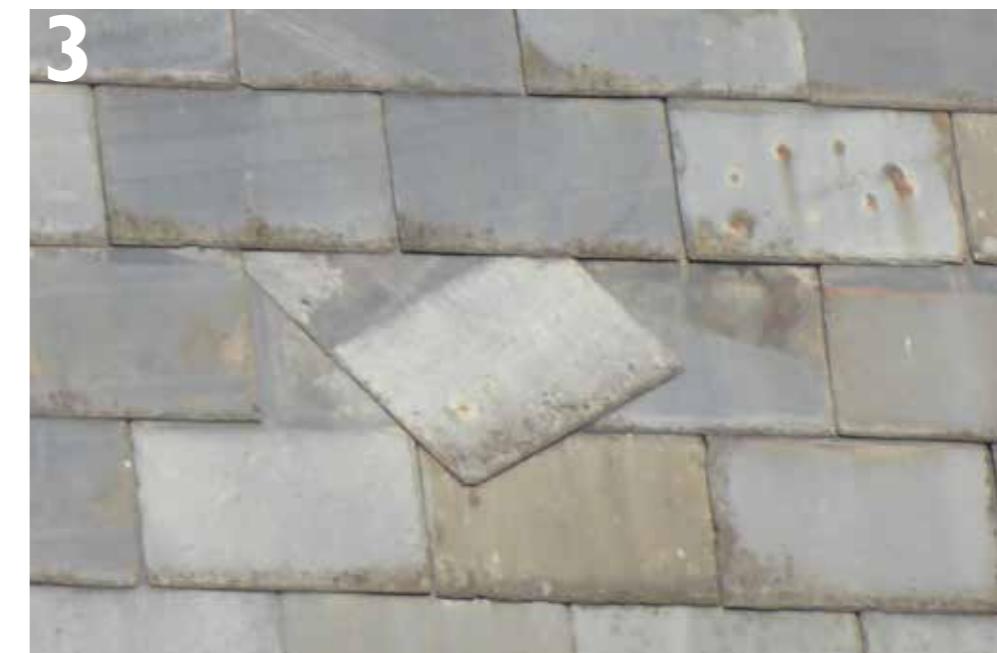
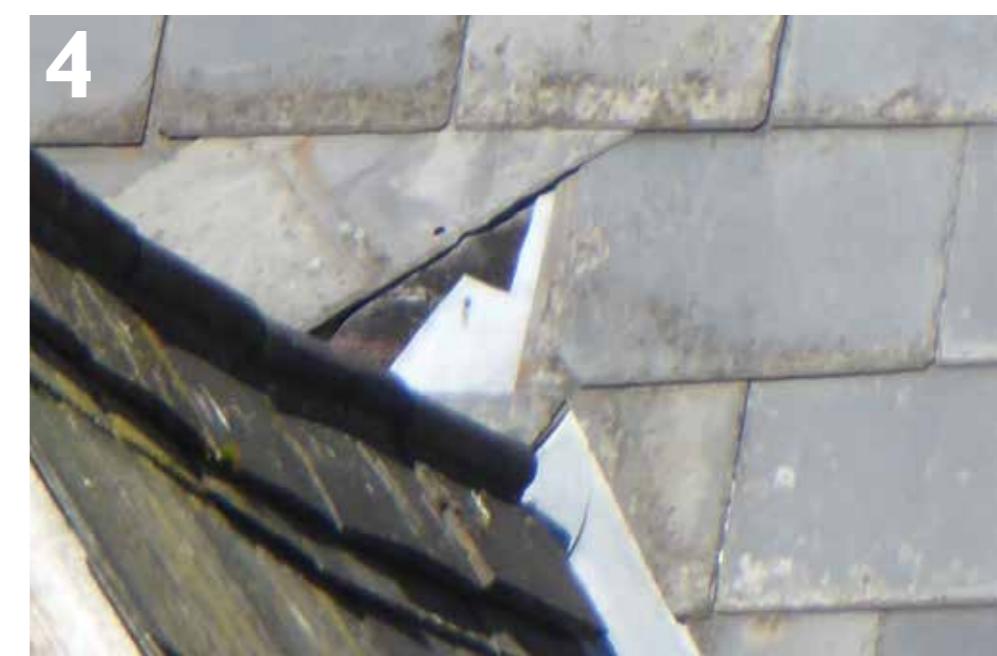
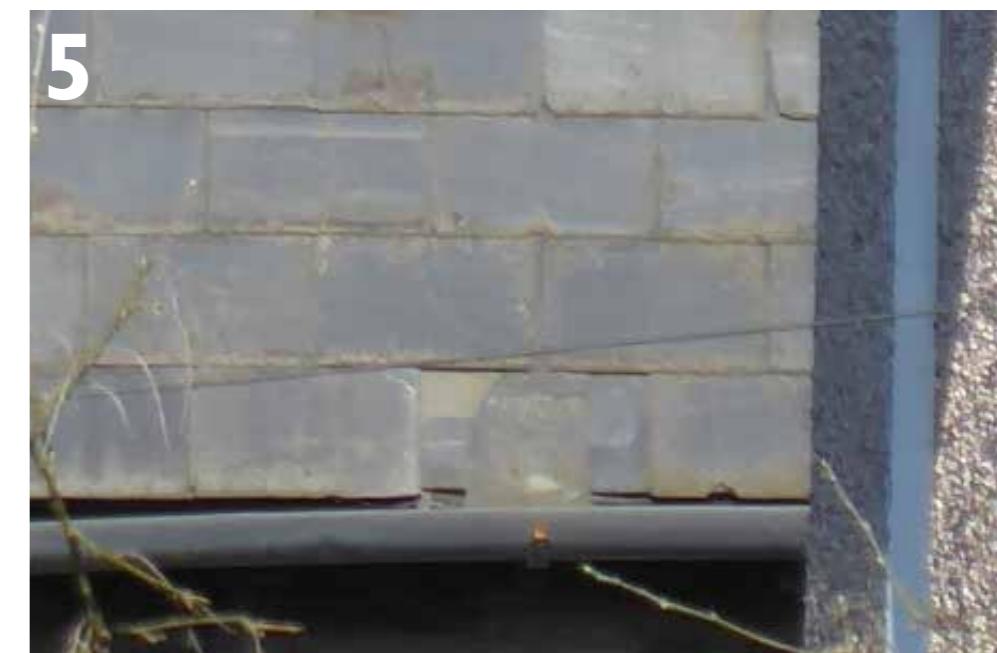
Examples of Condition Issues with the Roof (with numbers referring to photographs)

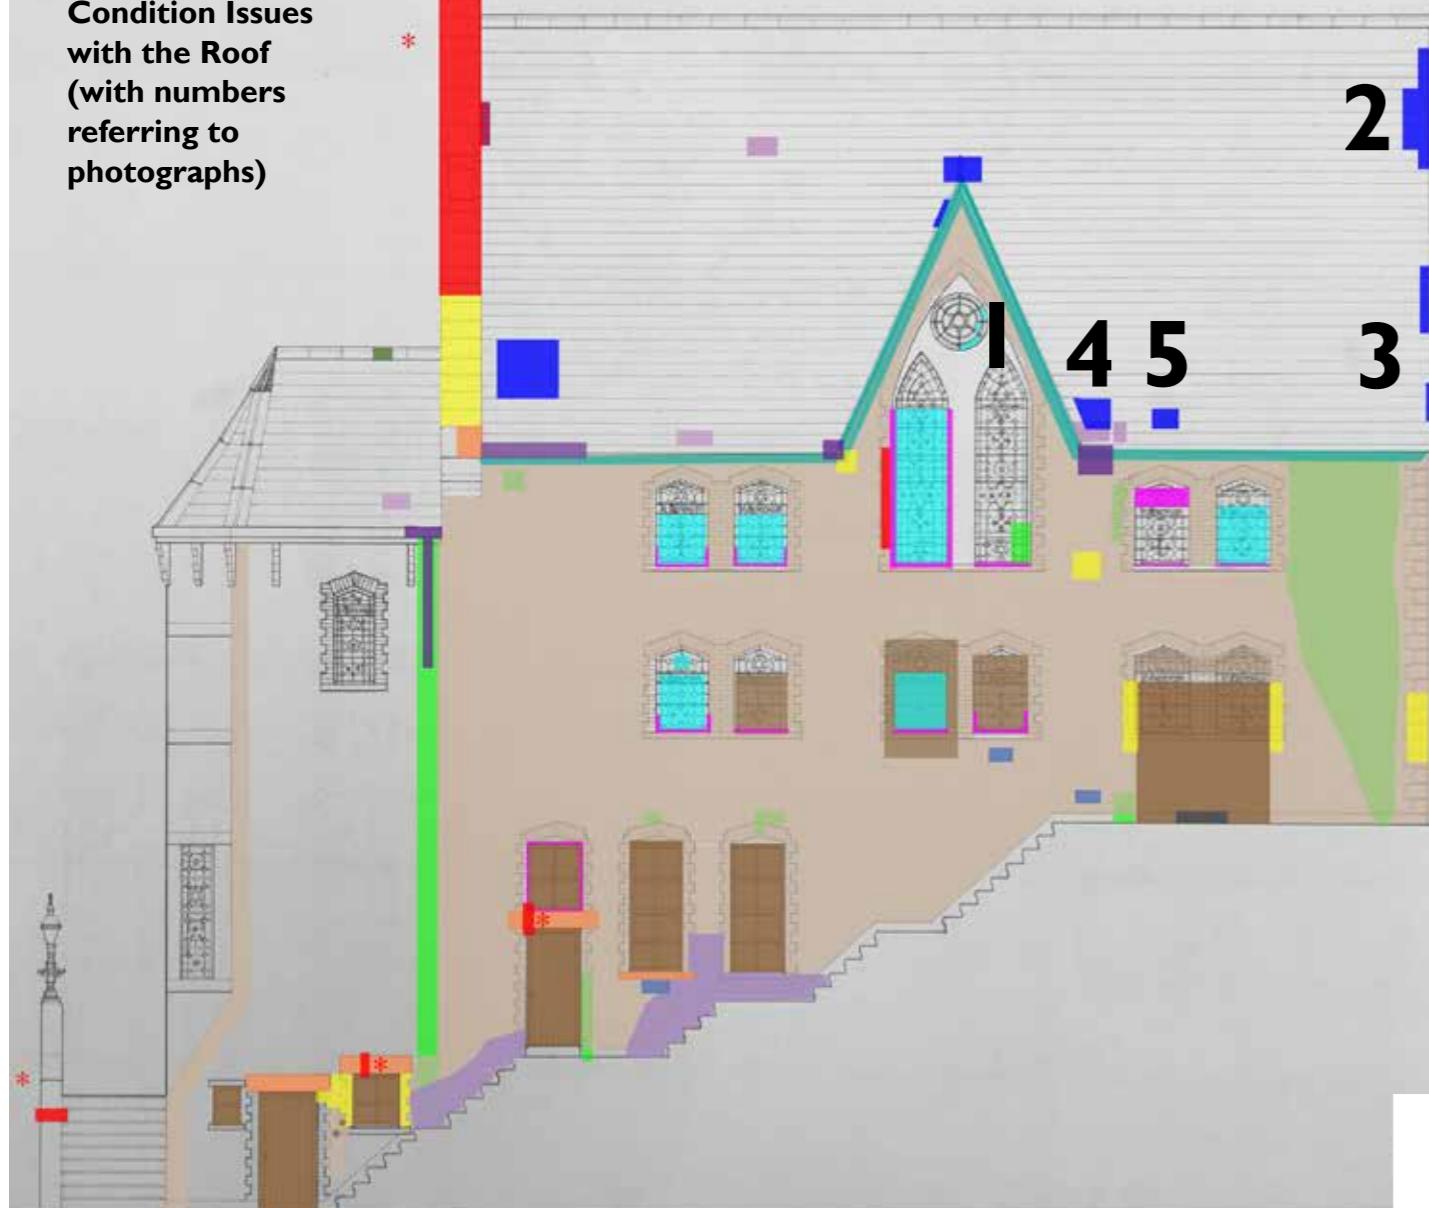
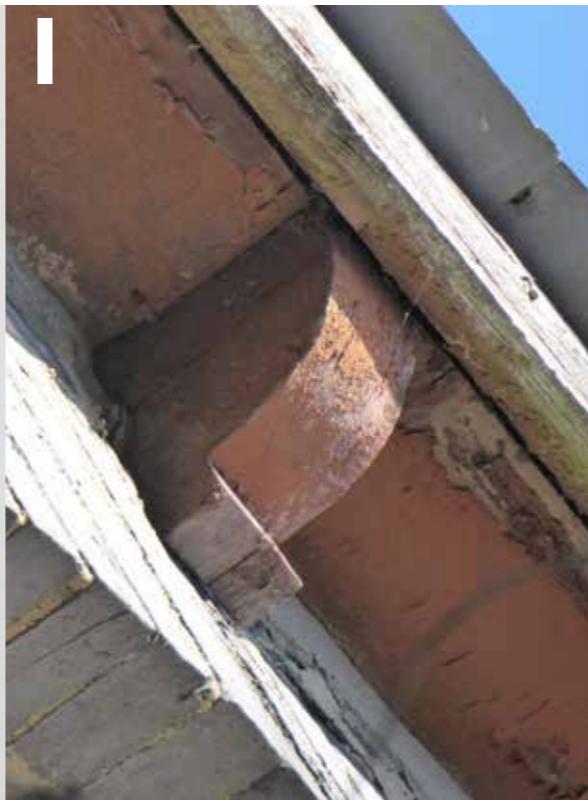
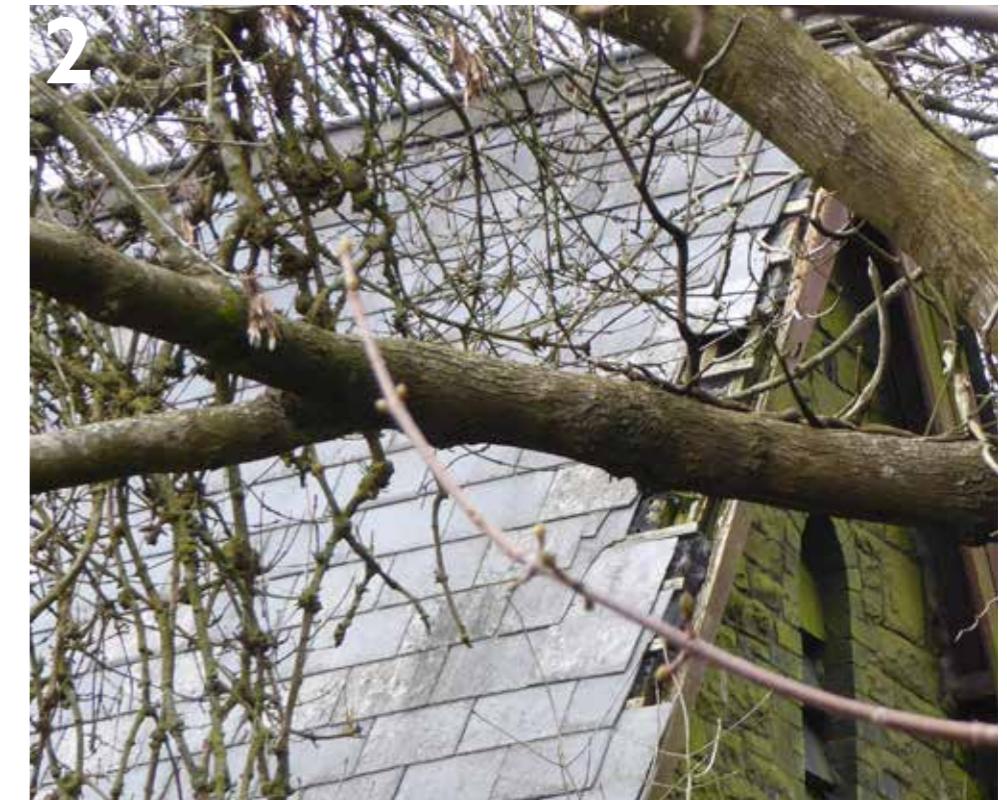
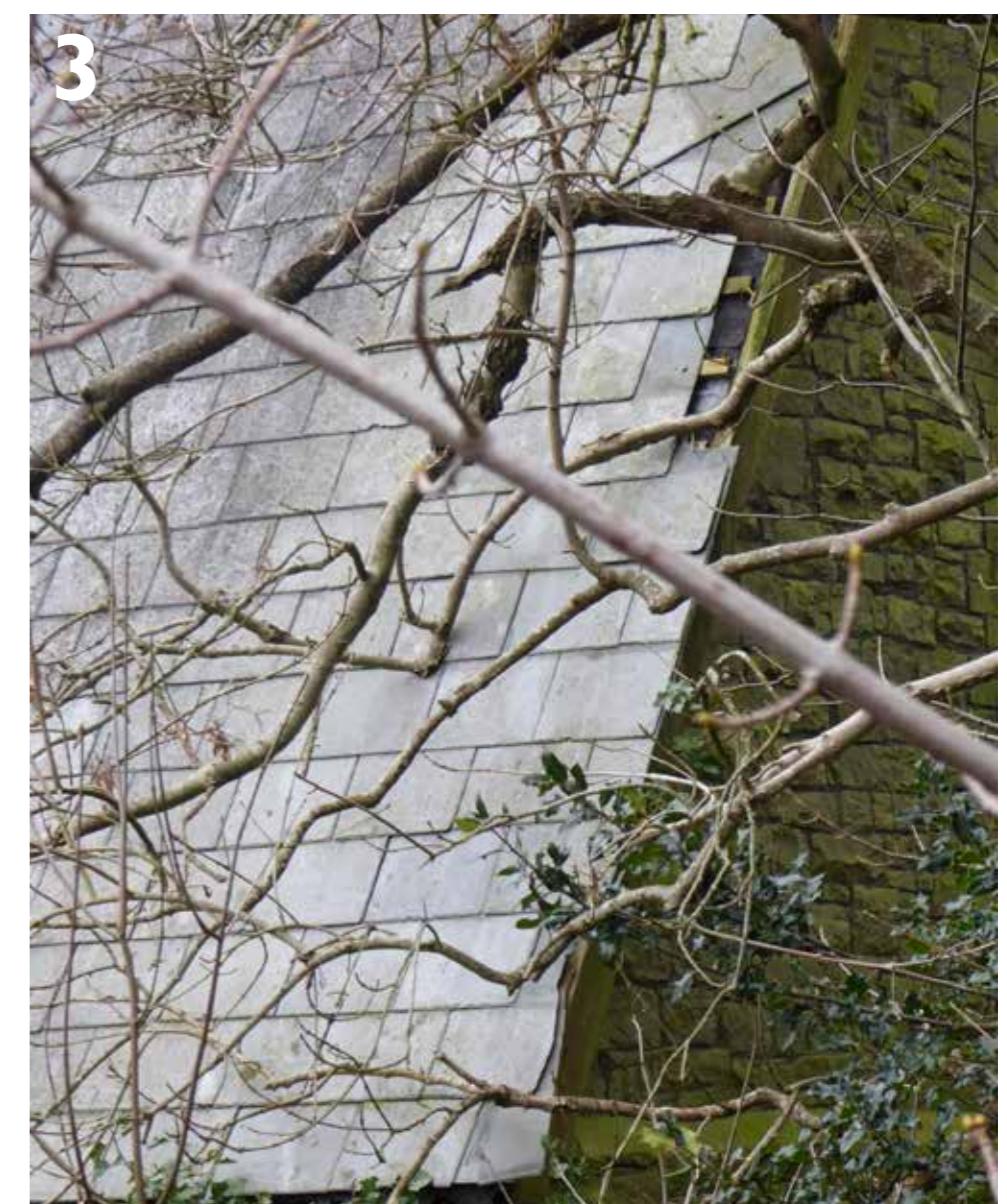
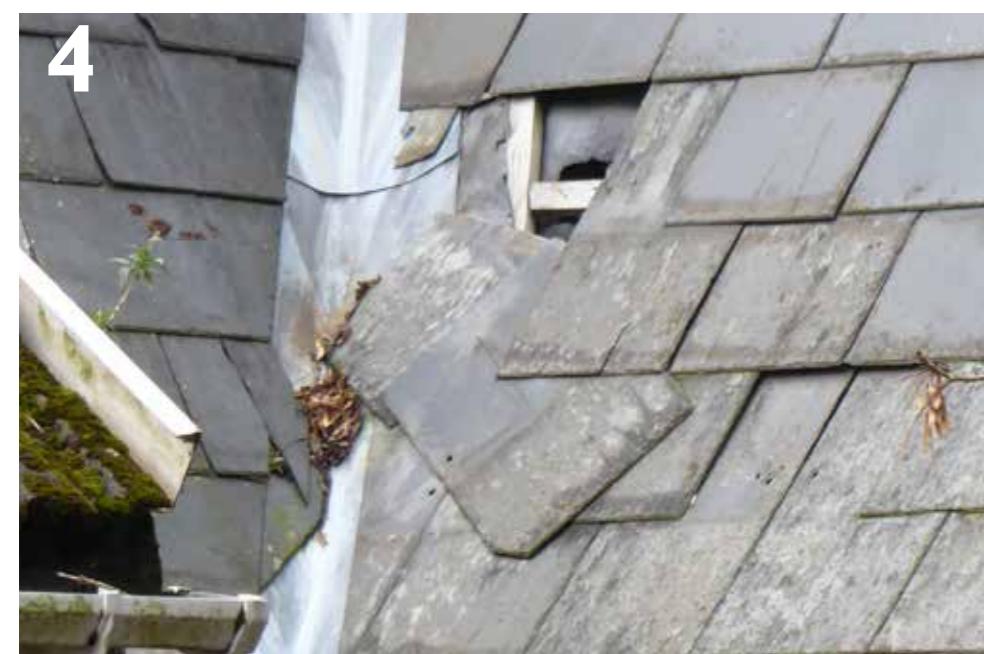
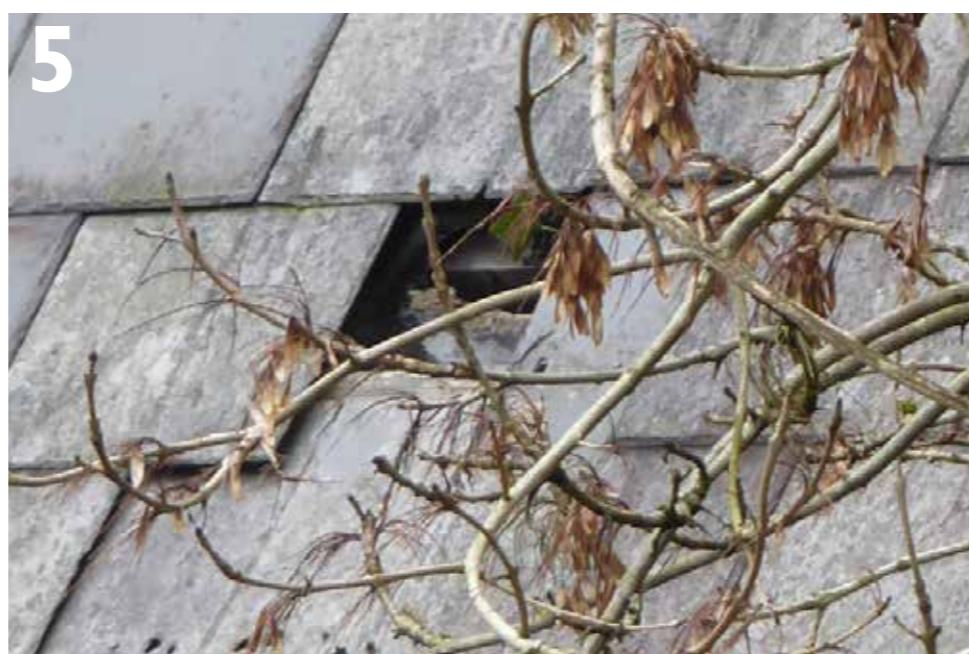
## Examples of Condition Issues with the Roof (with numbers referring to photographs)
