# Synagogue, Merthyr Tydfil

## RECORD OF BUILDING AND CONDITION ASSESSMENT REPORT

.....  
(449)2503-GVVP-A-HIS-P00

Date: 17.03.25

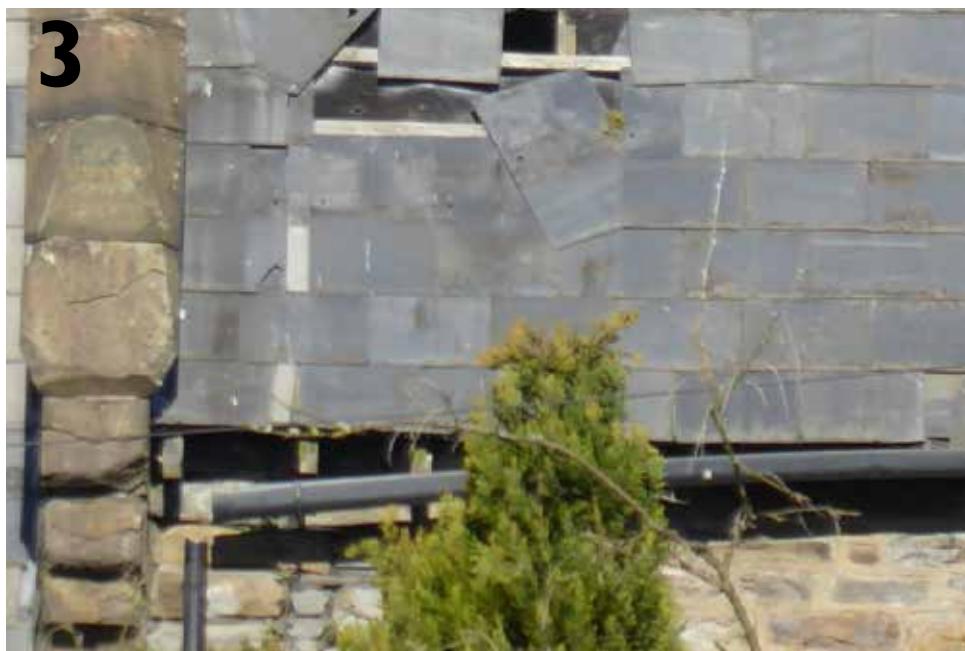
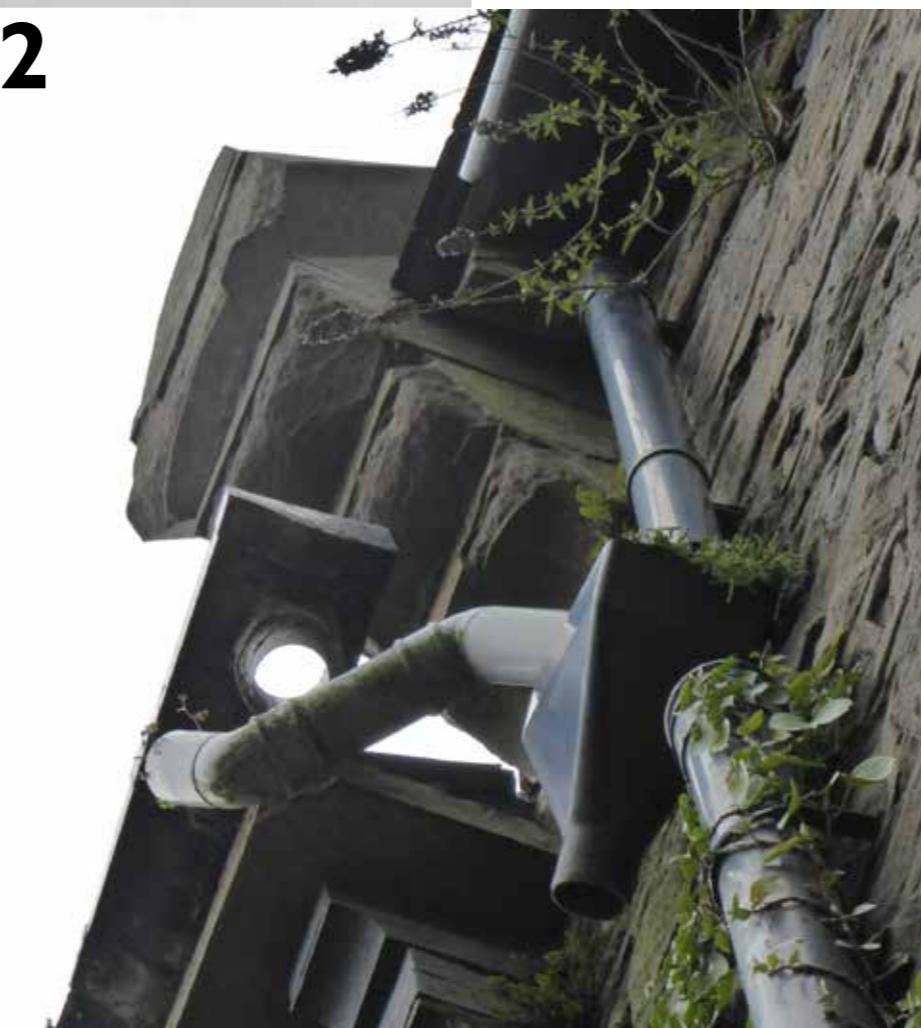
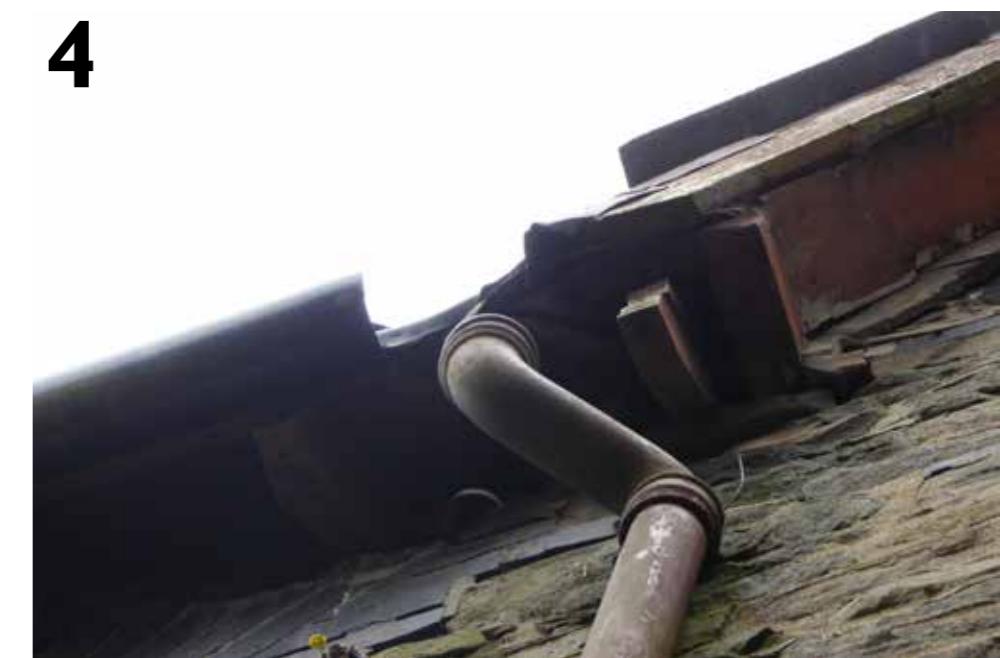
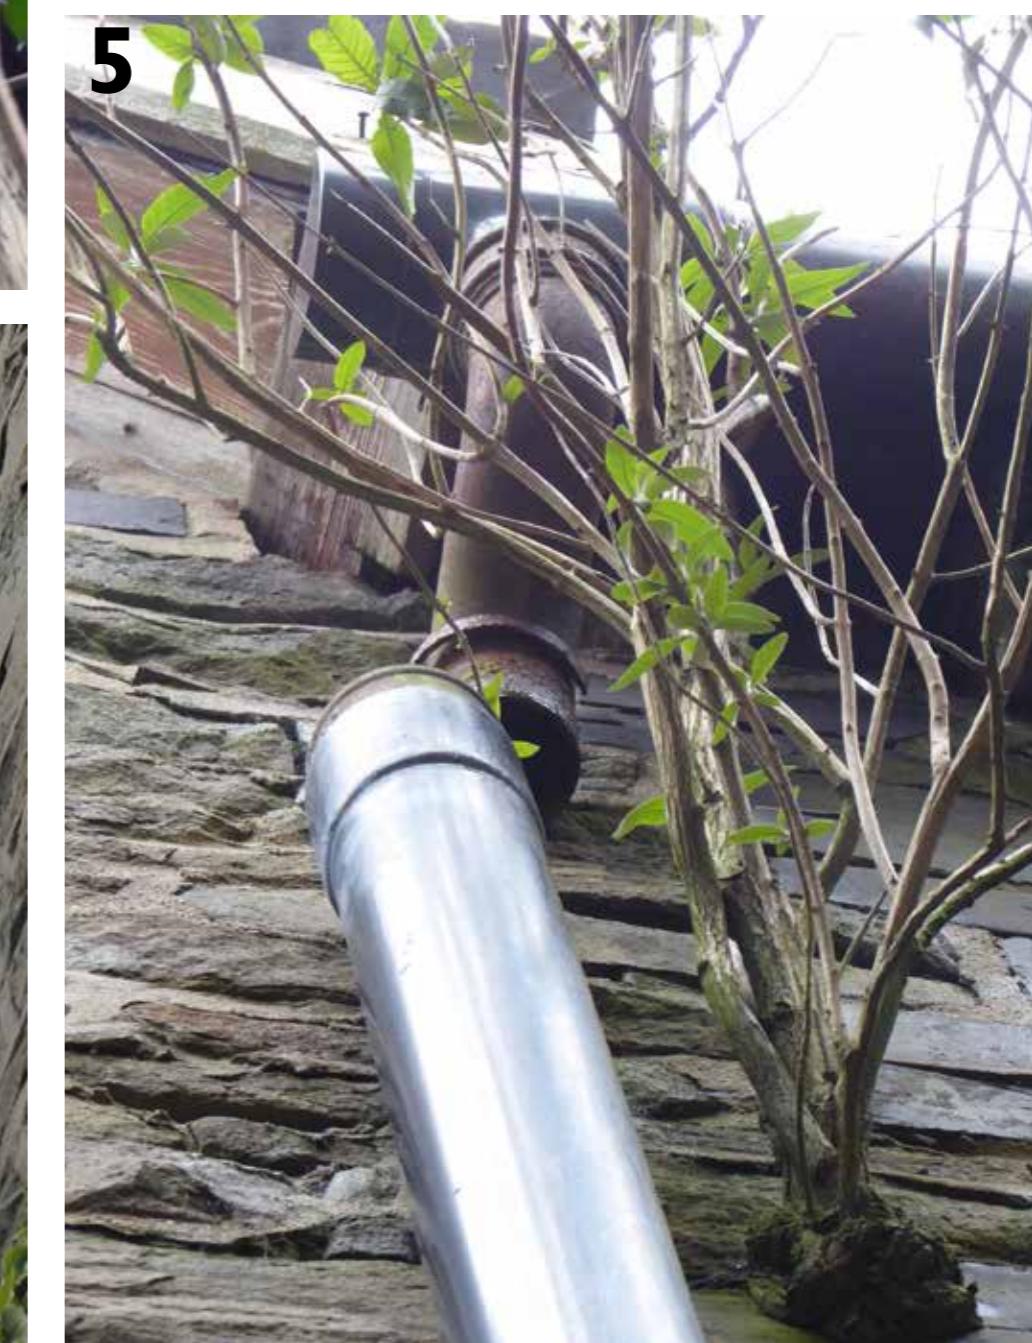
Examples of Condition Issues with the Rainwater Goods (with numbers referring to photographs)

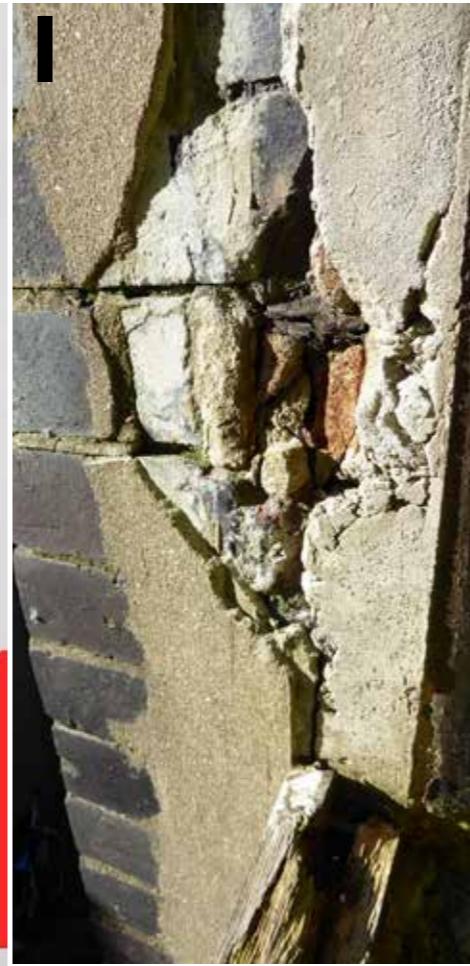
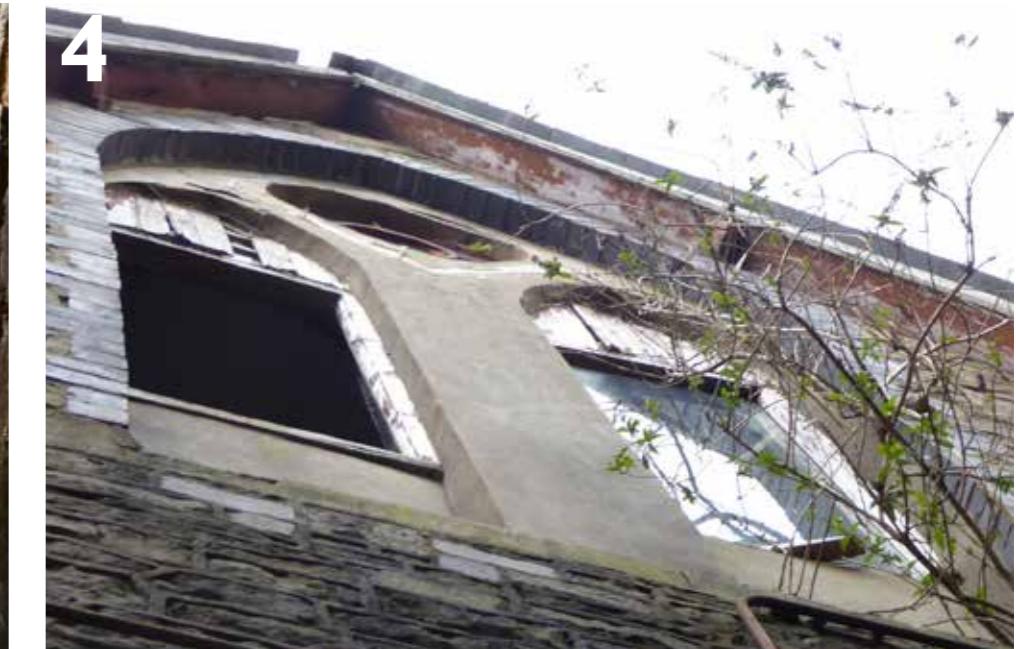
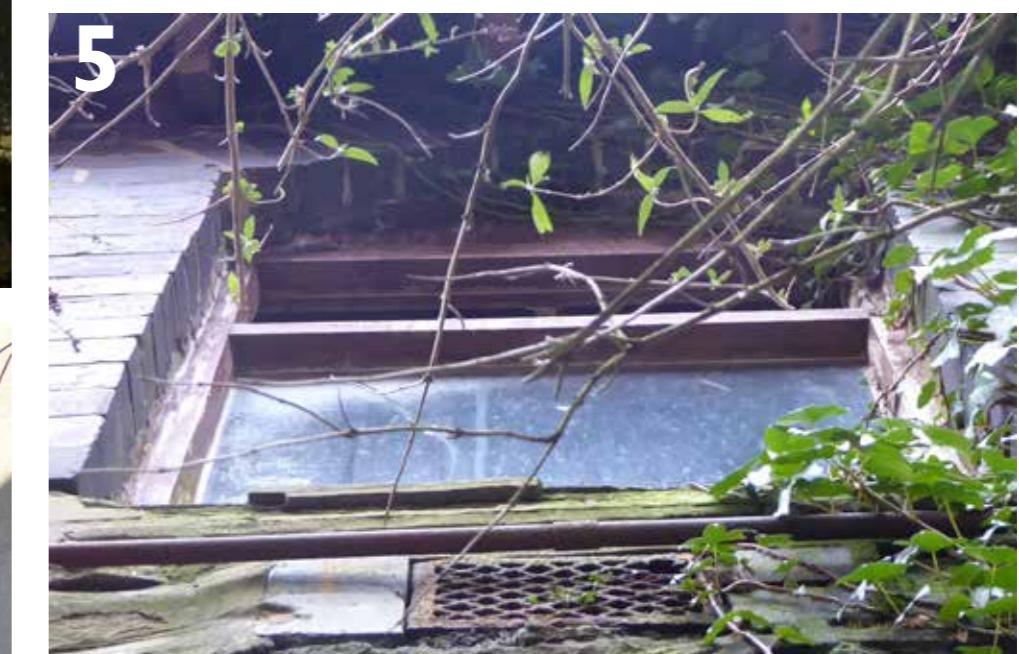
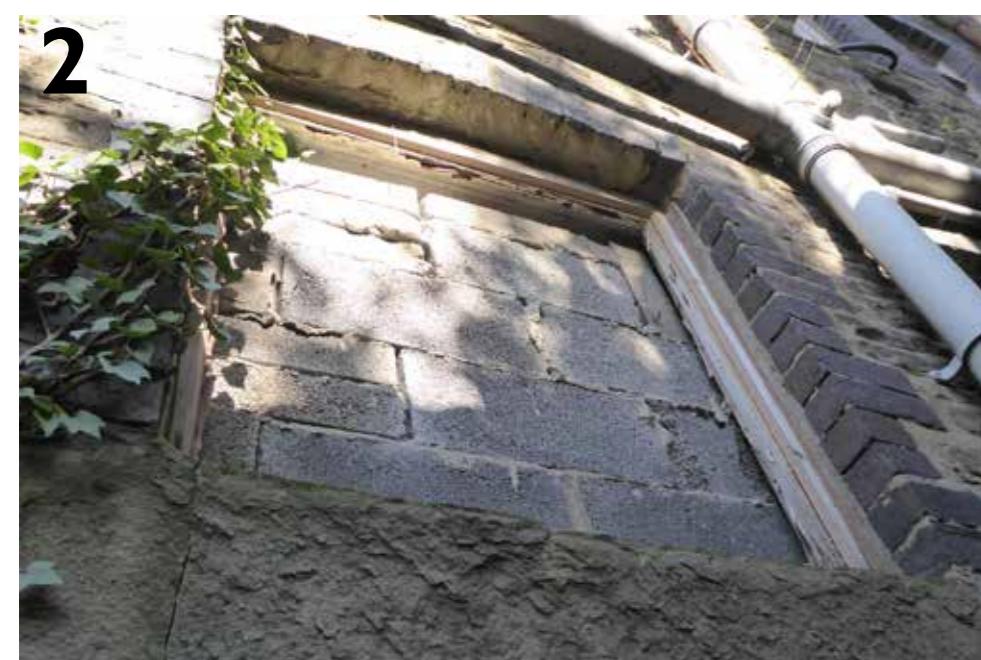
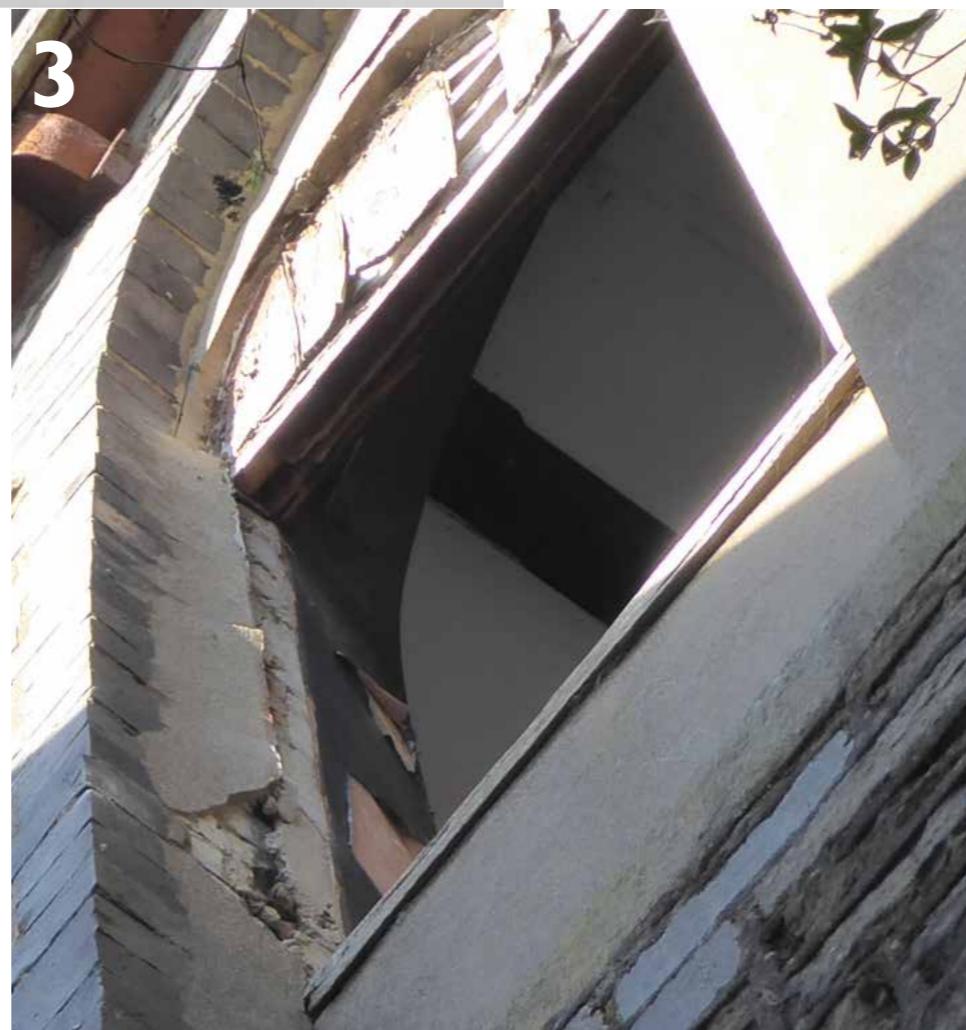
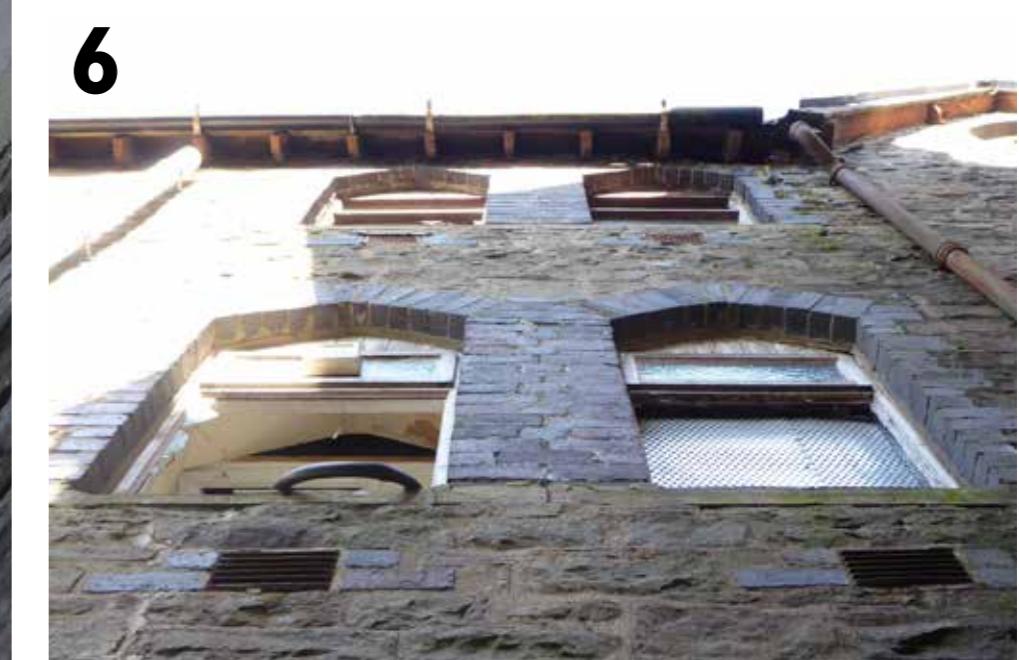
Examples of Condition Issues with the Windows (with numbers referring to photographs)

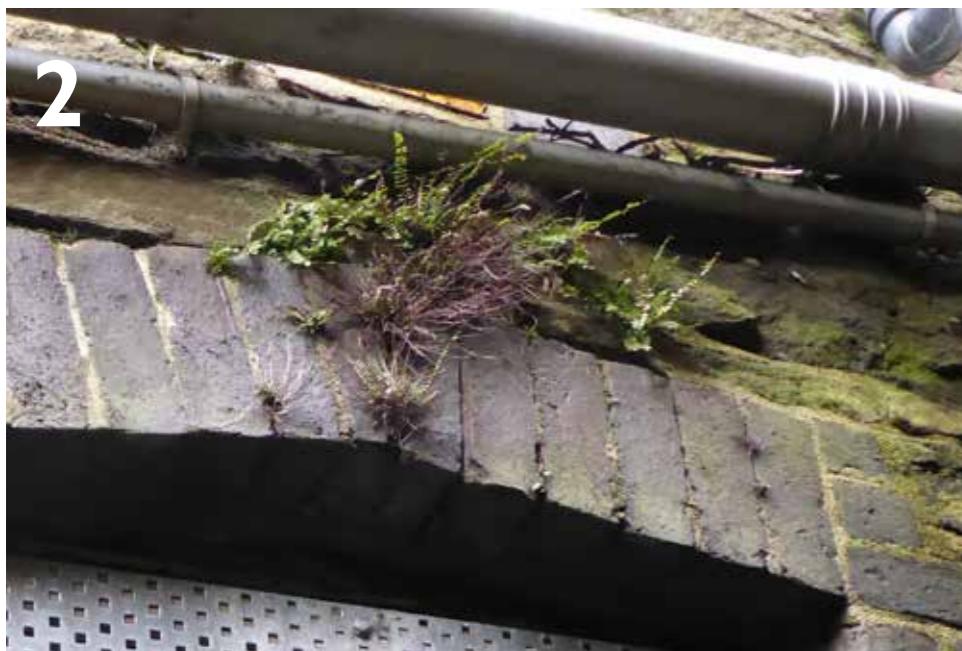
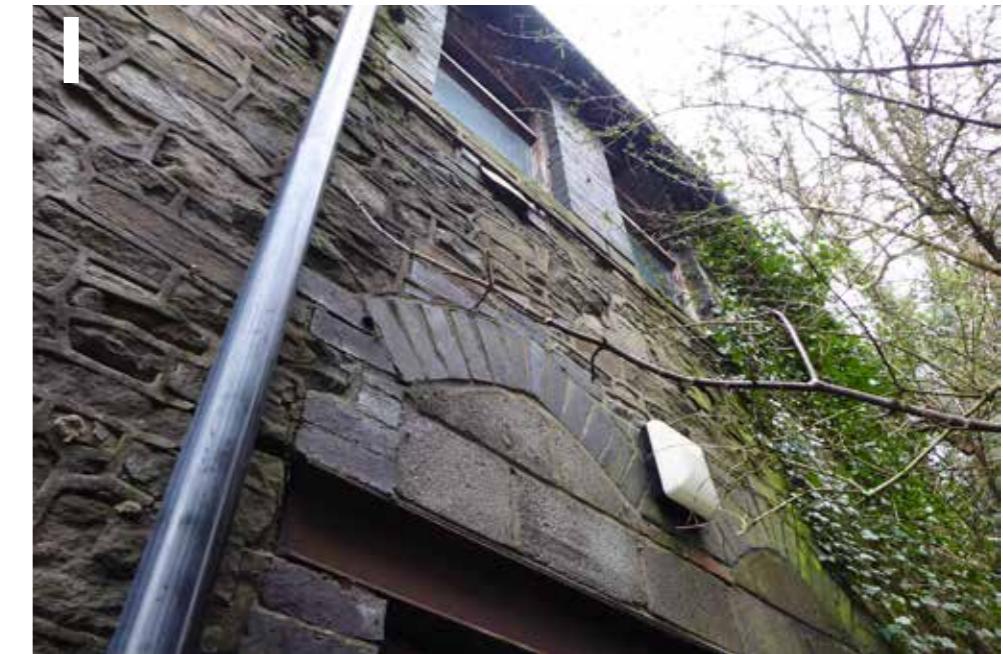
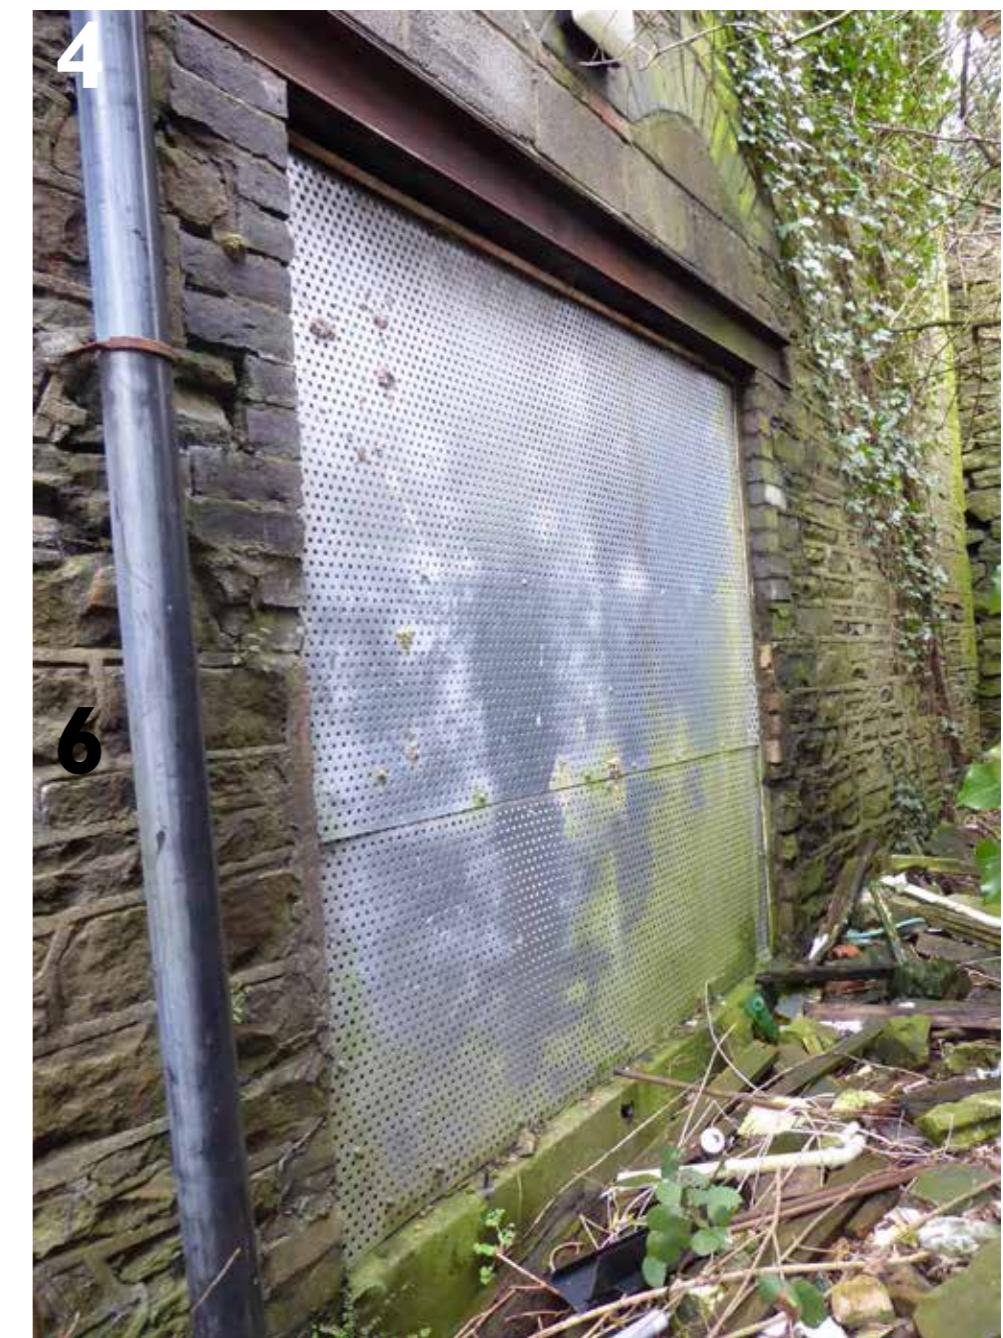
Examples of Condition Issues with Vegetation (with numbers referring to photographs)

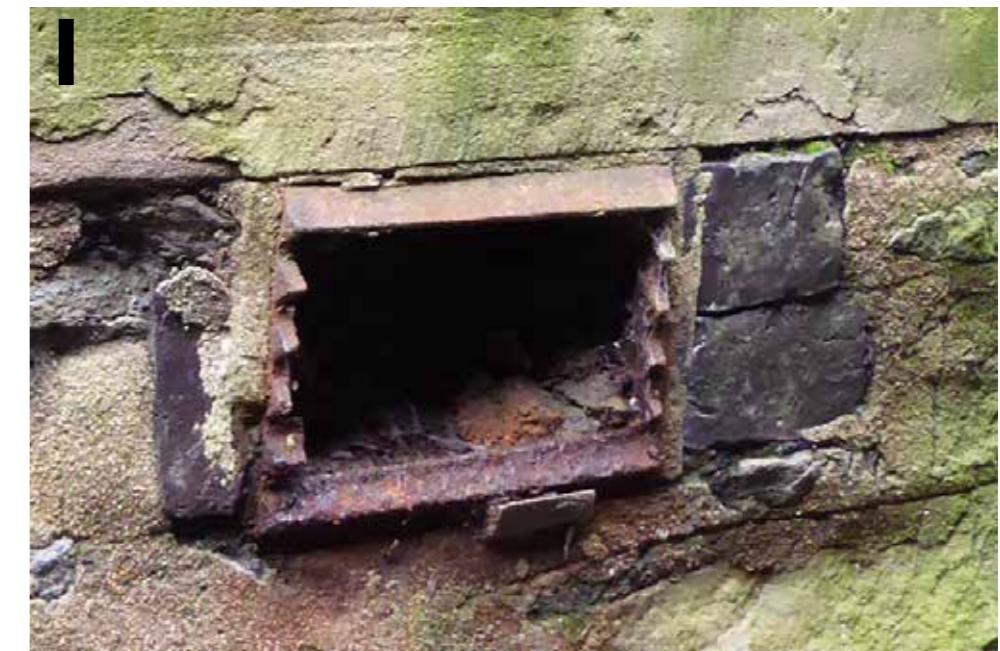
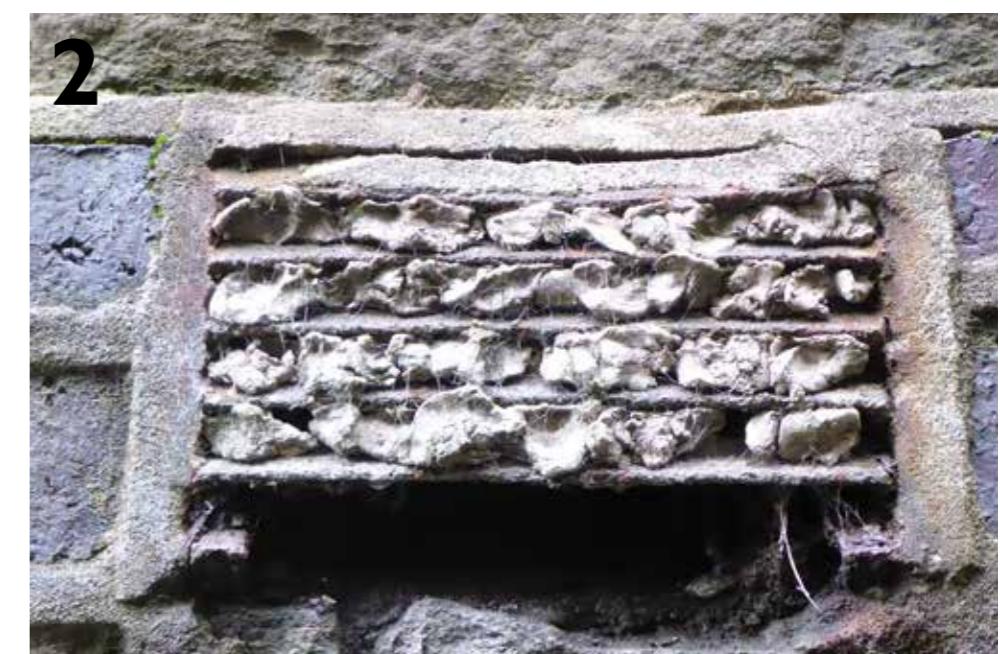
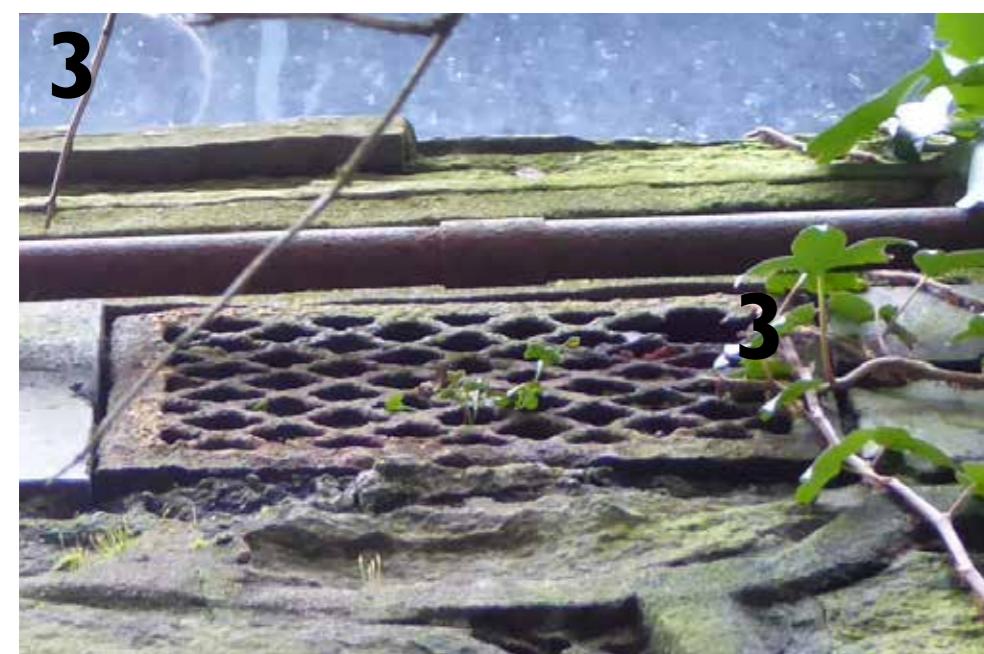
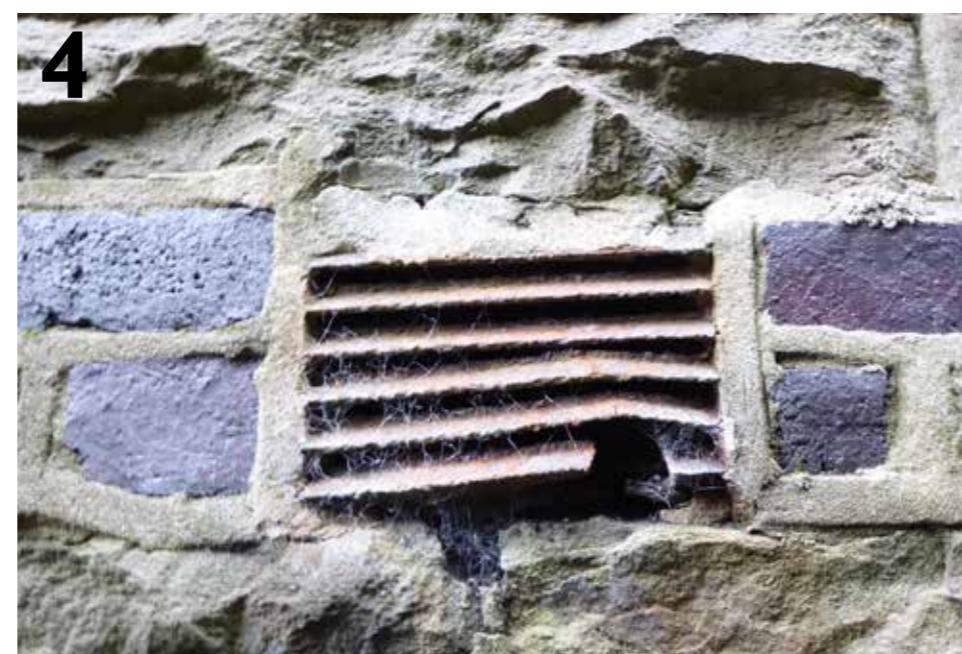
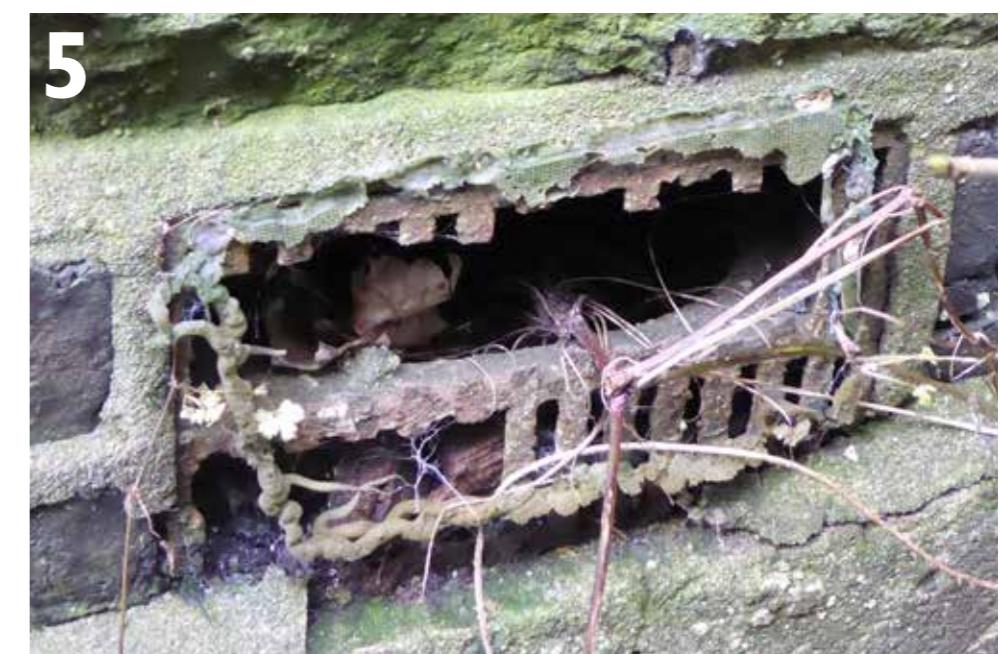
Examples of Condition Issues with the Vents (with numbers referring to photographs)

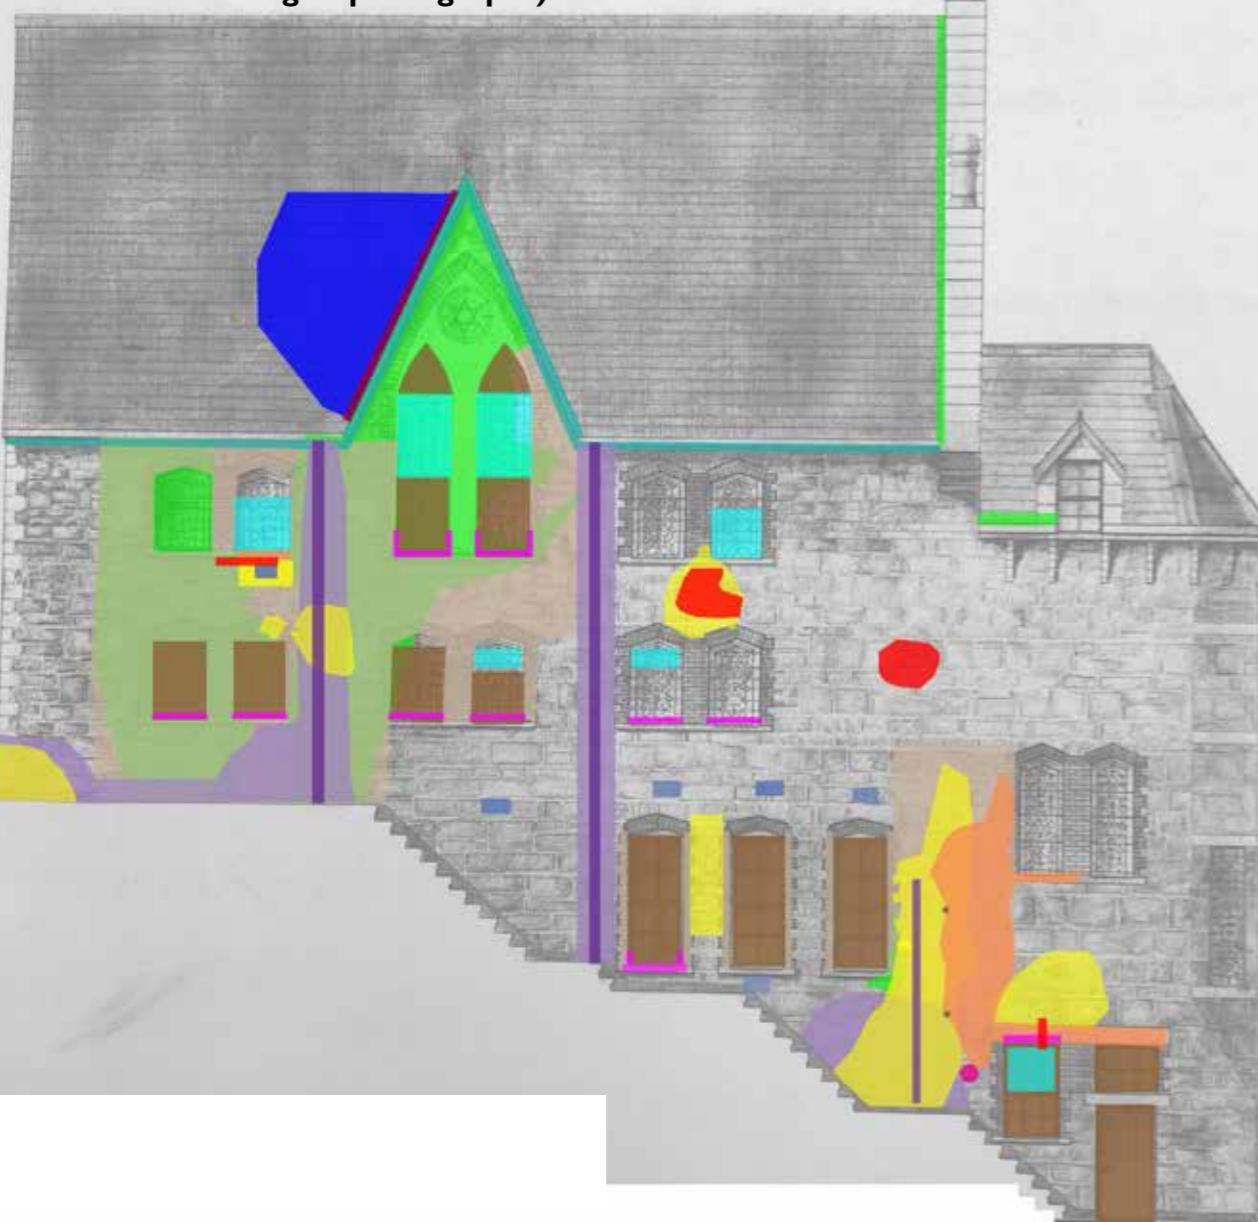
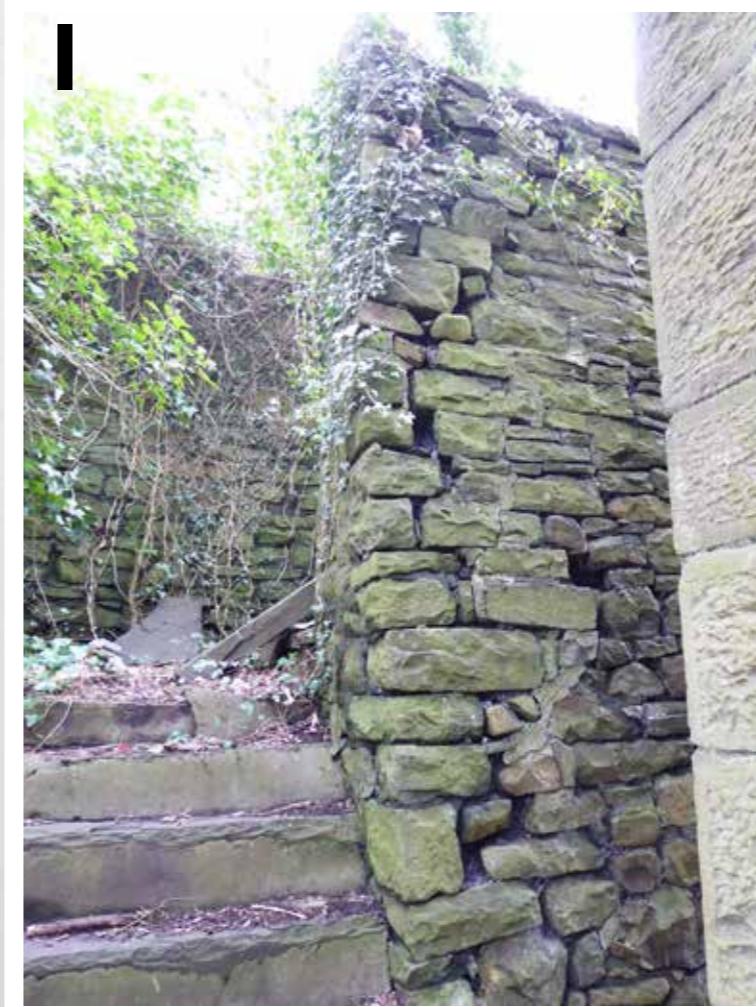
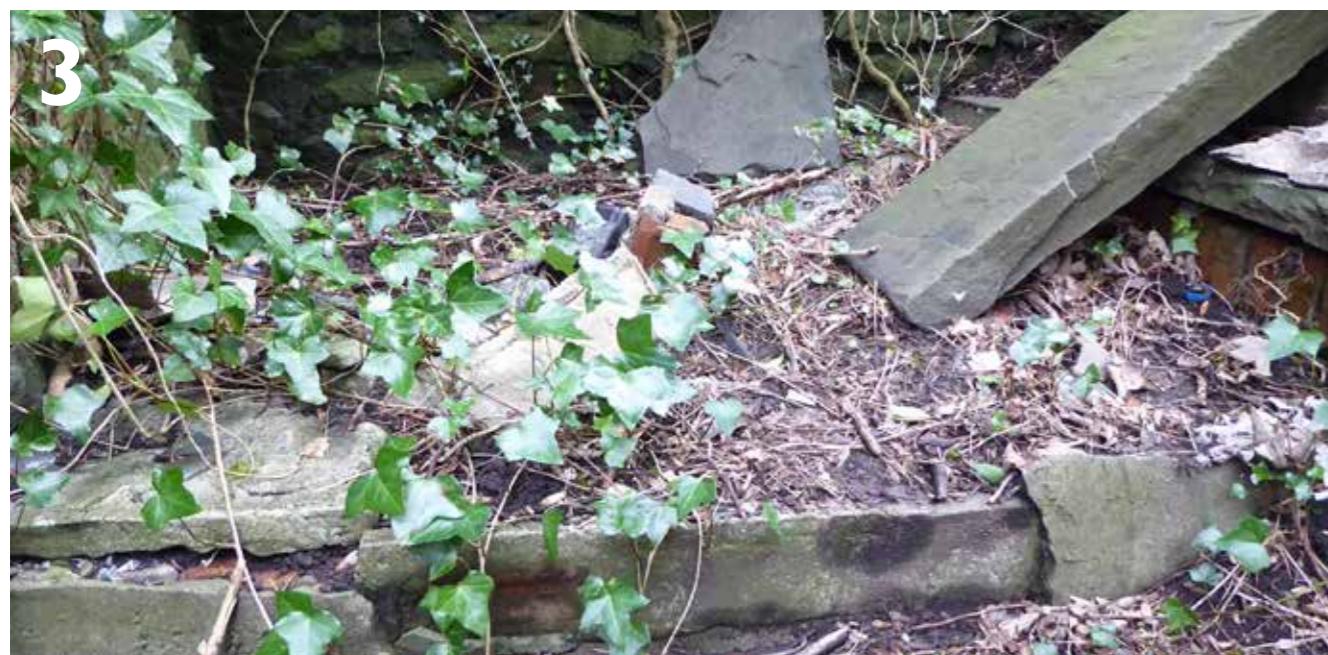
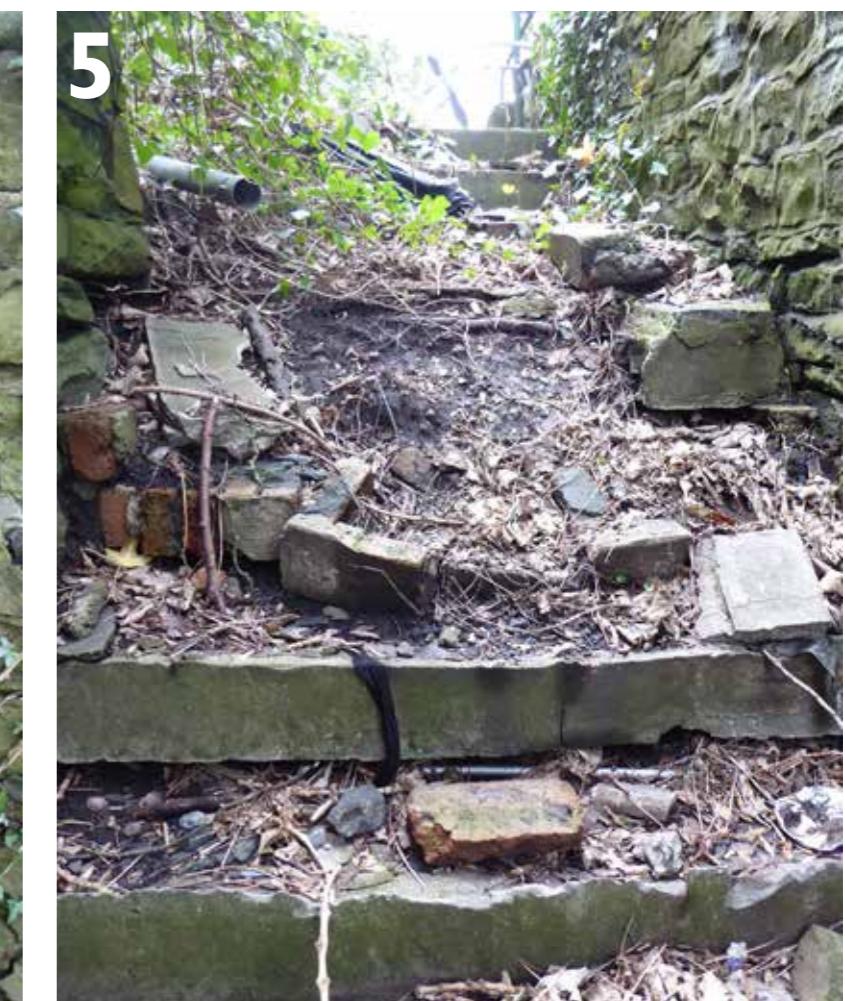
Examples of Condition Issues with the Stonework  
(with numbers referring to photographs)

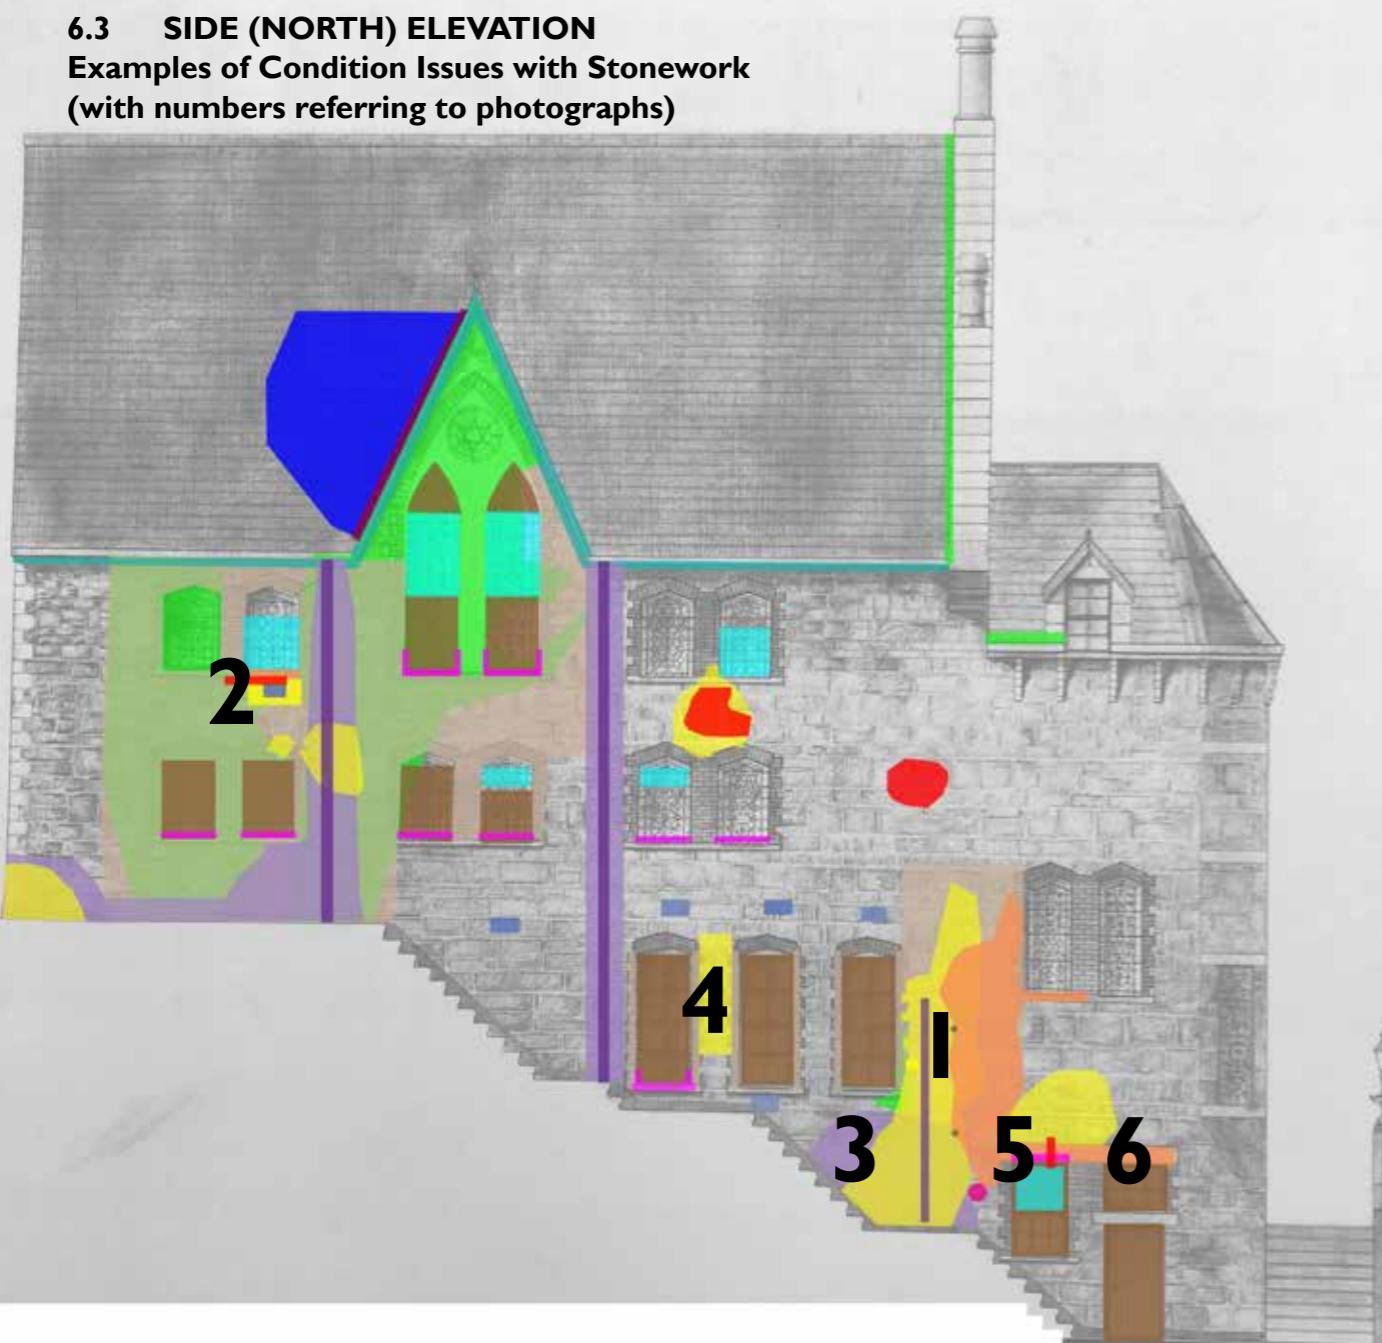
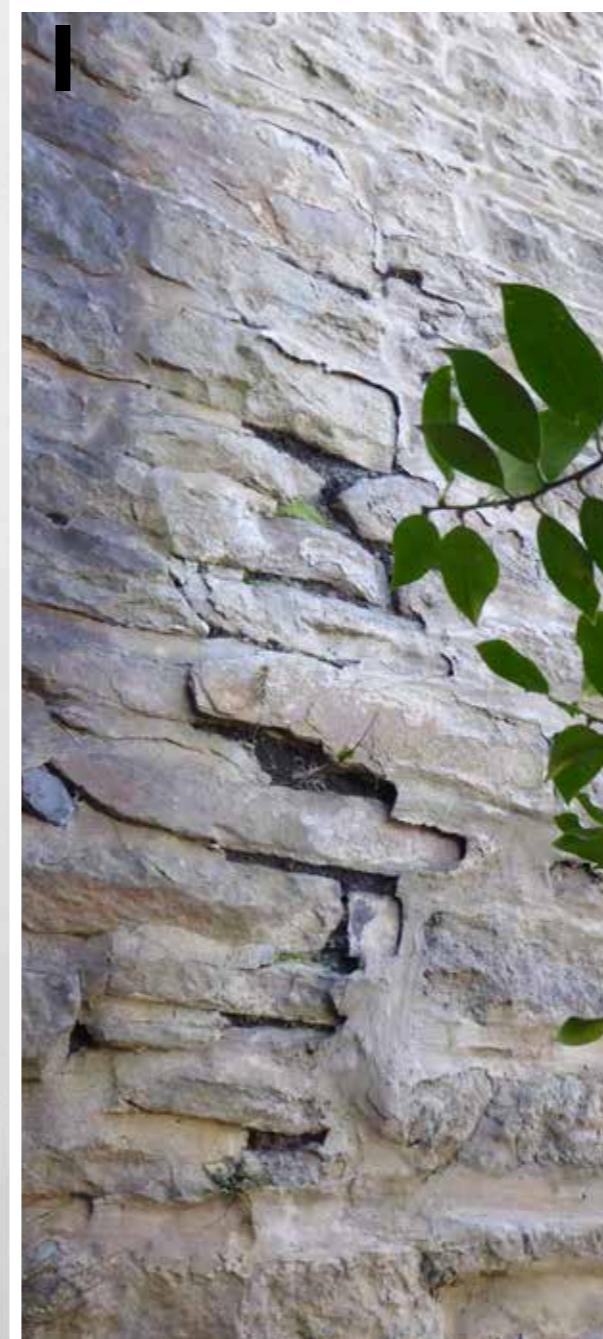
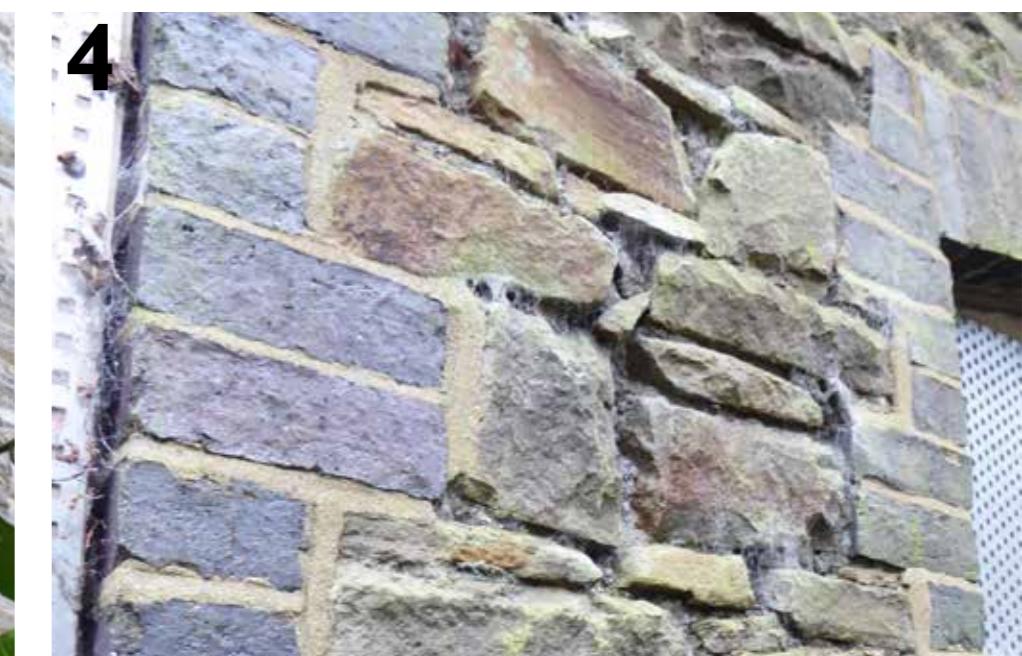
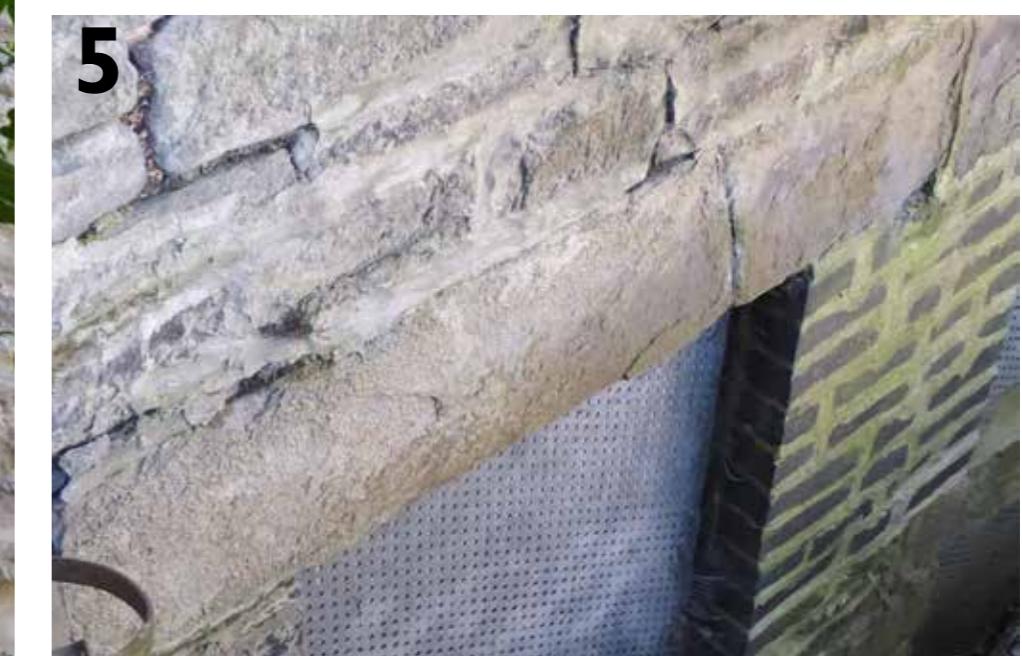
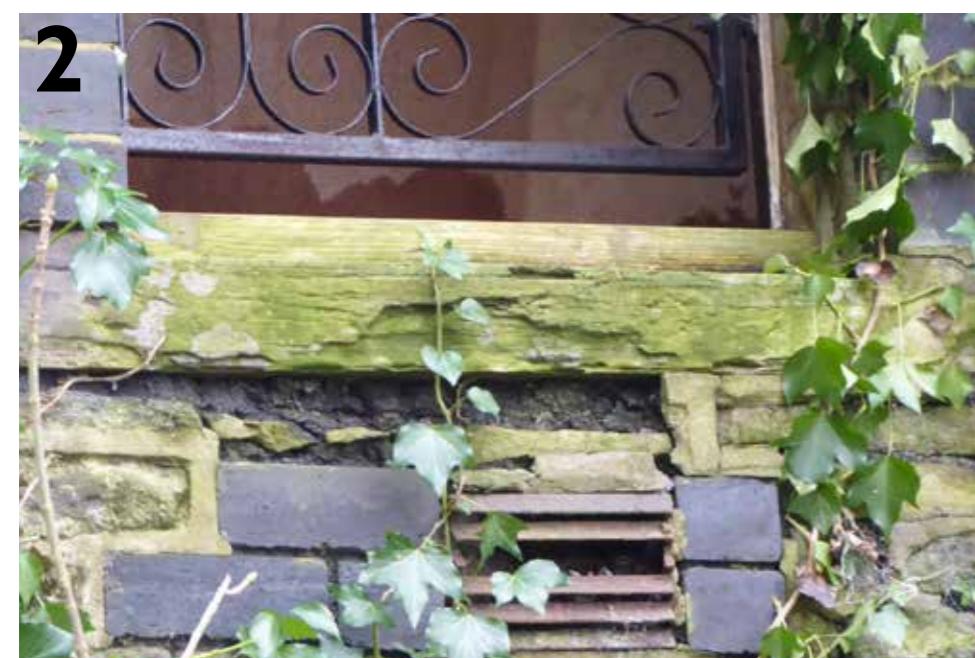
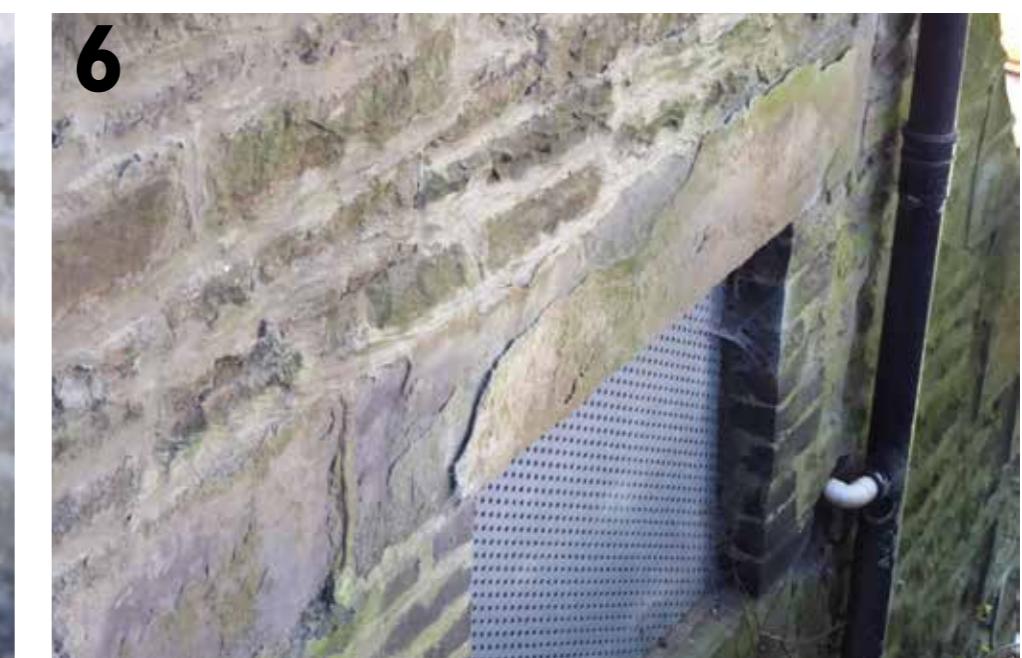
Examples of Condition Issues with Stonework  
(with numbers referring to photographs)
