# Synagogue, Merthyr Tydfil

## RECORD OF BUILDING AND CONDITION ASSESSMENT REPORT

.....  
(449)2503-GVVP-A-HIS-P00

Date: 17.03.25

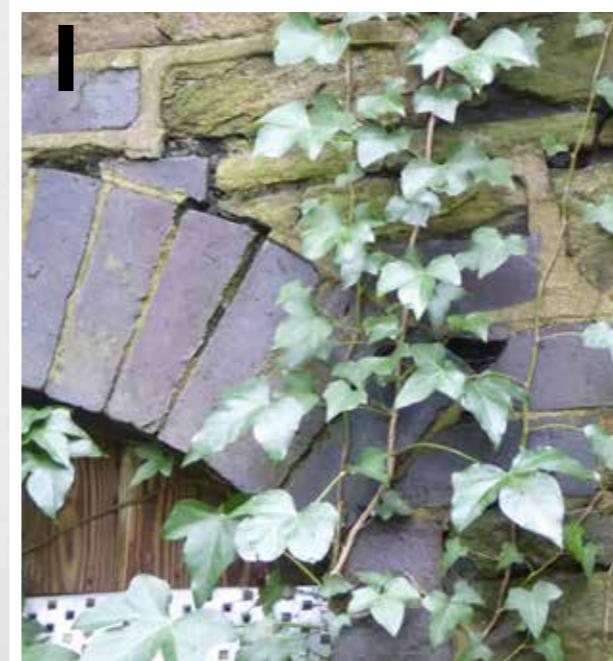
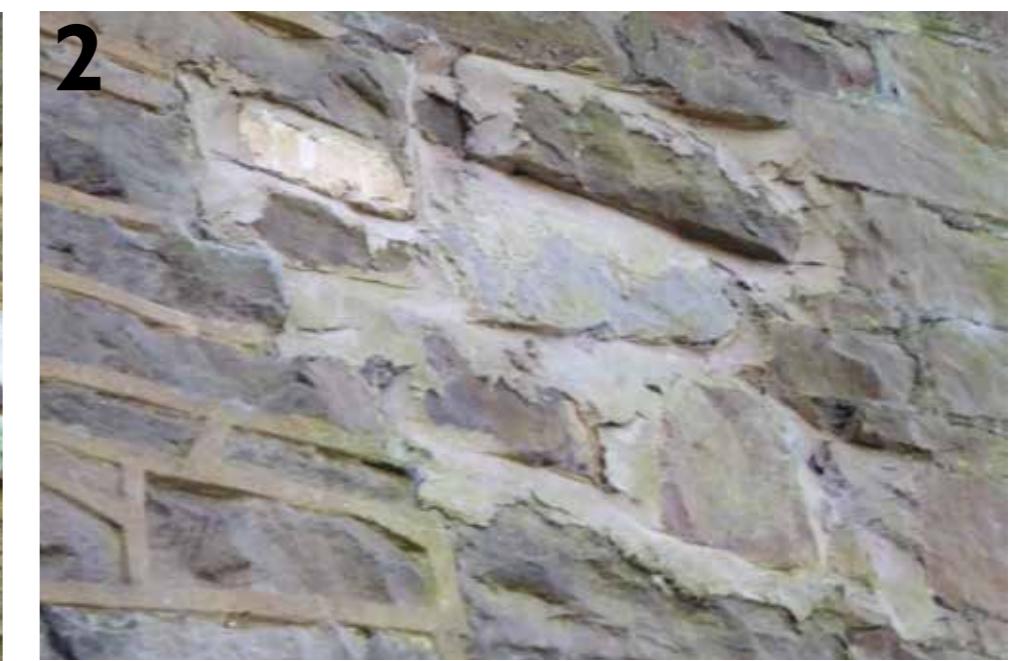
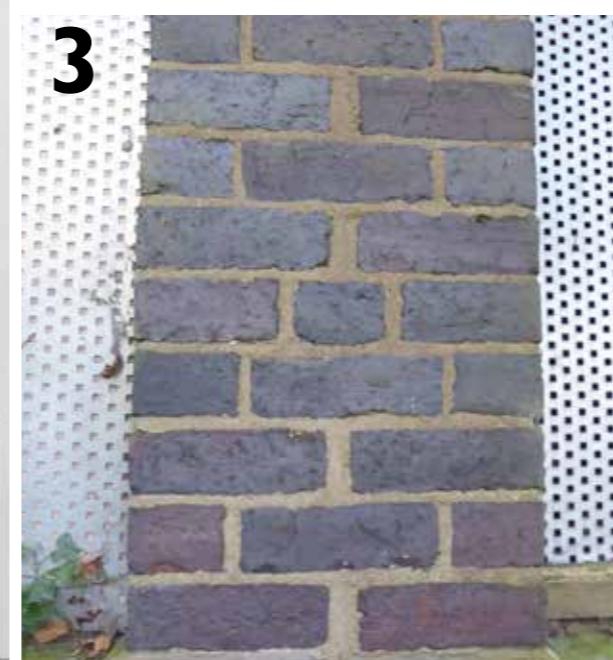
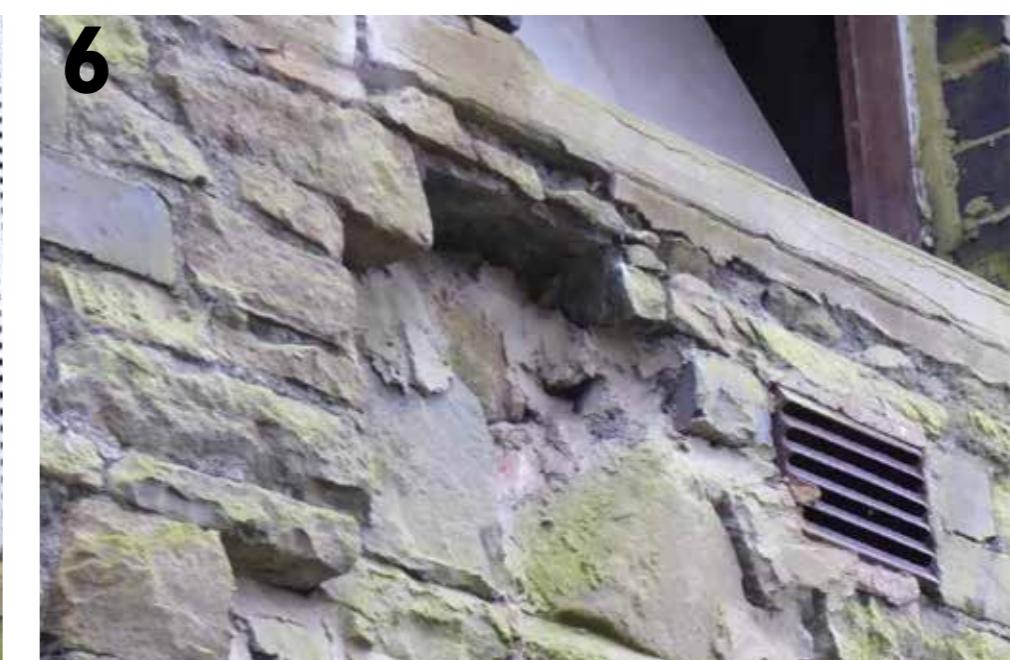
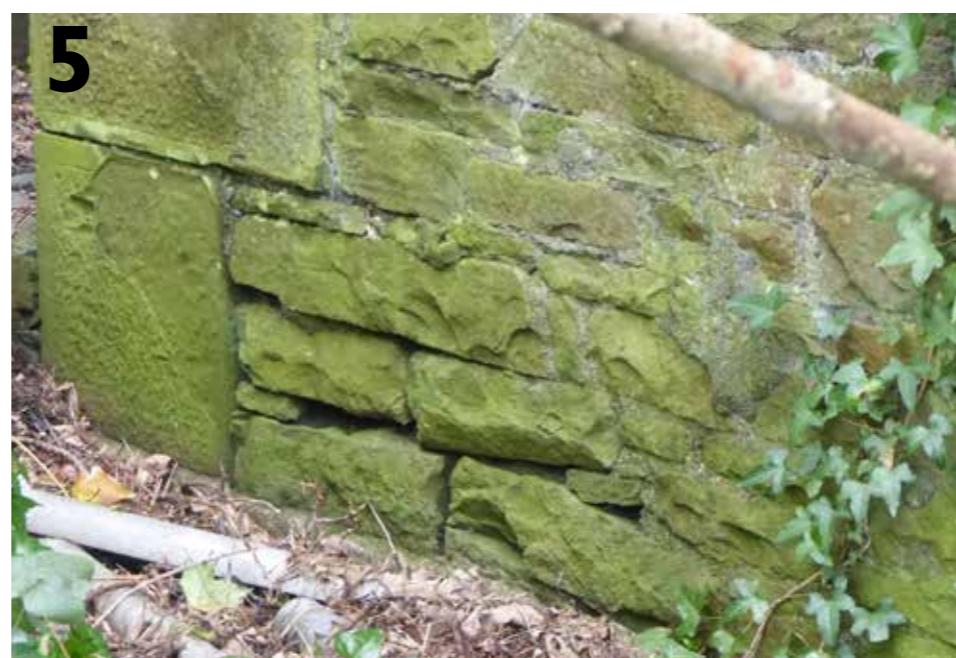
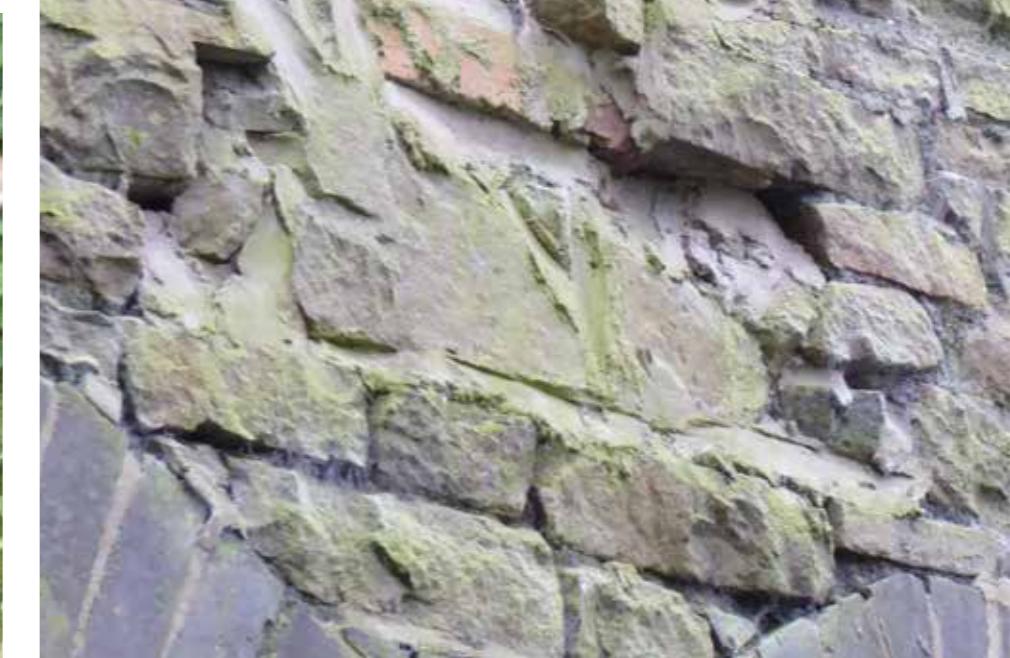
Examples of Condition Issues with Stonework  
(with numbers referring to photographs)

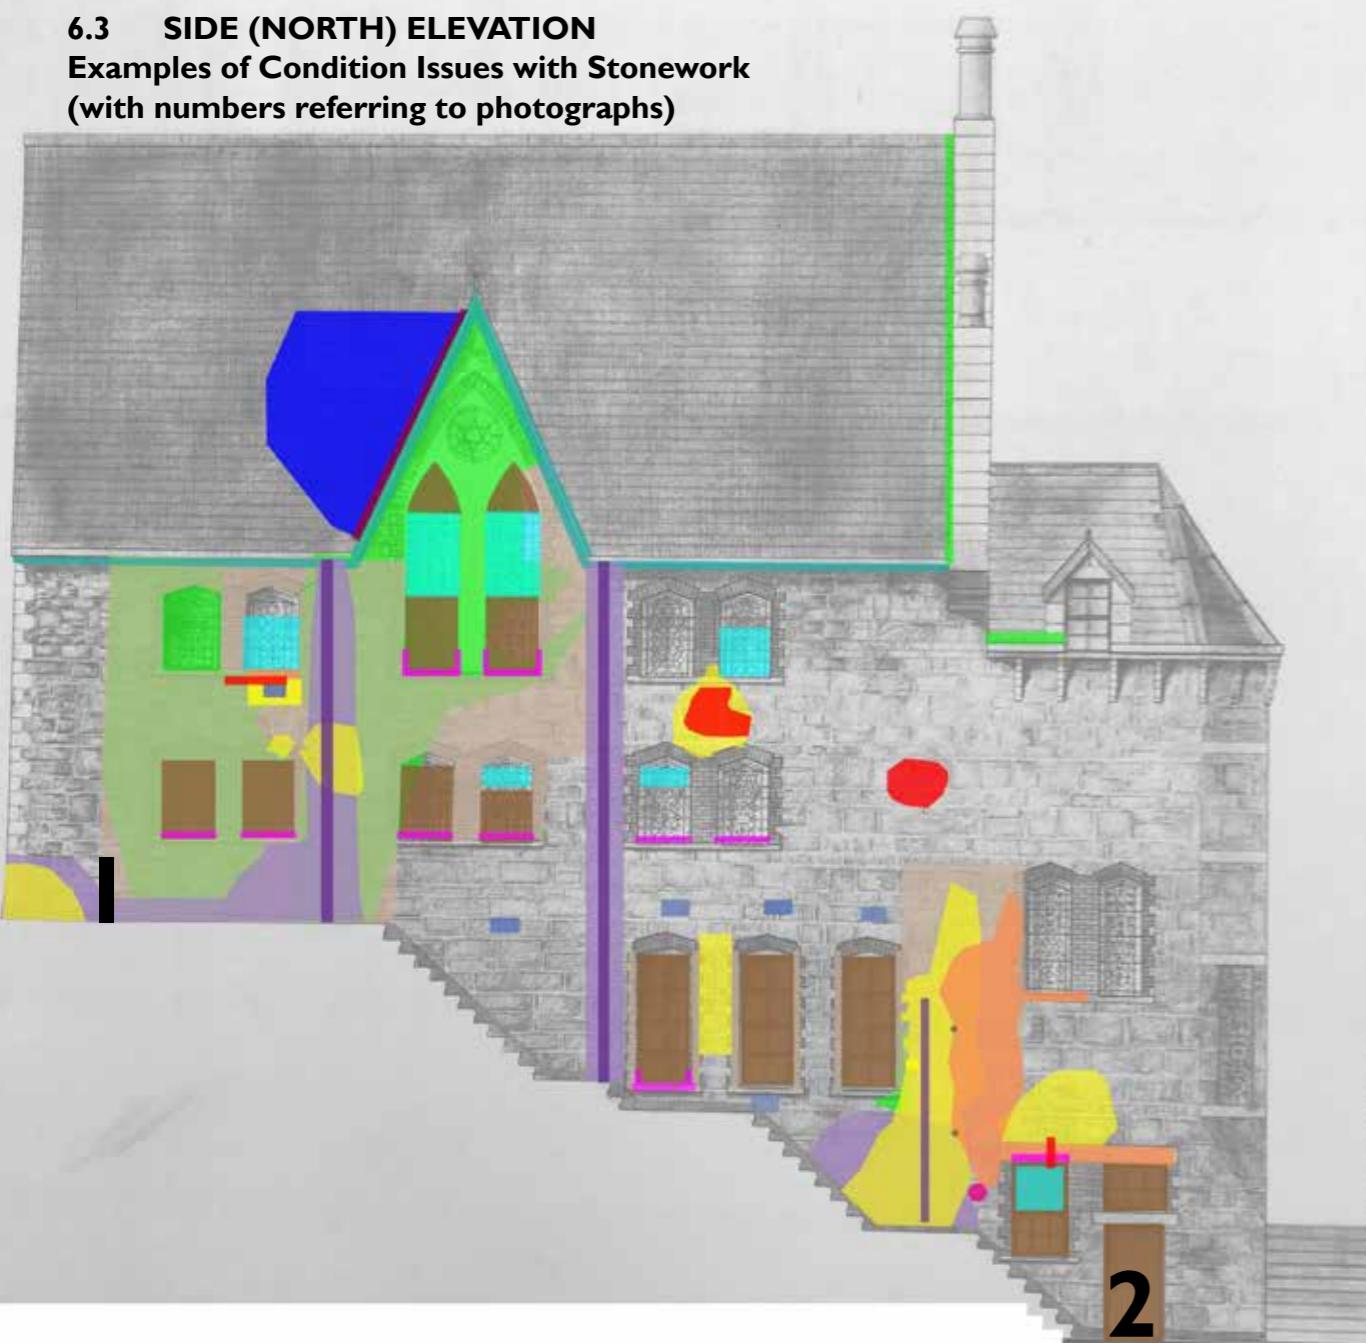
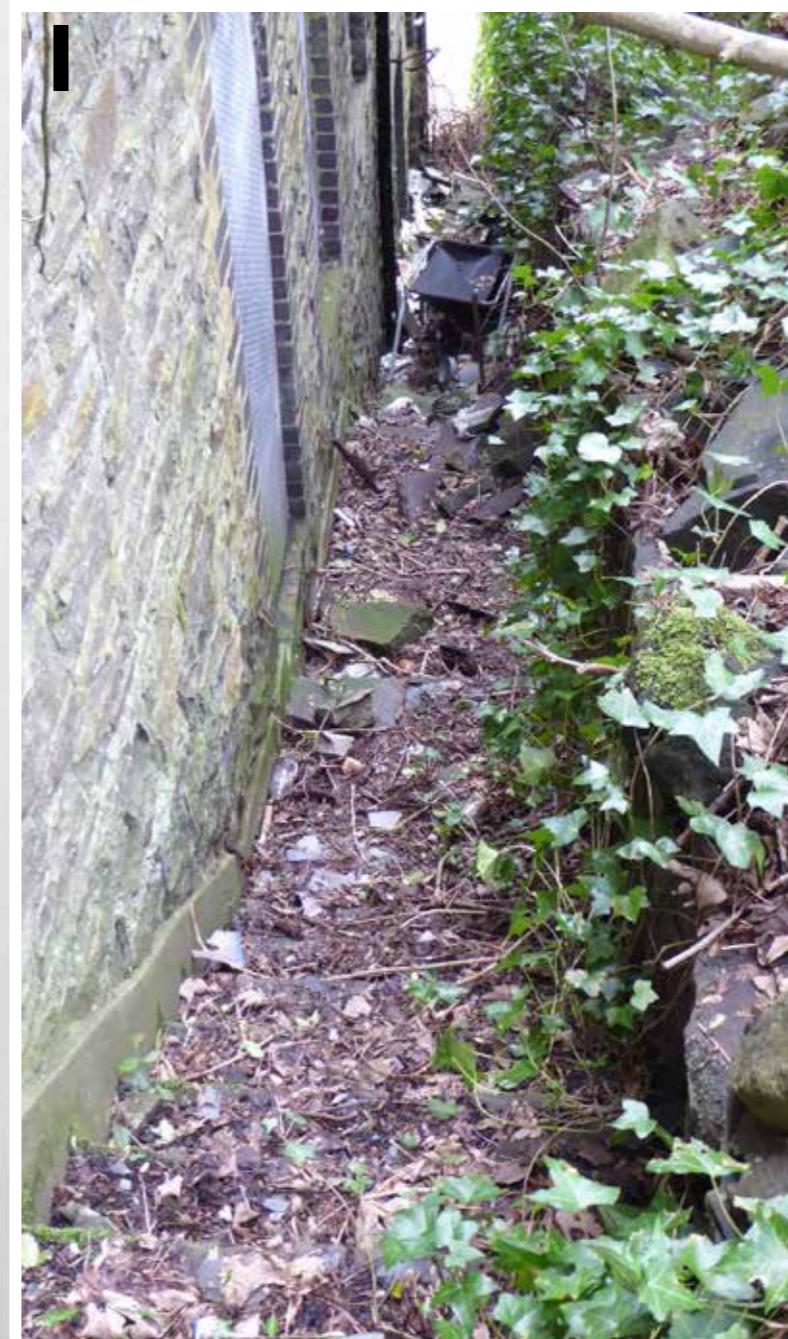
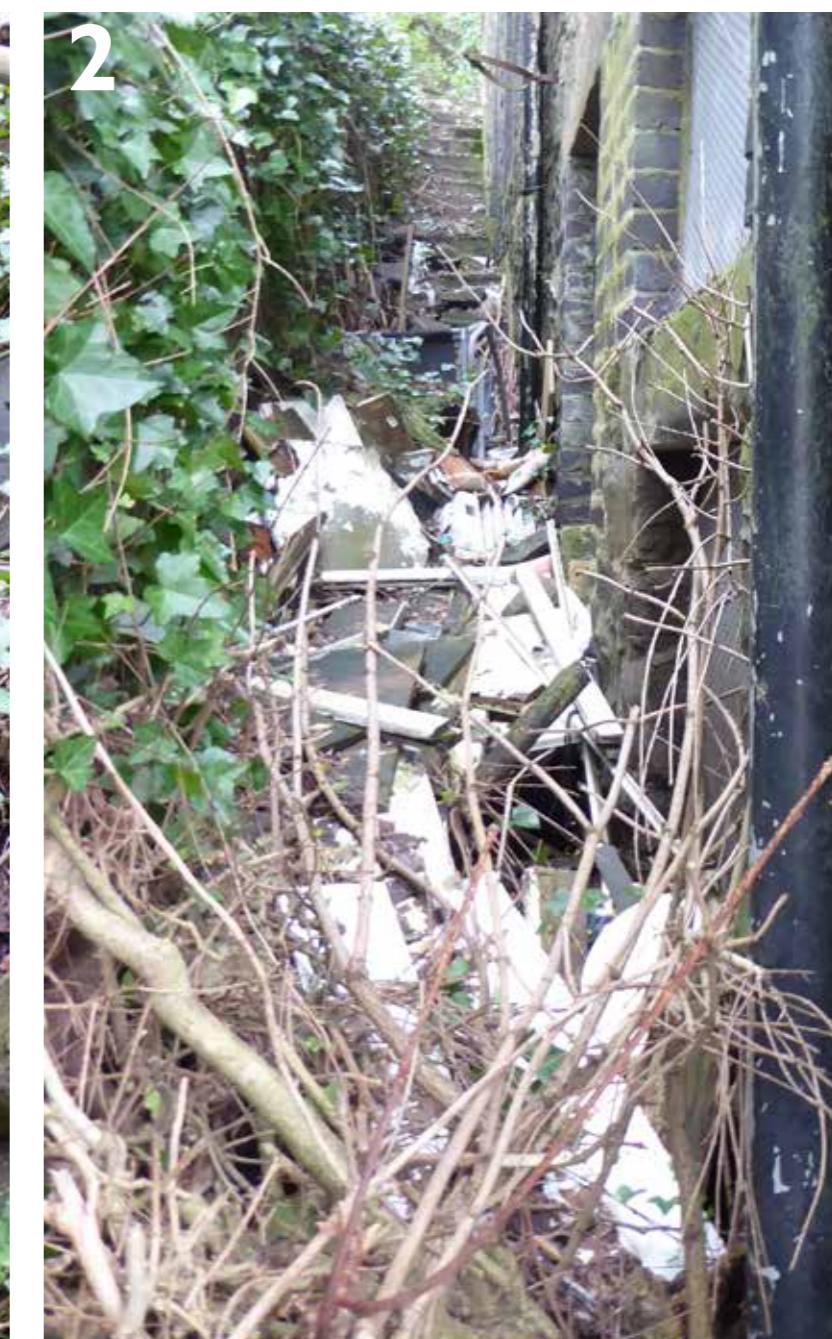
Examples of Condition Issues with Stonework  
(with numbers referring to photographs)

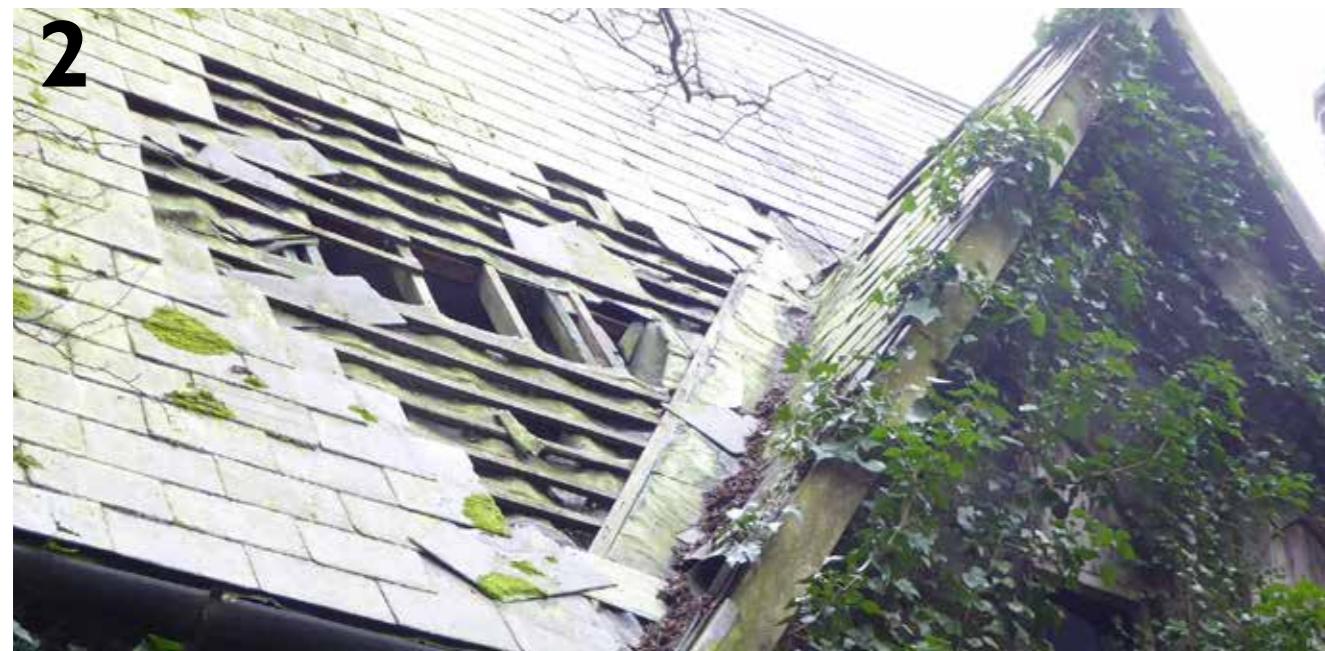
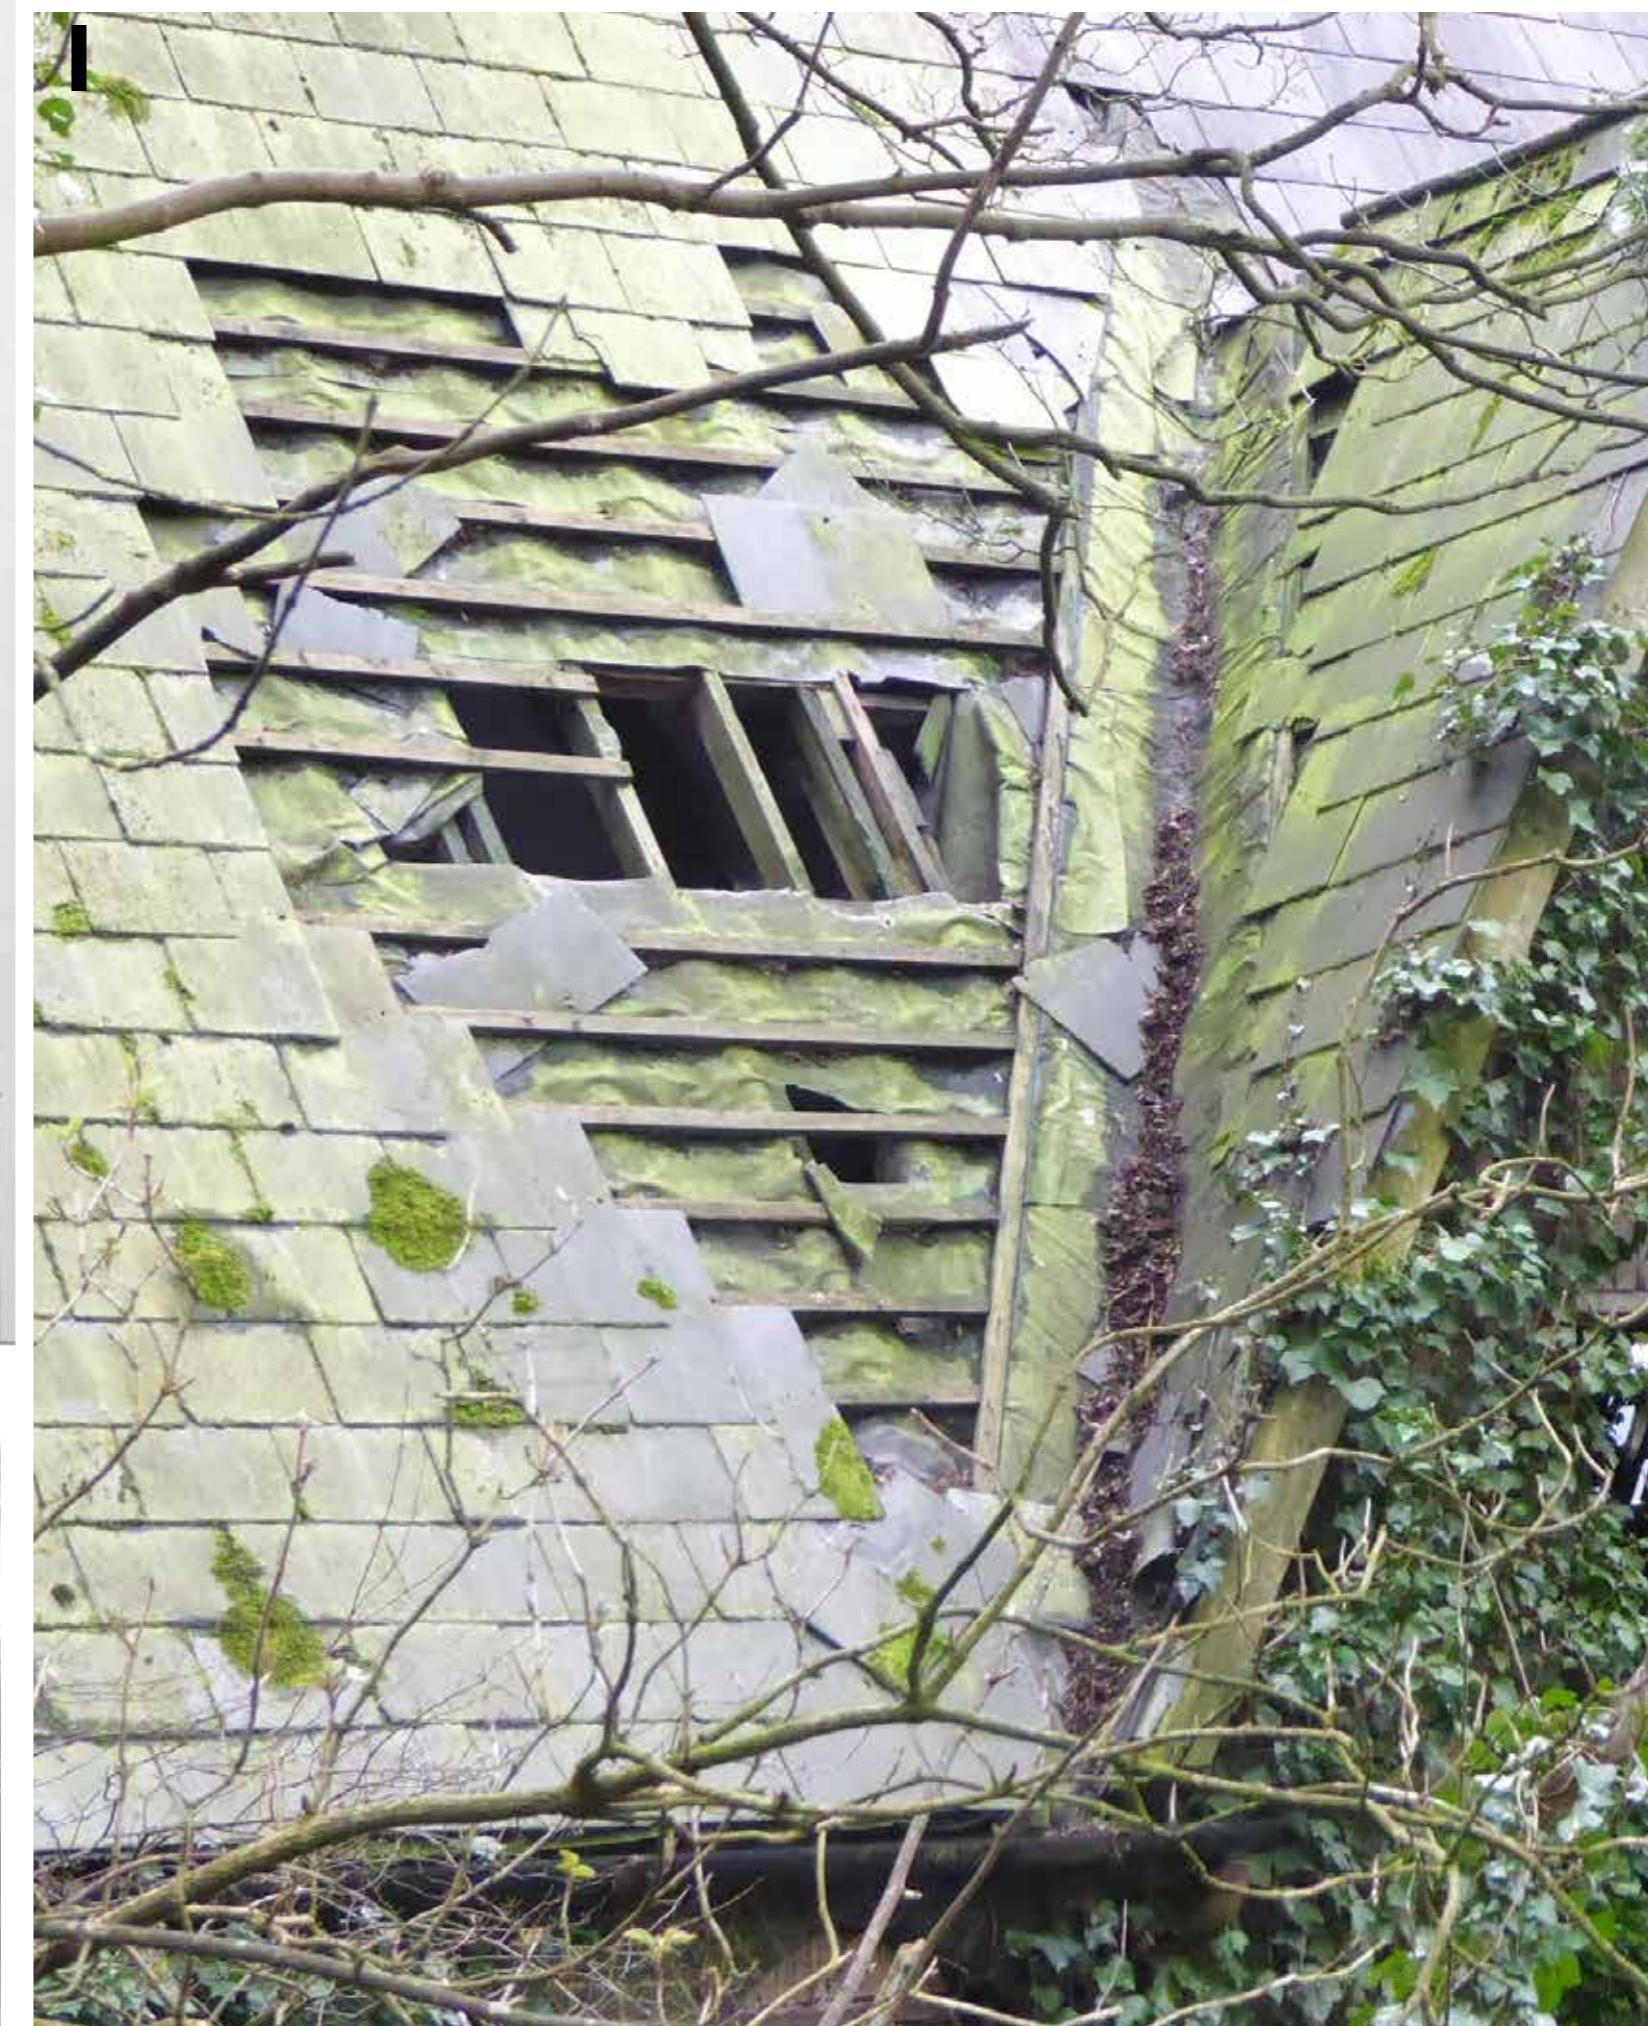
#### Examples of Condition Issues

with the Roof (with numbers referring to photographs)

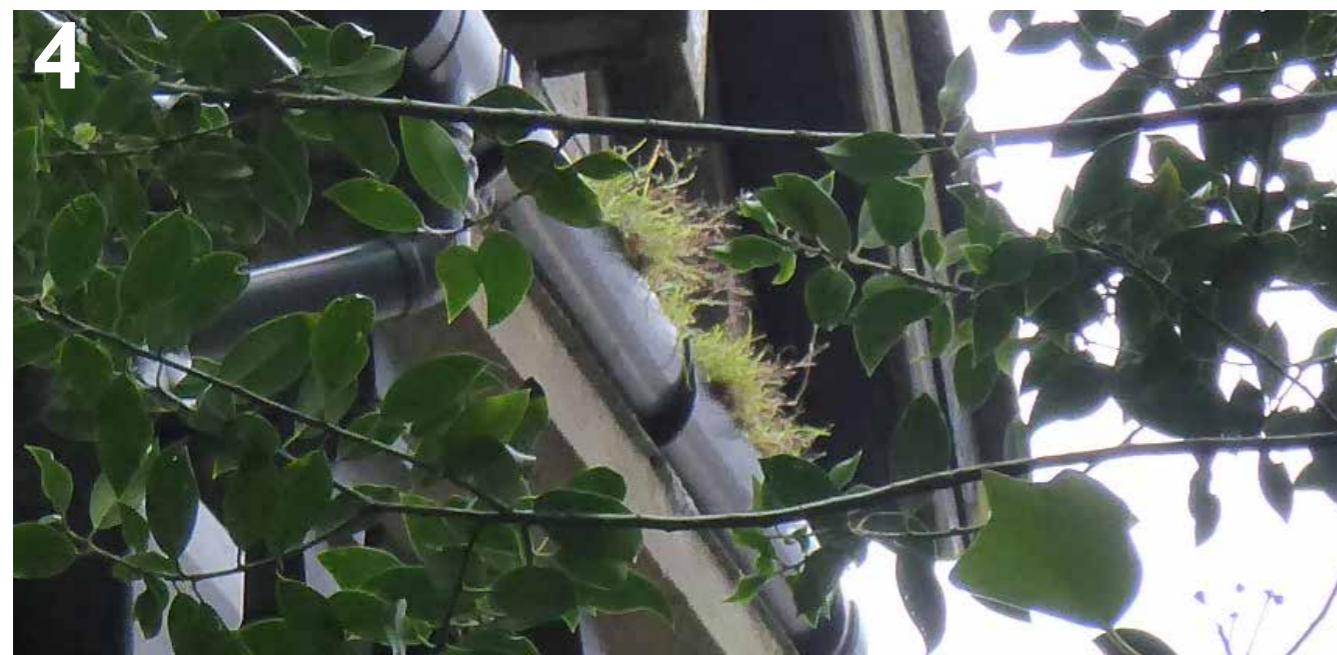
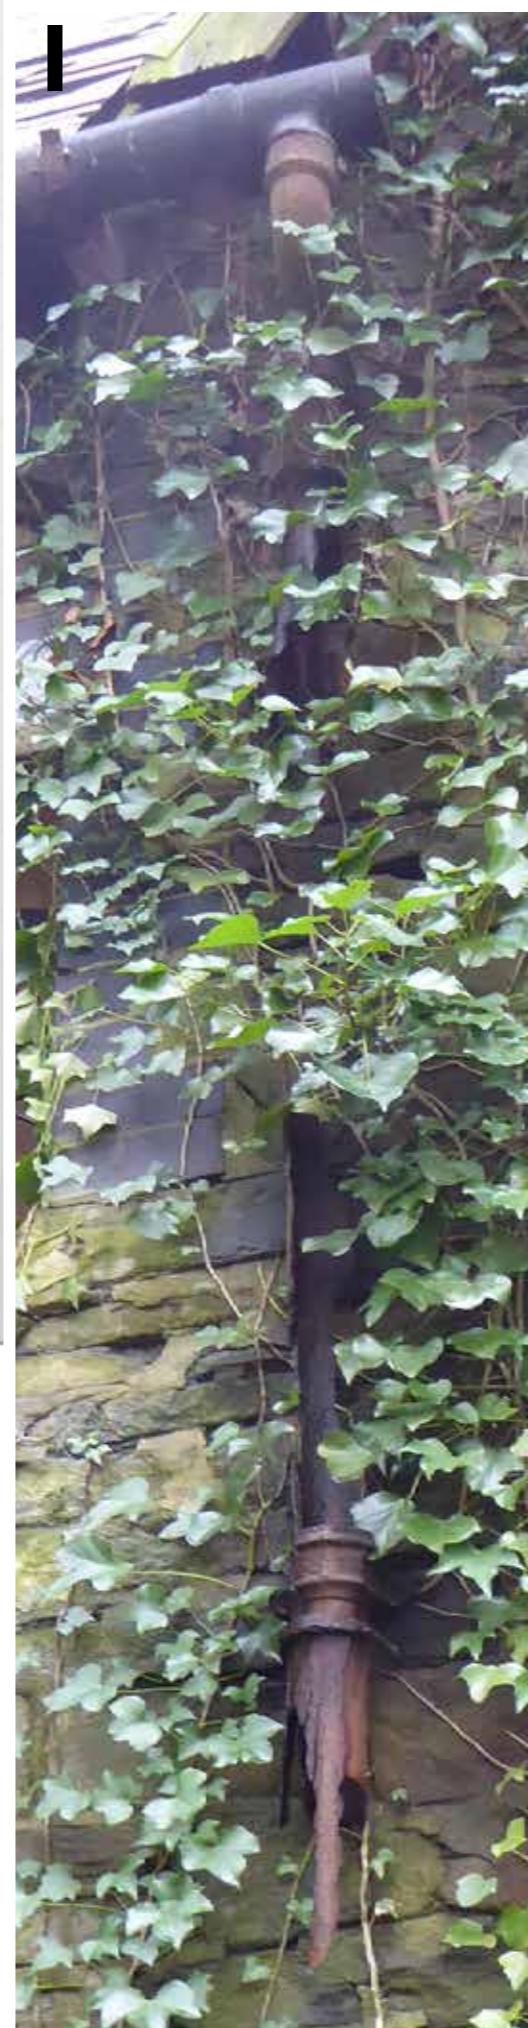
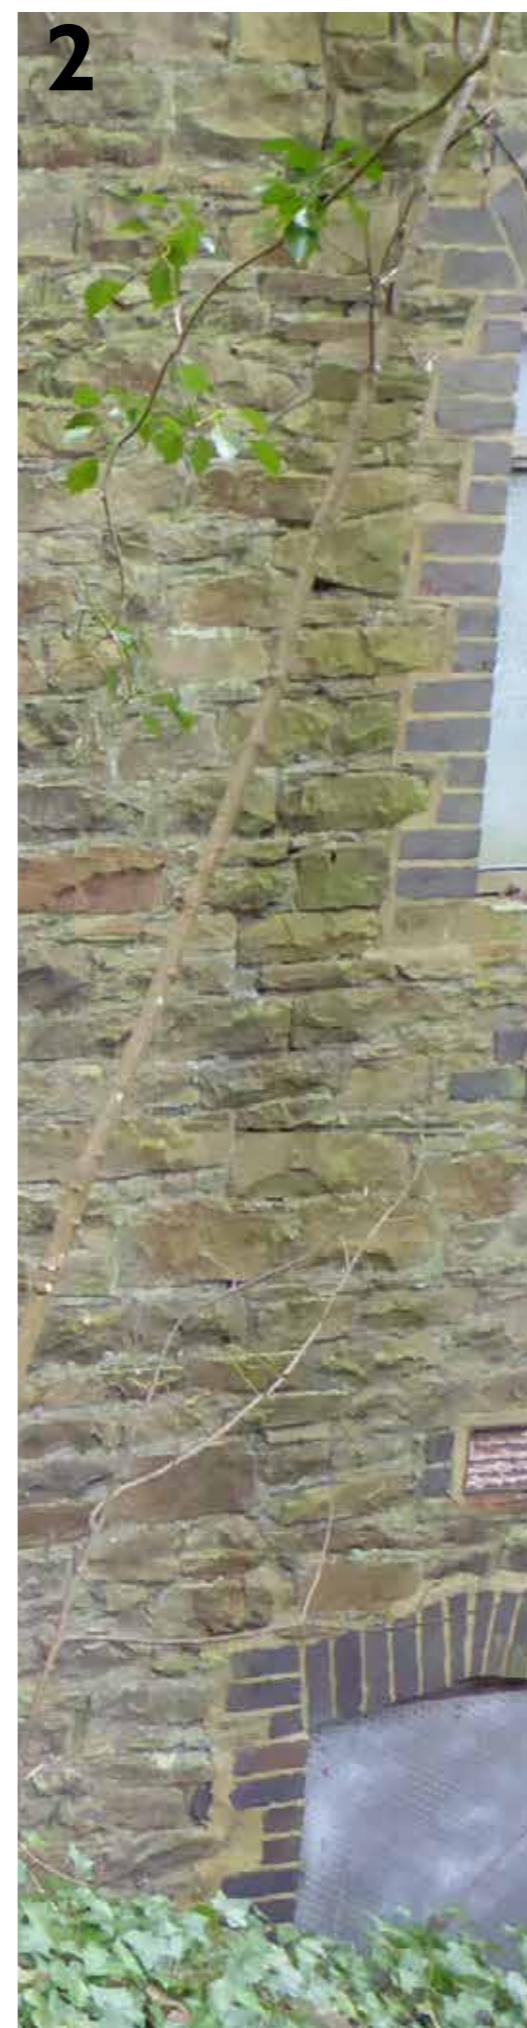
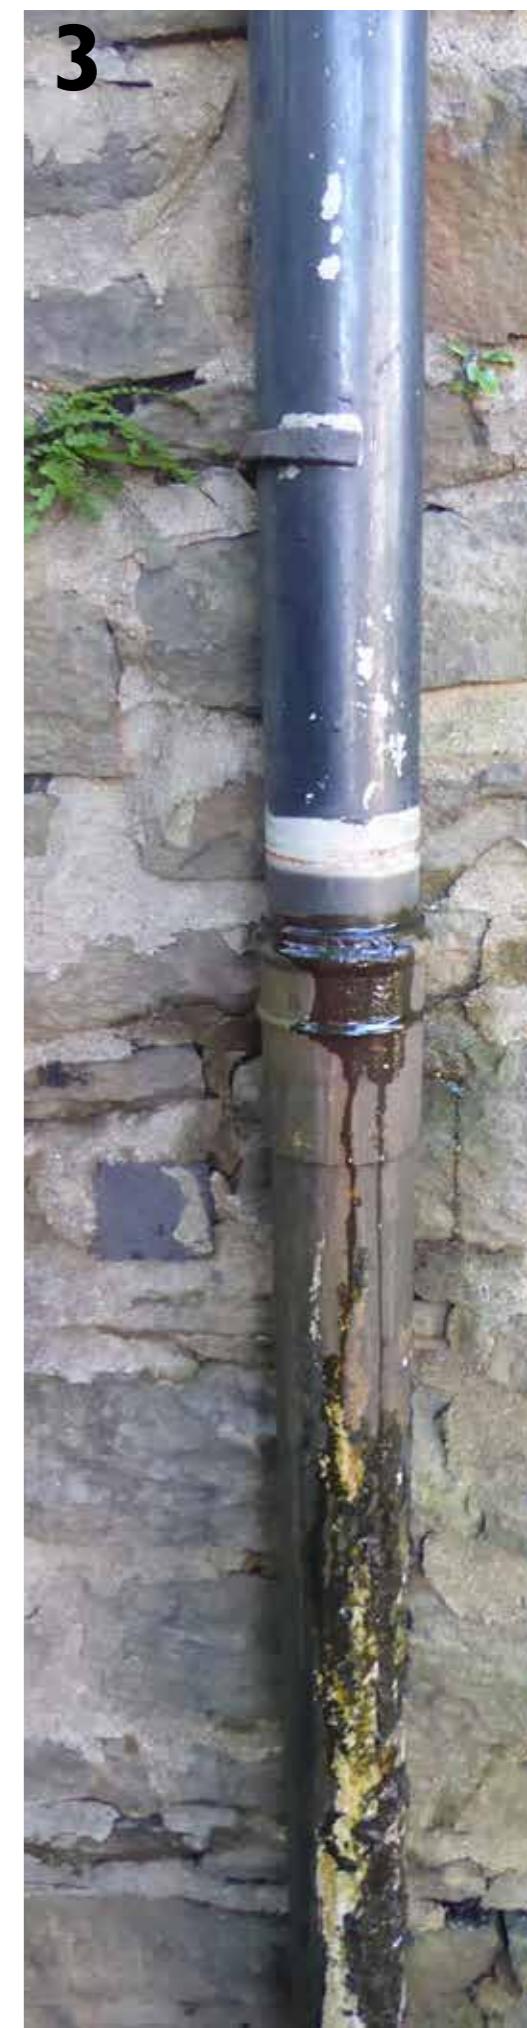
Examples of Condition Issues with the Rainwater Goods  
(with numbers referring to photographs)

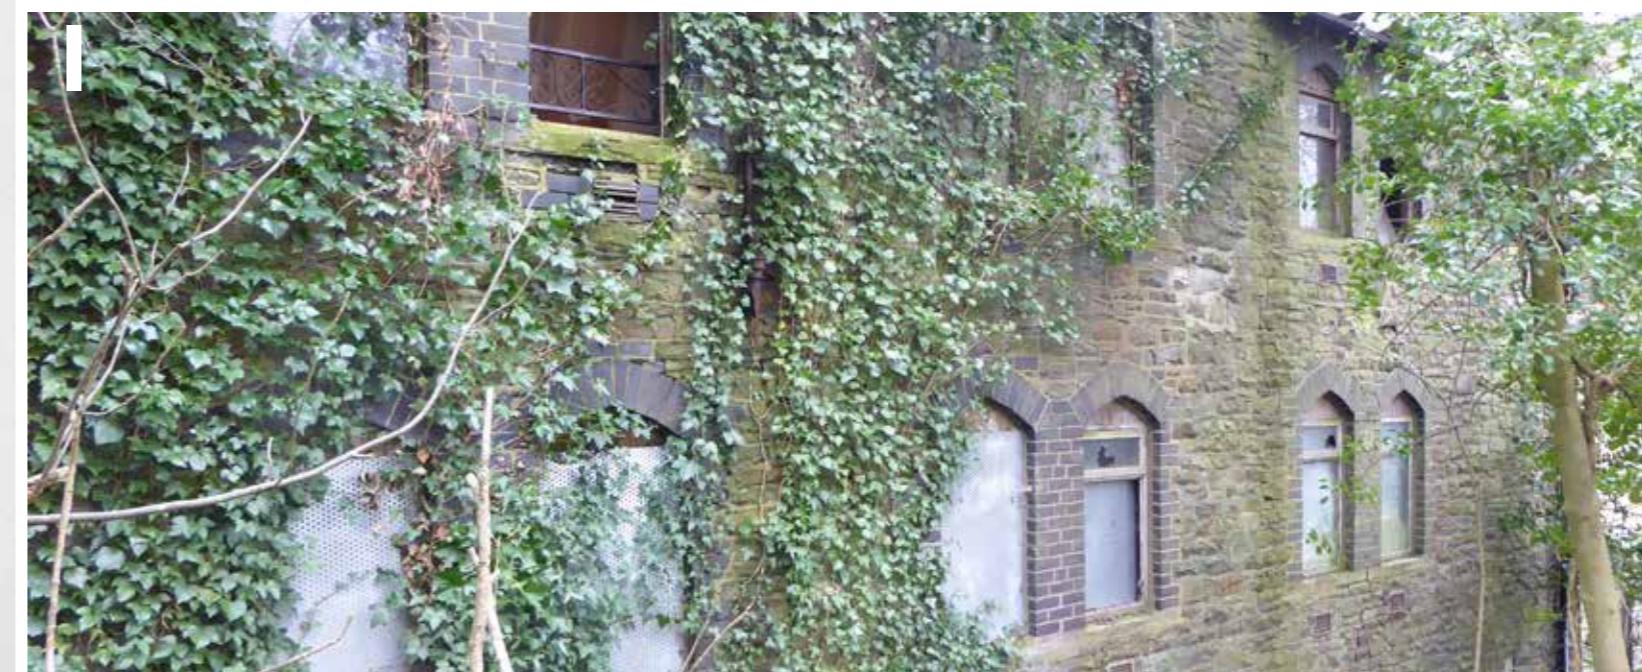
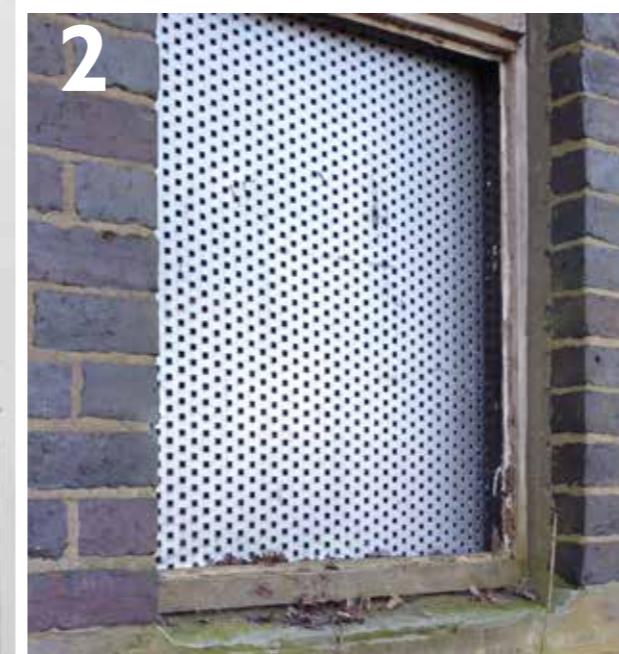
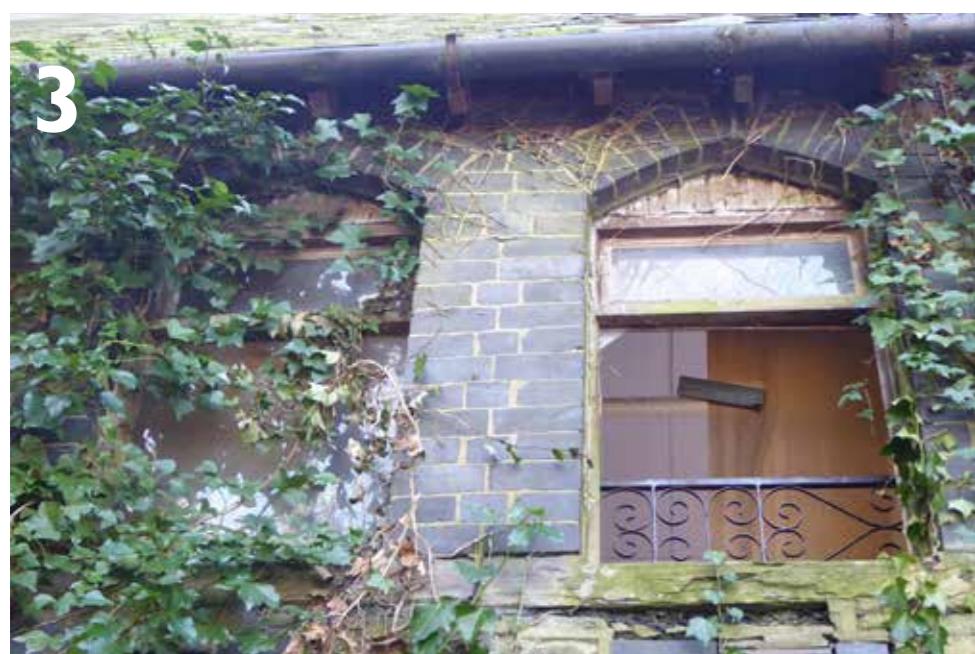
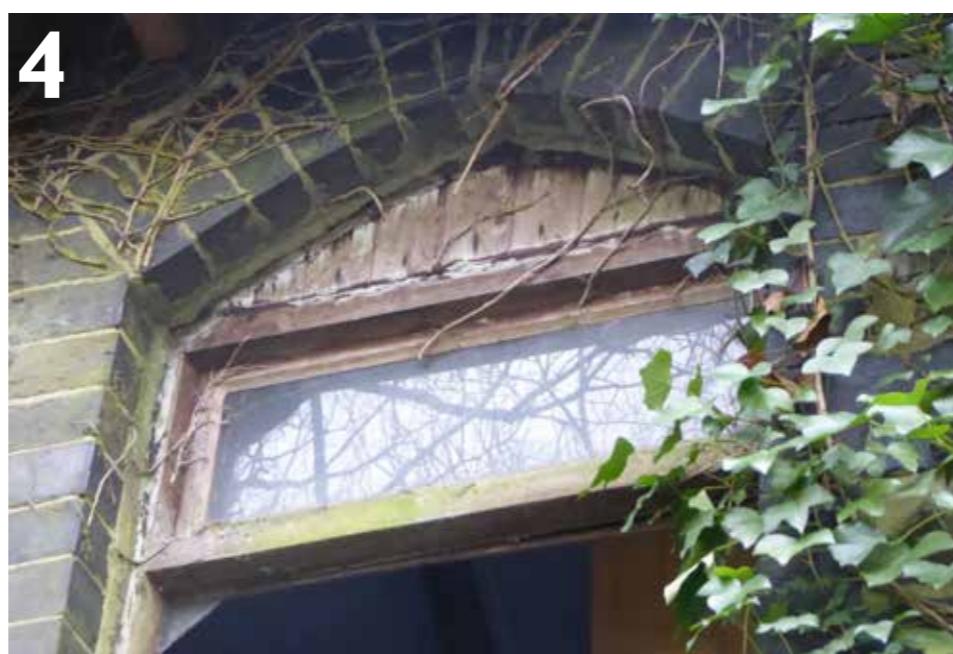
### 6.3 SIDE (NORTH) ELEVATION

Examples of Condition Issues with Windows  
(with numbers referring to photographs)
