# Synagogue, Merthyr Tydfil

## RECORD OF BUILDING AND CONDITION ASSESSMENT REPORT

.....  
(449)2503-GVVP-A-HIS-P00

Date: 17.03.25

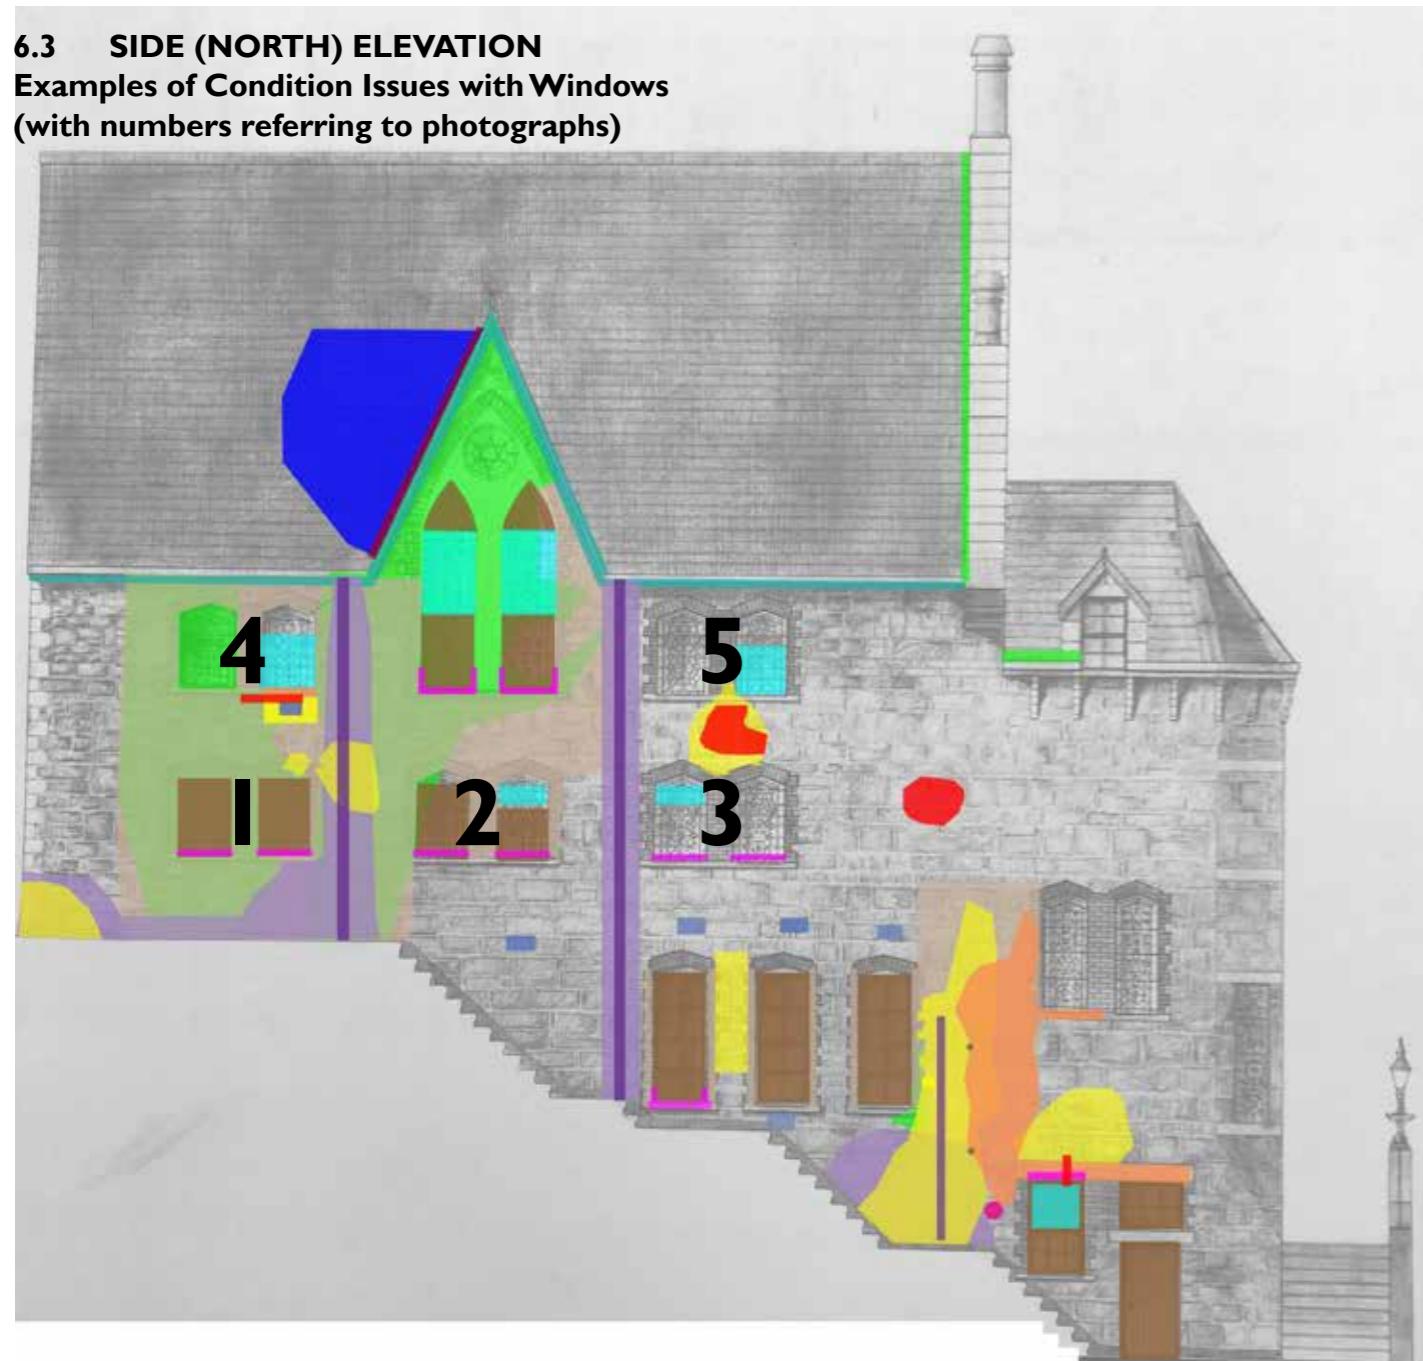
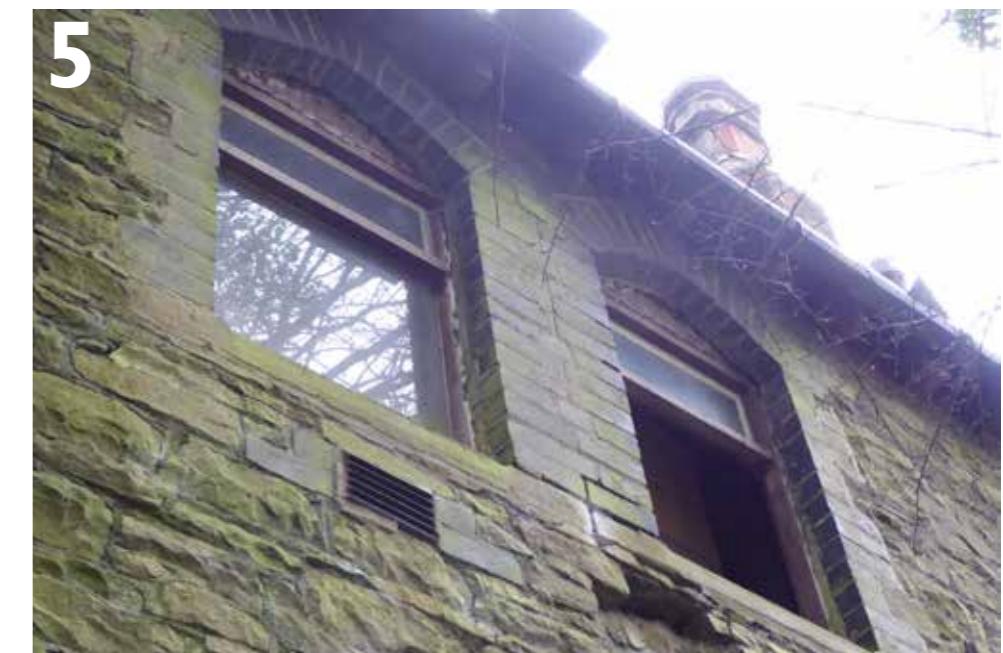
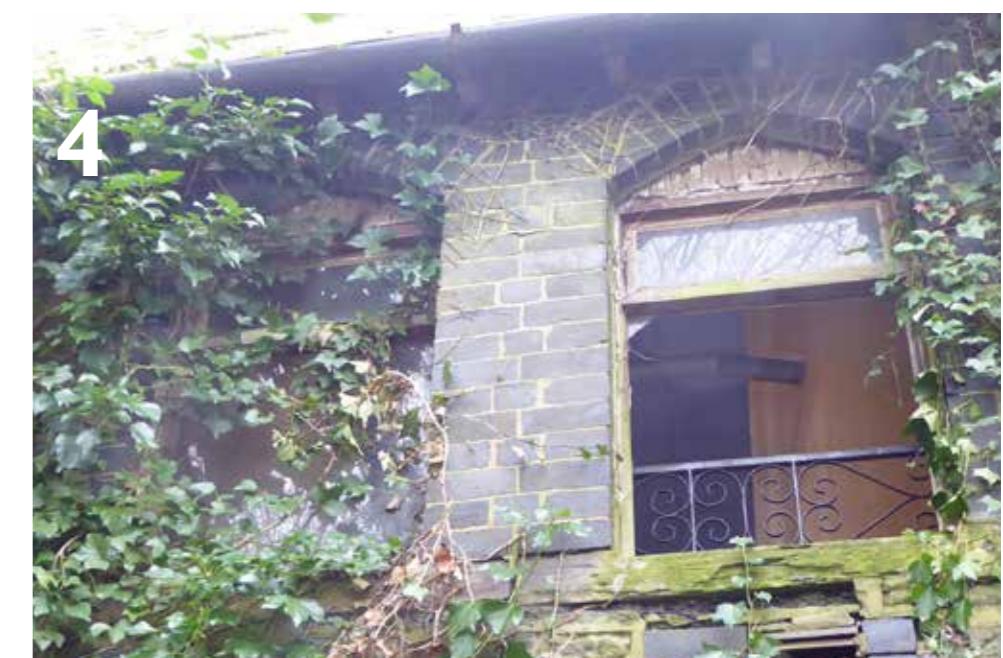
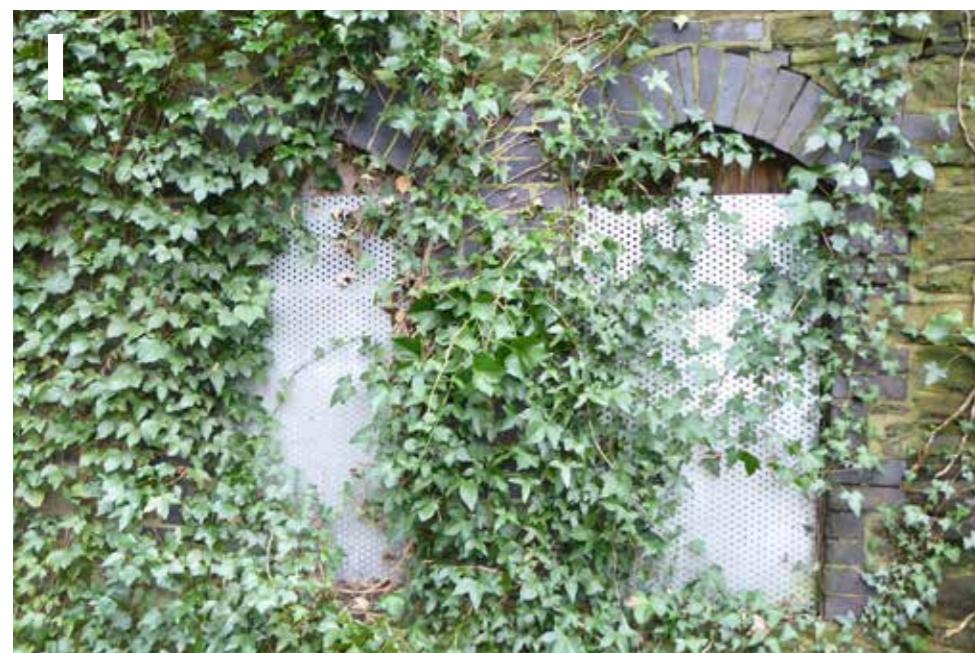
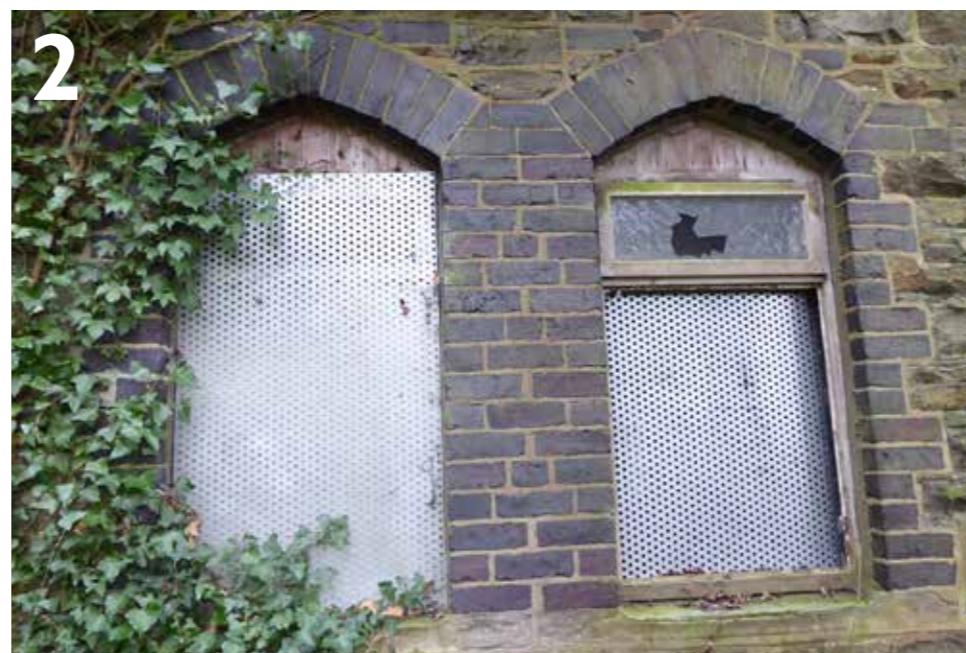
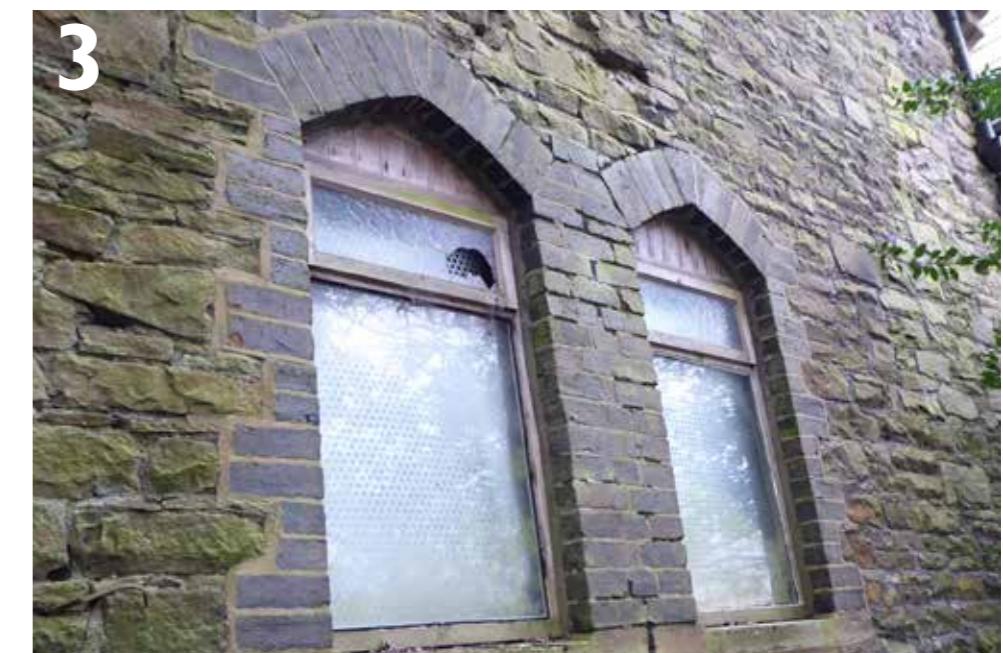
### 6.3 SIDE (NORTH) ELEVATION

Examples of Condition Issues with Windows  
(with numbers referring to photographs)

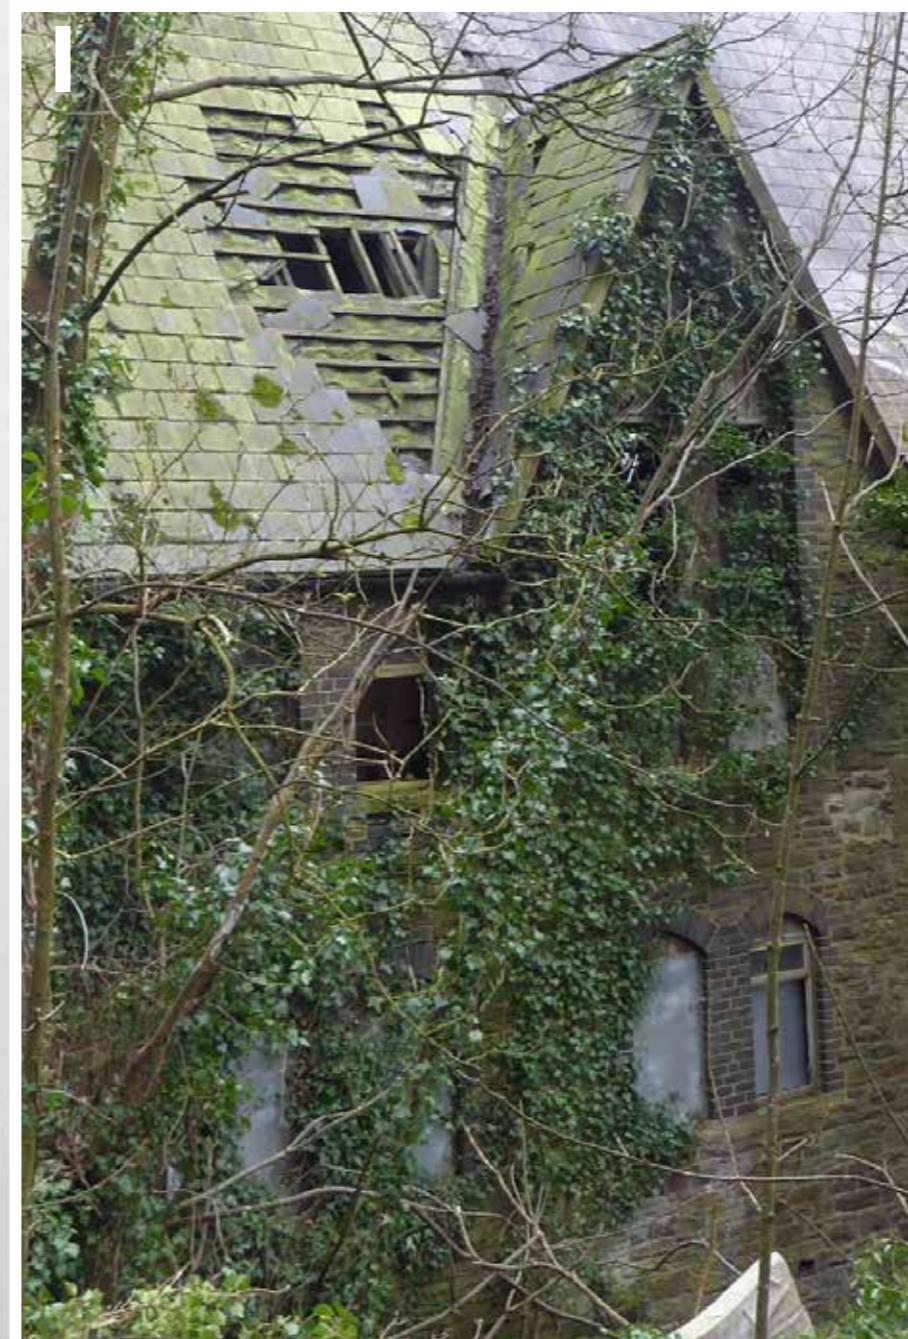
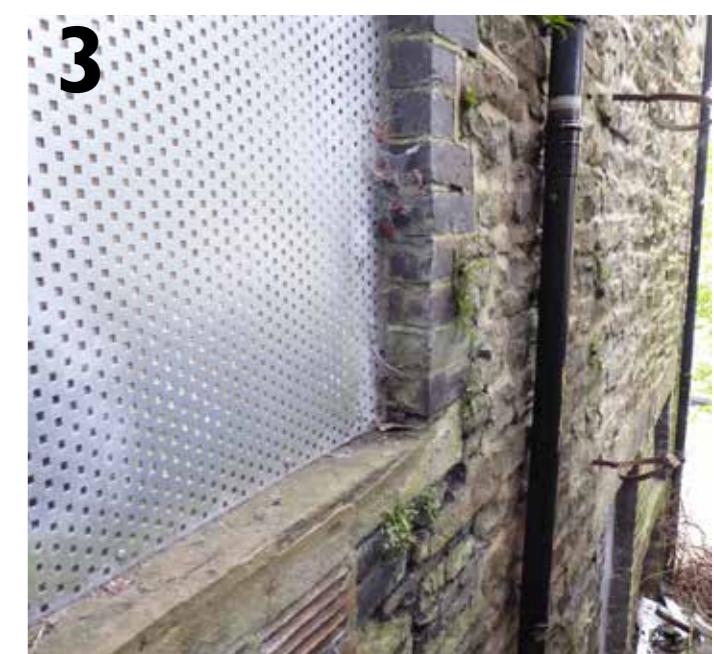
**6.3 SIDE (NORTH) ELEVATION**

Examples of Condition Issues with Vegetation  
(with numbers referring to photographs)

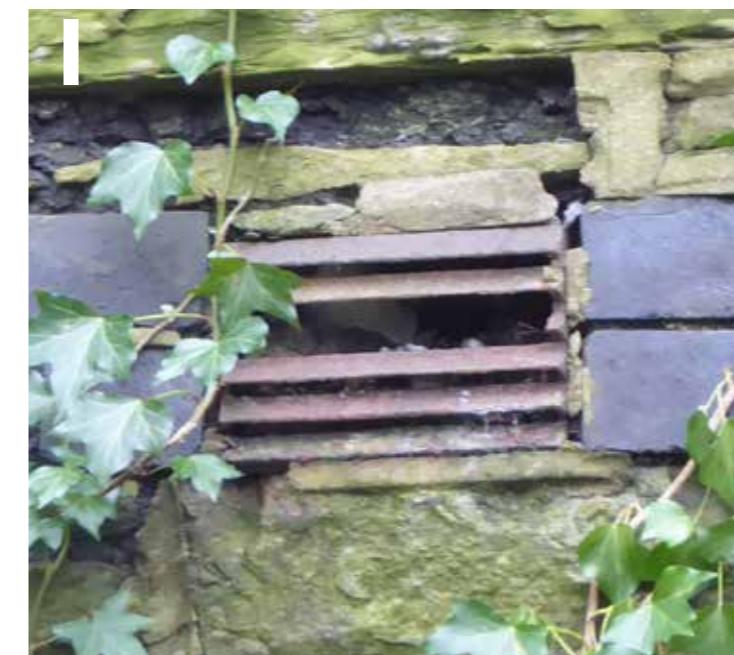
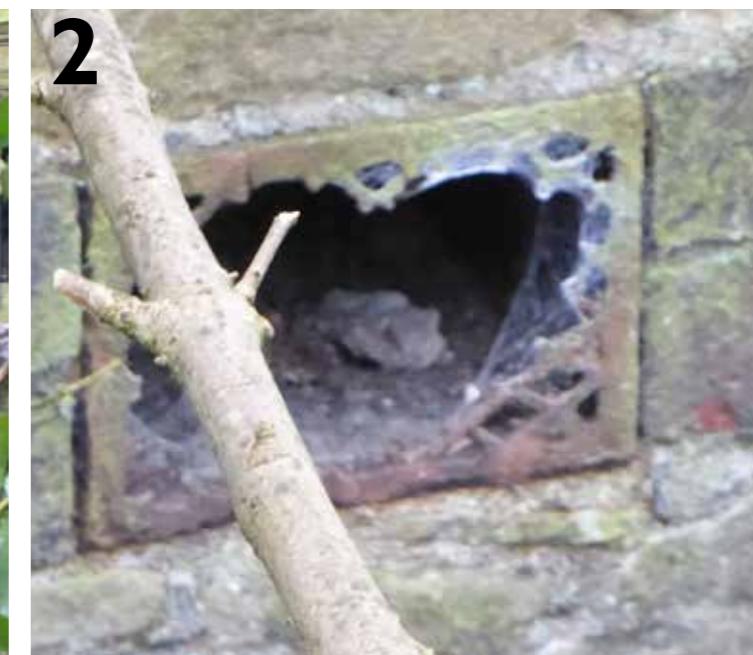
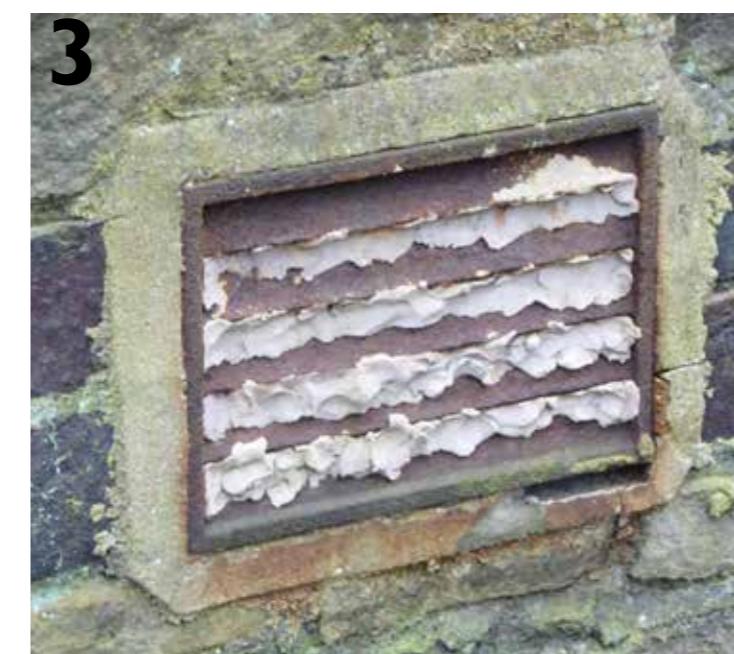
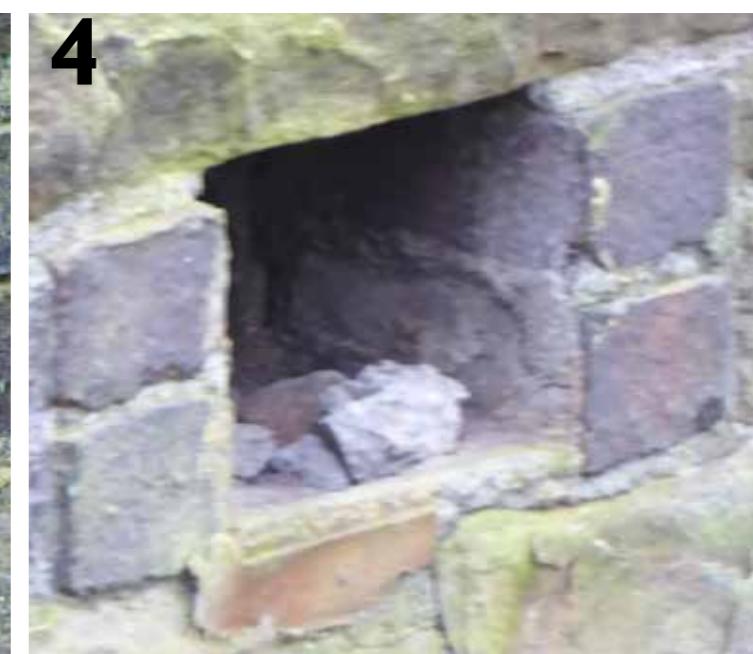
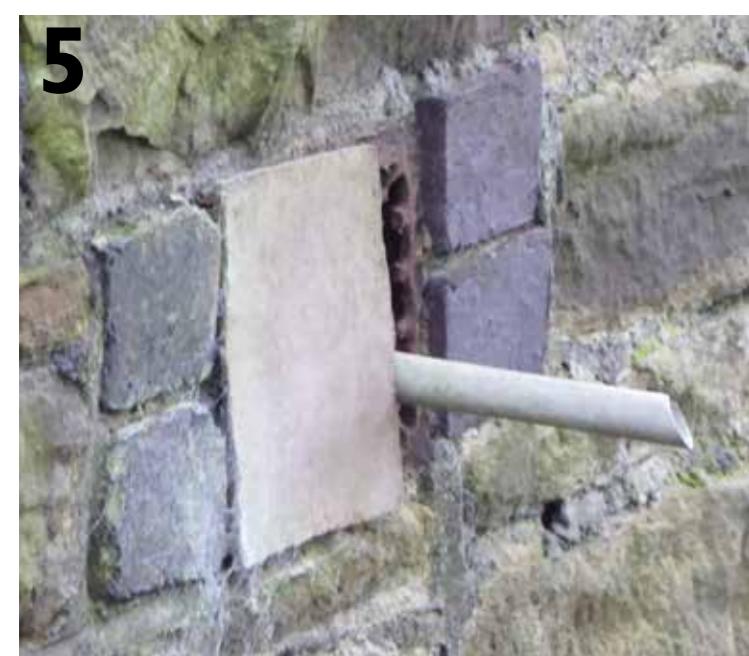
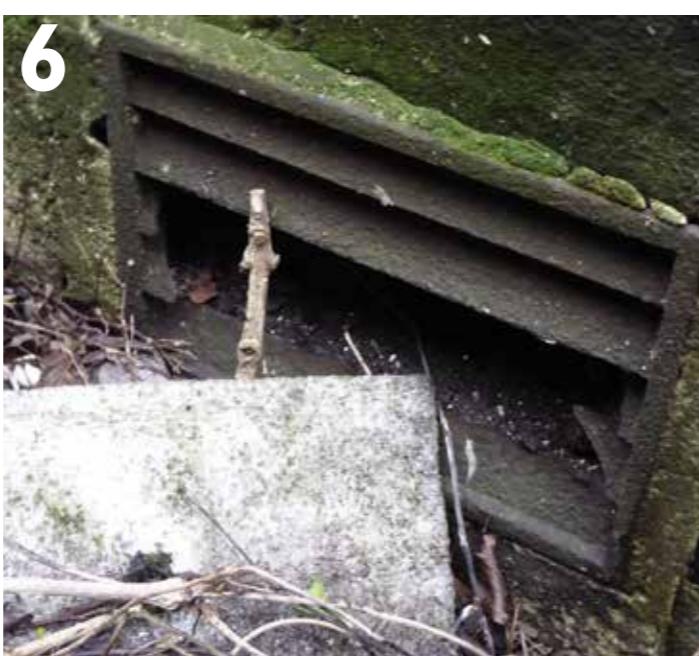
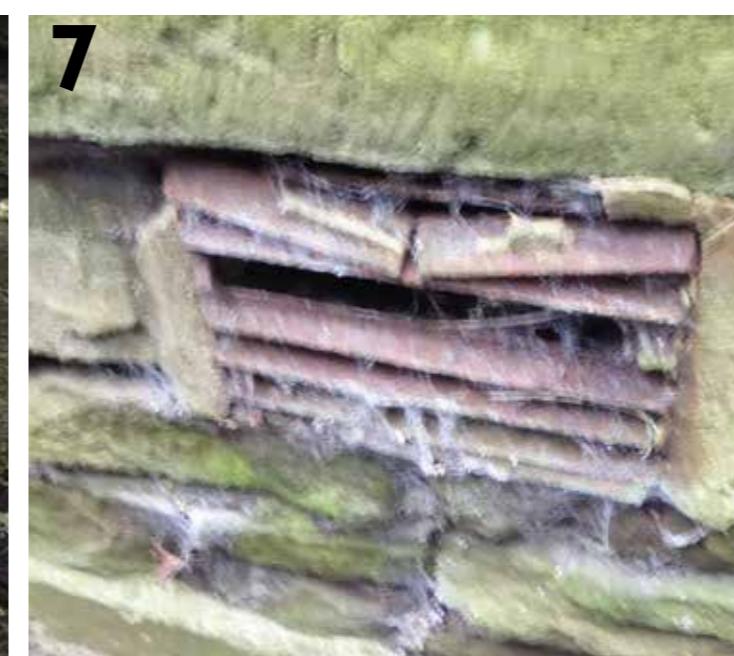
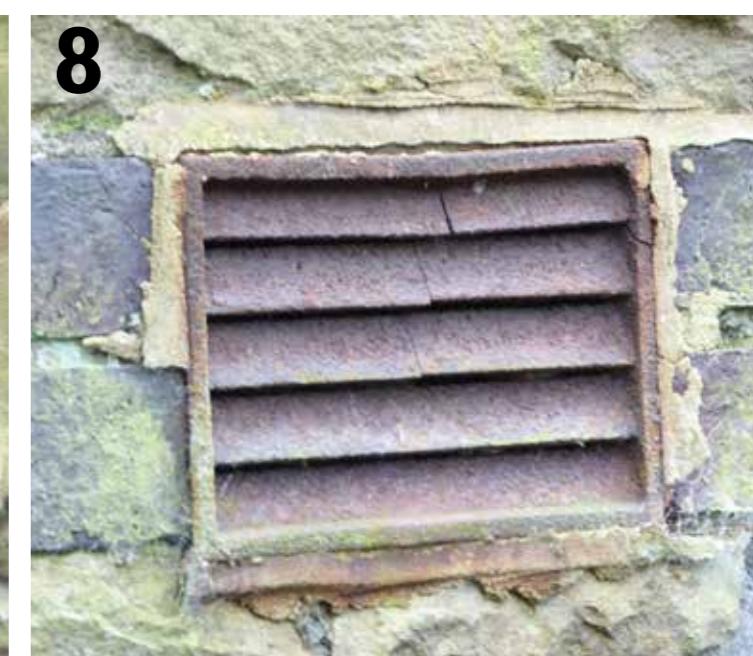
**6.3 SIDE (NORTH) ELEVATION**

Examples of Condition Issues with the Vents  
(with numbers referring to photographs)

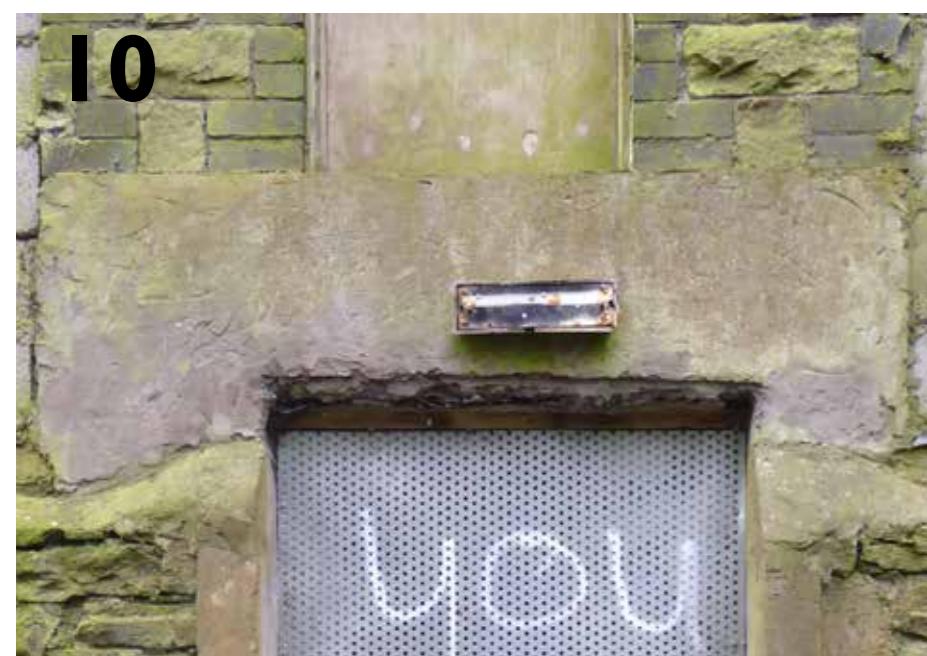
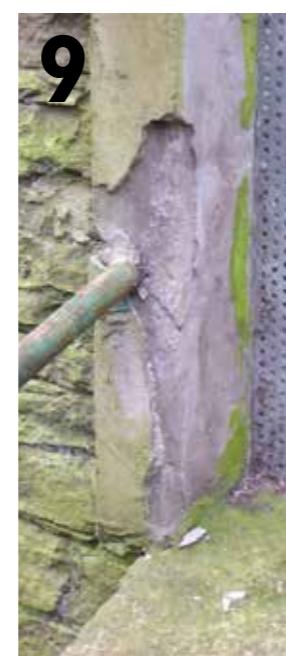
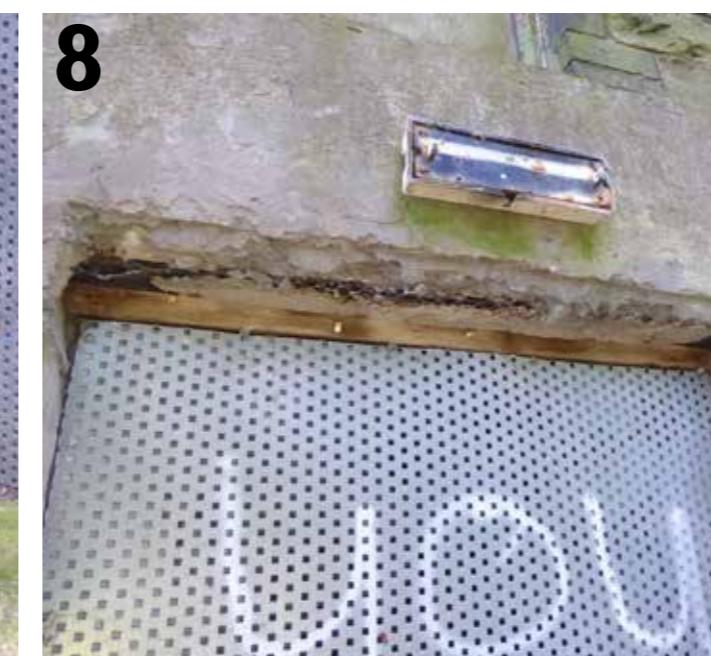
**6.4 REAR (EAST) ELEVATION**

Examples of Condition Issues  
with the Stonework  
(with numbers referring  
to photographs)

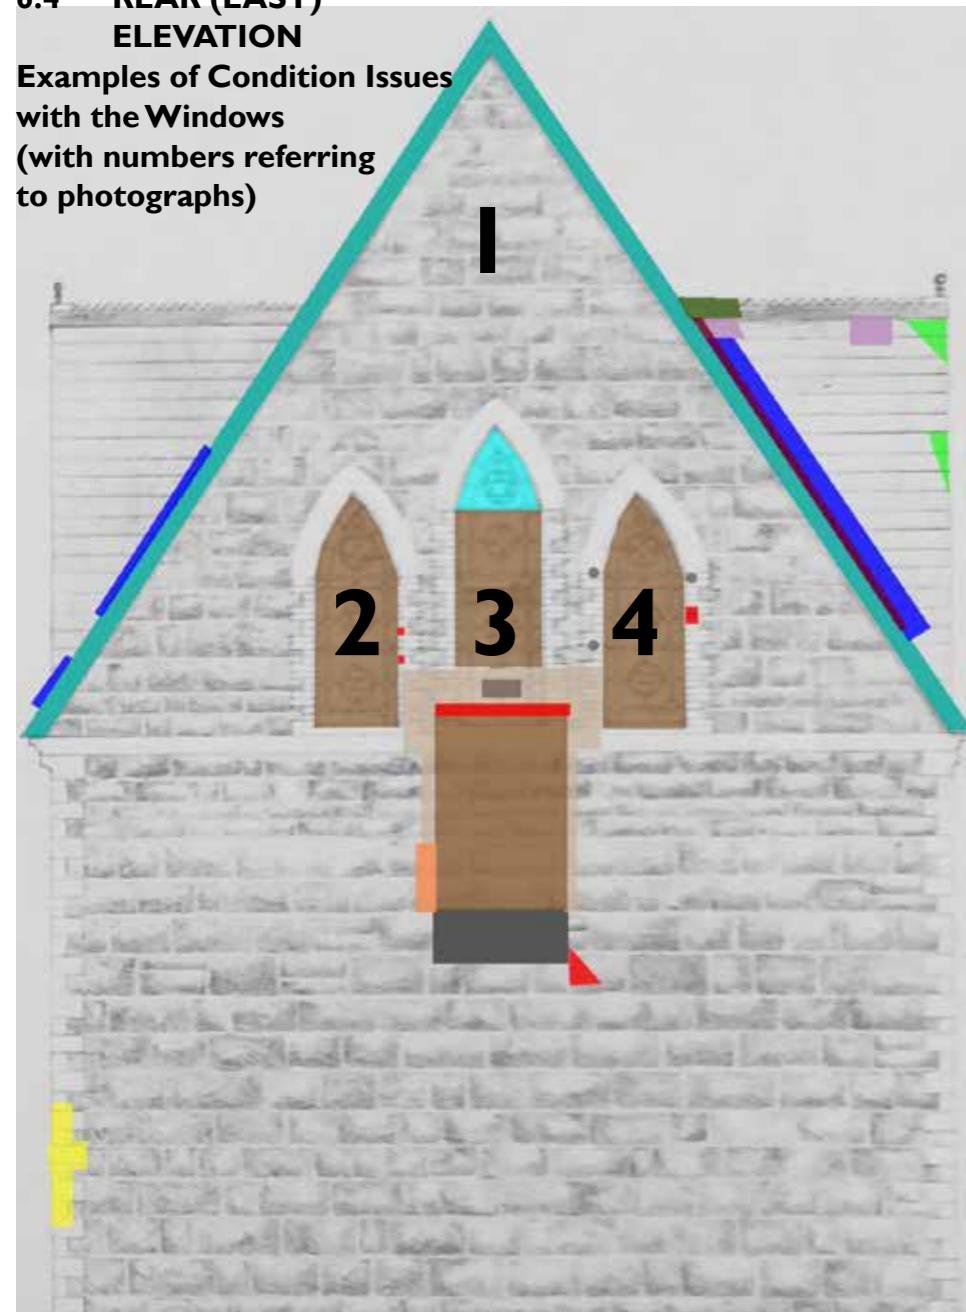
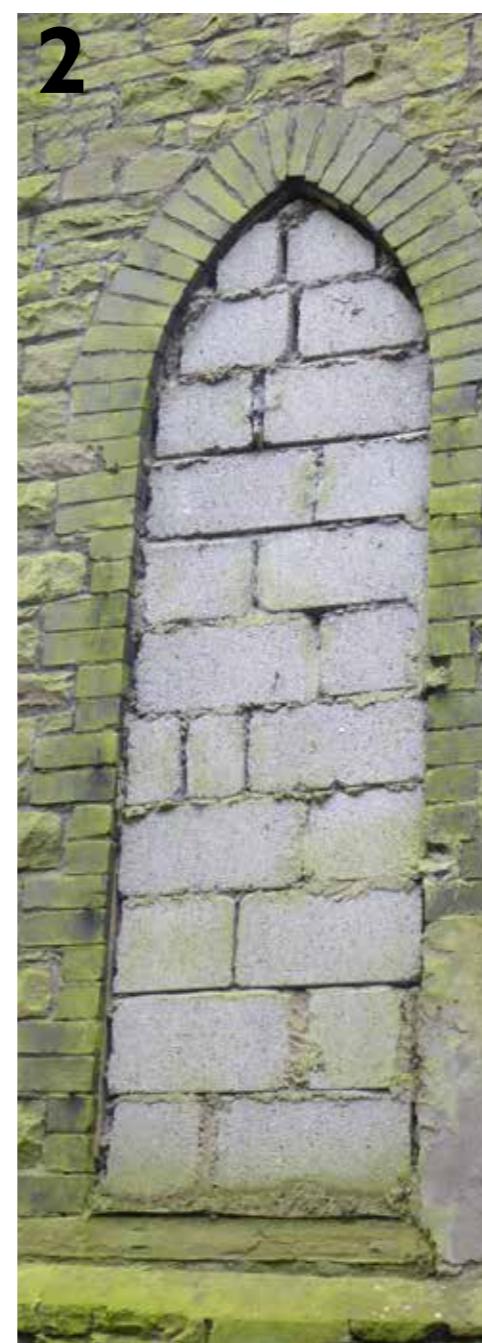
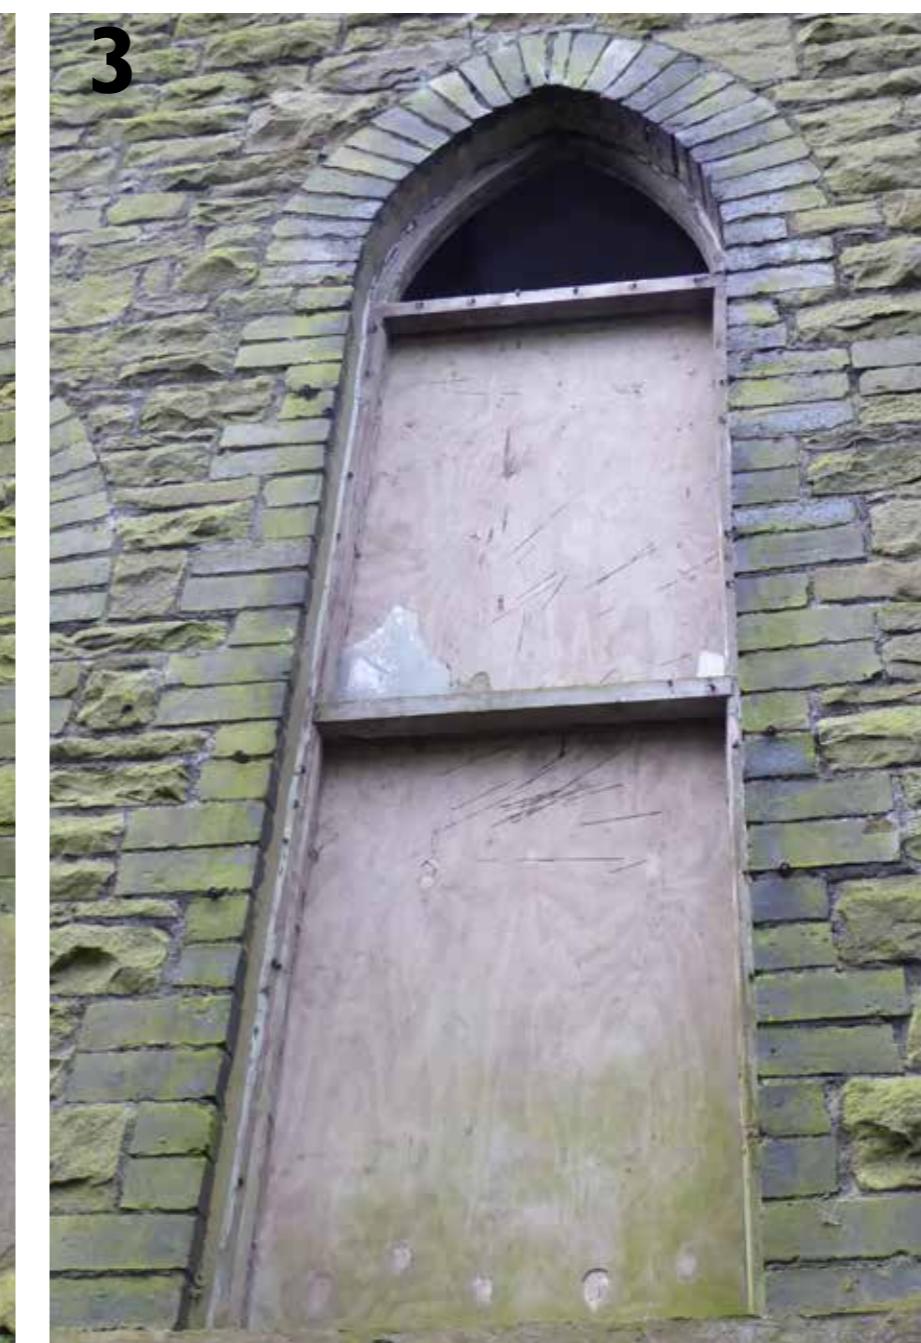
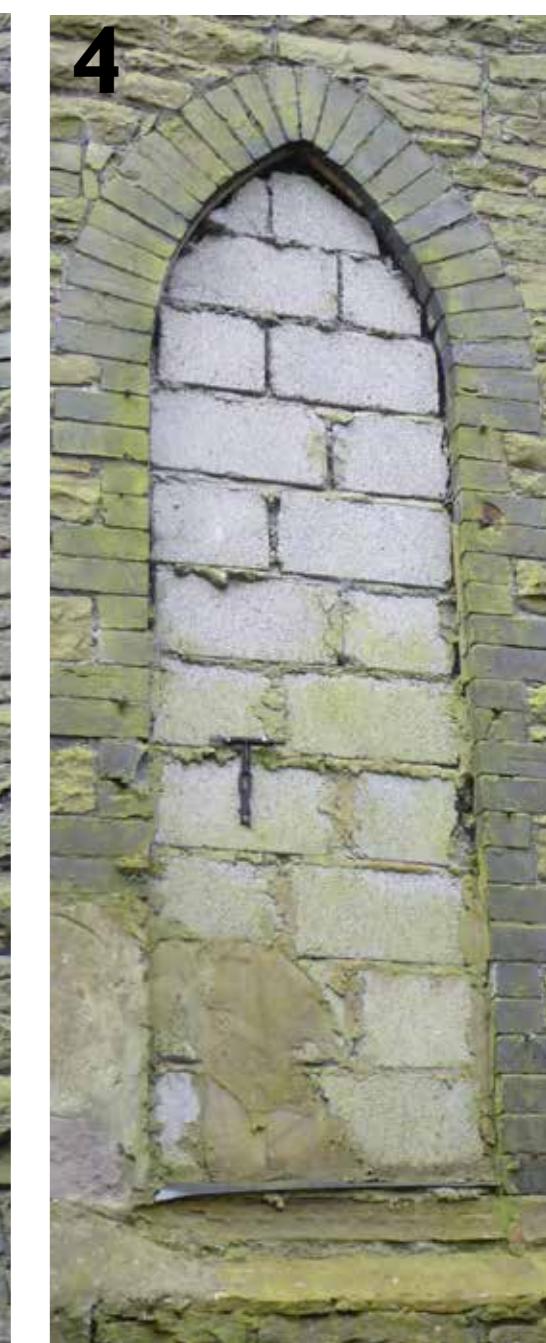
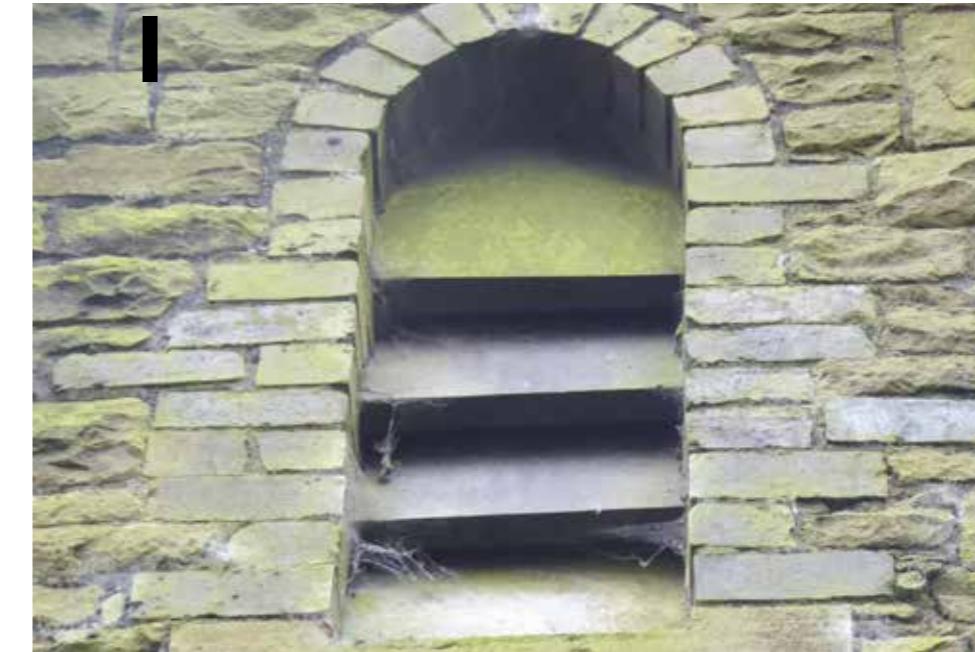
**6.4 REAR (EAST)  
ELEVATION**

**Examples of Condition Issues  
with the Windows  
(with numbers referring  
to photographs)**
